SERVICE BULLETIN

APPLICABILITY: 2013 MY BRZ

NUMBER: 12-145-13

SUBJECT: Condensation in Rear Combination Lamps, Retaining Nut Change

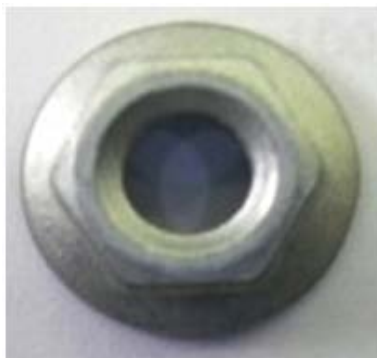
Due to a smaller diameter flange surface, the original retaining nuts may distort the rear body panel mounting and sealing surfaces for the combination lamps enough to allow moisture seepage past the seals into the combination lamps and possibly the trunk area.

Original Nut, 12mm diameter flange surface

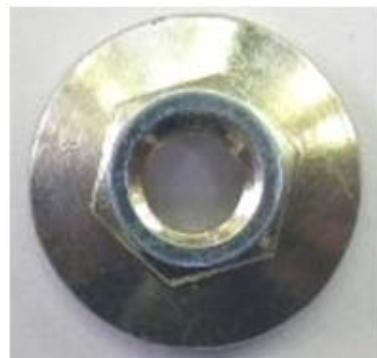
Revised Nut, 15mm diameter flange surface

The revised retaining nuts with a larger diameter flange surface were incorporated into production starting with VIN D*605847.

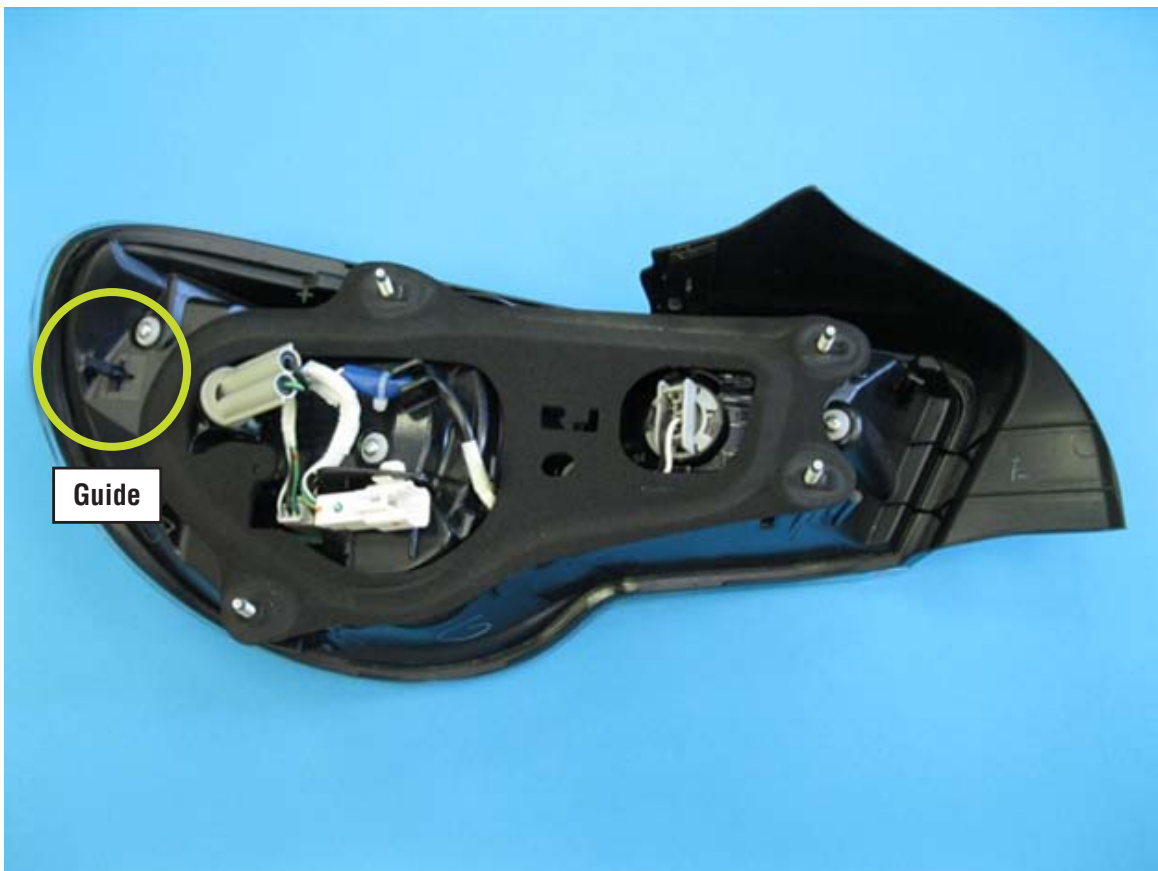
NOTE: There is a plastic guide on the outside corners of the combination lamps as shown in the photo below. Be careful when removing and reinstalling the lamps not to damage it.

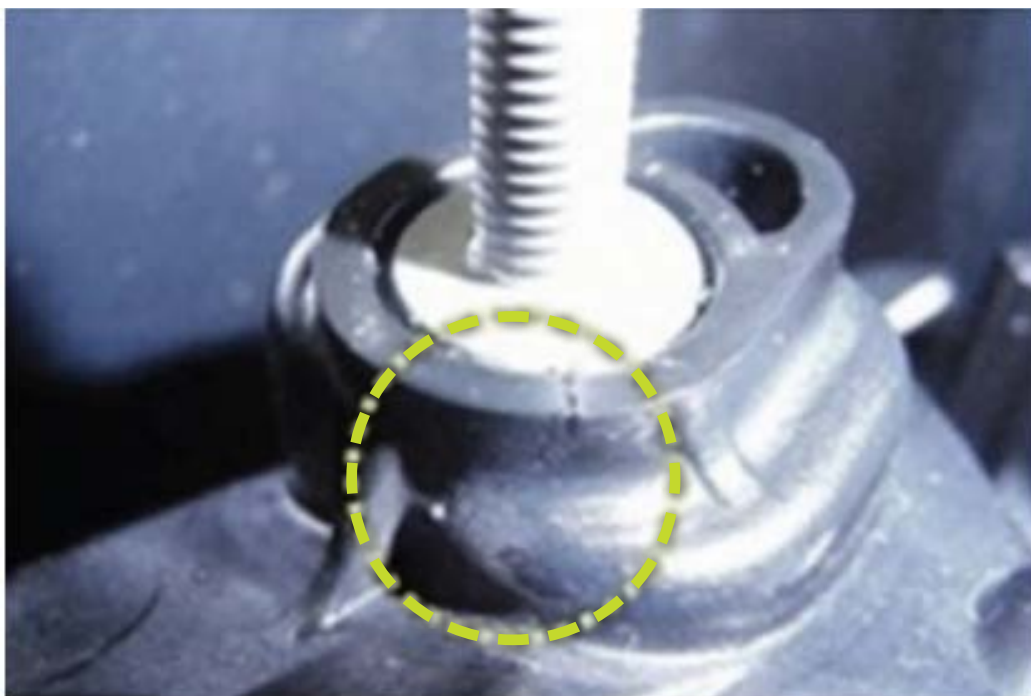
Example of crack

Once the combination lamps are removed, inspect their mounting stud boss areas carefully for any cracking as shown in the photo example below. Any damaged combination lamps must be replaced.

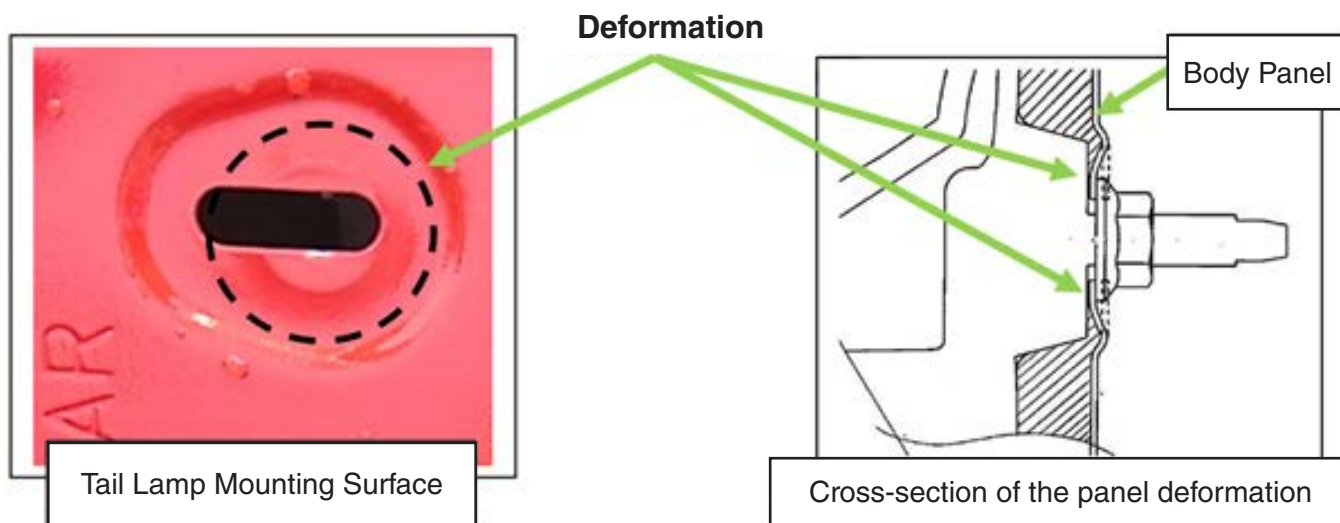
Inspect the rear body panel in the retaining nut areas for any deformation of the metal as shown in the illustrations below.

If any deformation is found, CAREFULLY straighten the affected mounting area using a small body hammer and dolly.
