Technical Information Bulletin**Connecting Rods on Certain 3304 and 3306 Gas and Diesel Engines Have Failed{1225}**

Media Number -TIBU6940-00

Publication Date -26/02/2013

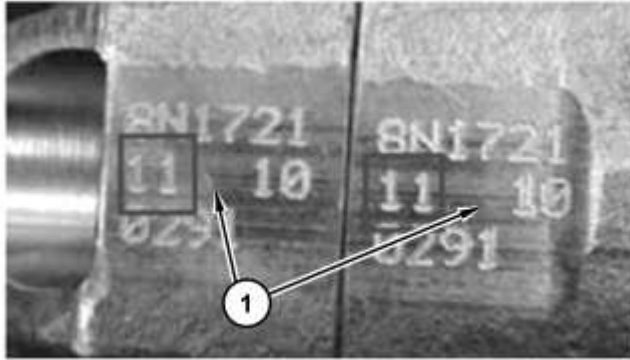
Illustration 1

Caterpillar is aware of recent failures of the **8N-1721** Connecting Rod and the **8N-1984** Connecting Rod on certain diesel and gas applications of 3300 engines. Primary failure mode is a ventilated cylinder block due to the connecting rod crank end failure. All failures have occurred before 500 hours in service. Root cause has been identified and the team is working to resolve the issue.

Markings on the Suspect 8N-1984 Connecting Rod and the 8N-1721 Connecting Rod

(1) Date code markings

These defective factory new rod assemblies do not have any marking on the machined bottom face of the connecting rod cap.

- First pair of digits is year
- Second pair of digits is month

Note: Do not use factory new connecting rod assemblies with manufacturing dates between April 2011 and December 2012.

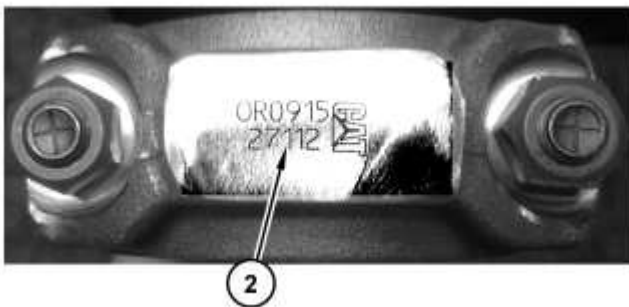
Illustration 2

Markings on the Correct 0R-0914 Connecting Rod and the 0R-0915 Connecting Rod

(2) One type of marking

Only use Genuine CAT Reman connecting rod assemblies. The genuine CAT Reman connecting rod assemblies can be identified by viewing the connecting rod cap from the bottom face. The defective factory new rod assemblies do not have any marking on this machine surface. Genuine CAT Reman connecting rod assemblies have one of the two markings shown Illustrations 2 and 3.

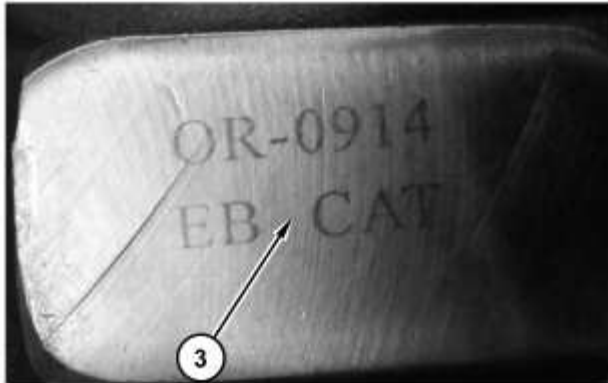
Illustration 3

(3) Other type of marking
