## i-MID Software Update

### SYMPTOM

The odometer, trip computer, fuel range, and fuel economy statuses are not visible on the i-MID display.

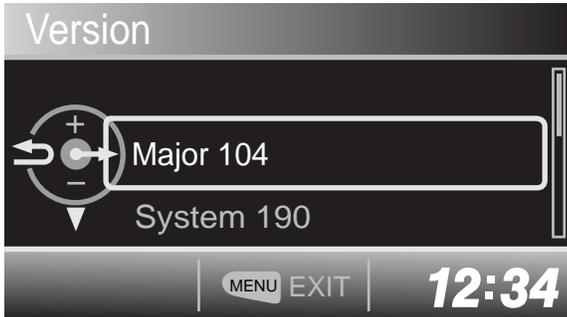
5. Check the software version.

- If the software version is **MajorV105** or later (shown on the i-MID display as **Major 105** or later), this service bulletin does not apply. Continue with normal troubleshooting.
- If the software version is **MajorV104** (shown on the i-MID display as **Major 104**), go to step 6.
