Service Campaign Bulletin

Campaign No. 2013010003, January 2013

SUBJECT: **Model 204, Model Year 2012**
Apply Seam Seal to the Left and Right Rocker Panels

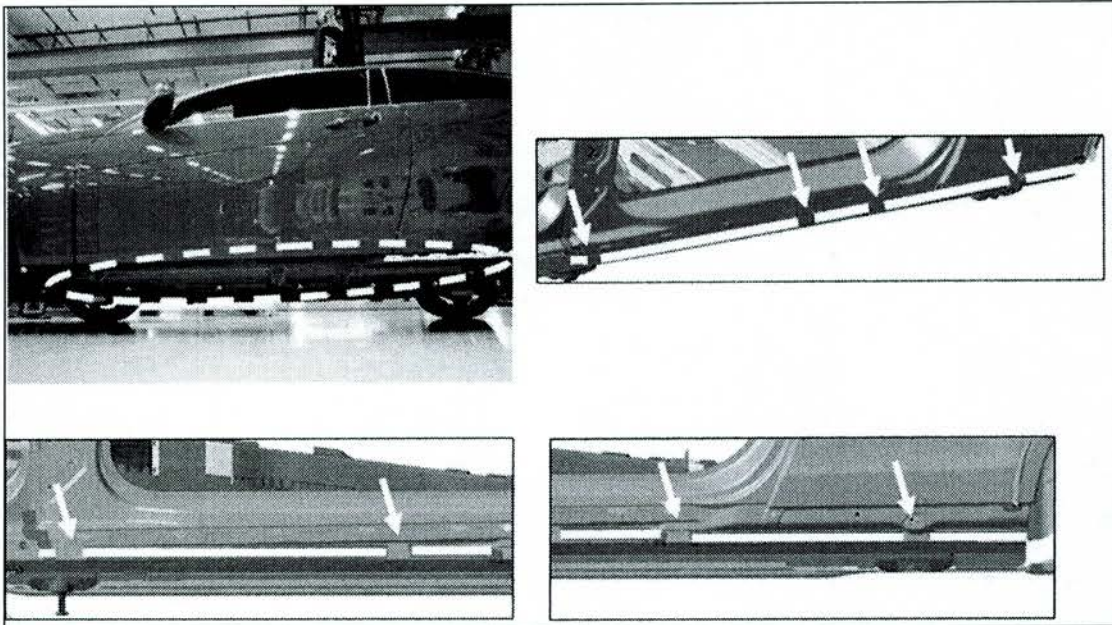
**Figure 1**

This Service Campaign has been initiated because Daimler AG (DAG), the manufacturer of Mercedes-Benz vehicles, has determined that the seam seal at the rocker panels may be missing due to a production issue. An authorized Mercedes-Benz dealer will apply seam seal on the left and right rocker panels at the next workshop service.

1. Remove/install longitudinal member panel (circled, Figure 1) at left and right, refer to WIS: AR88.80-P-6000CW.

2. Clean the area to be processed under the longitudinal member panel thoroughly and then degrease with silicone remover (marked area).

3. Apply missing sealant (to marked areas, Figure 1) using a standard size caulking gun (locally sourced).

Ensure that the water drains (4 on each side) remain open (arrows, Figure 1).
