SB-10051999-5427

SI B66 01 13
Distance Systems, Cruise Control, Remote Control

PDC: Complete Failure of Front and/or Rear Sensors

F25

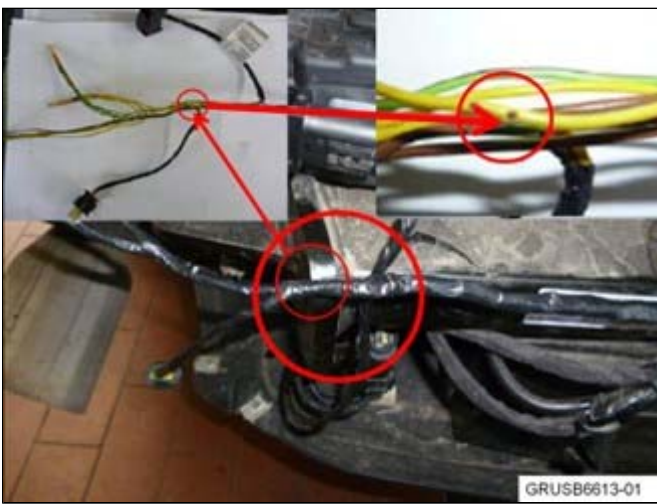
8. This picture shows a location where the rear PDC wire harness rubs against the trailer hitch if installed.

Note: This picture is a view of the left rear of the vehicle.

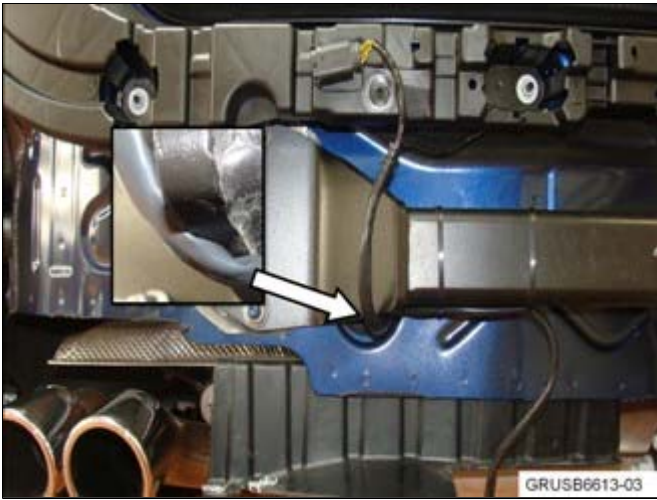
10. This picture shows a different trailer hitch installed, and another location where the PDC wire harness is pinched or rubs against the trailer hitch.
11. Apply felt strip to the location on the trailer hitch where the PDC wire harness contacts.

Note: This picture is a view of the left rear of the vehicle.

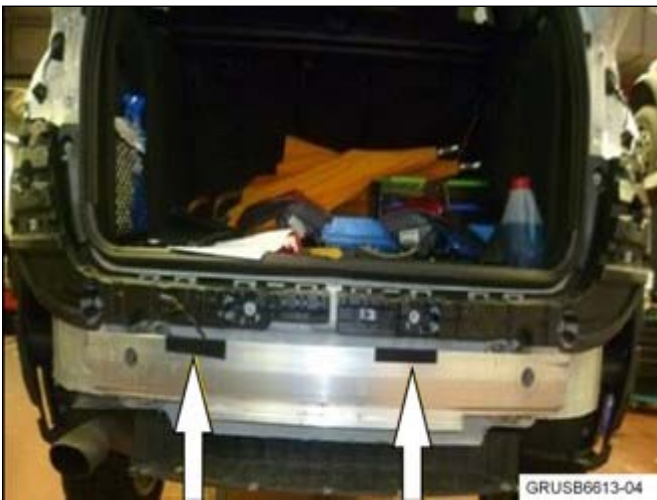
Note: This vehicle does not have a trailer hitch installed.

13. The arrows point to two locations where the PDC wire harness could be damaged.
14. Install felt strip on the bumper bracket as shown.

12. If needed, remove the rear bumper support. Refer to Repair Instruction RE5112050, "Removing and Installing Support for Rear Bumper Panel."

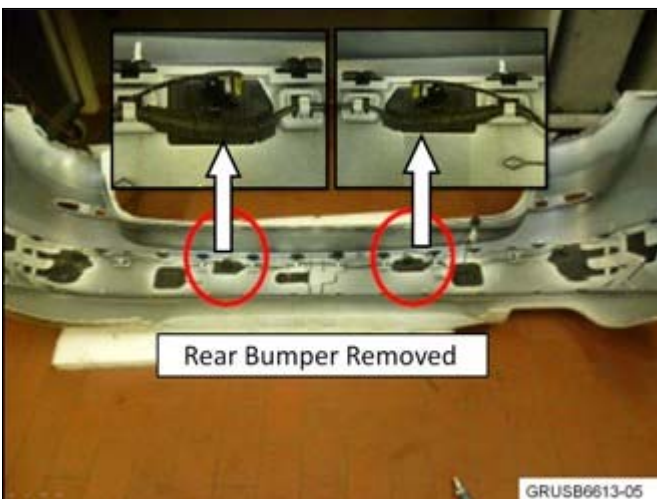
15. The arrows point to two locations where the PDC wire harness on the bumper could be damaged.
16. Wrap the wire harness using felt to prevent future damage.
17. Reinstall the bumper and verify the functionality of the PDC sensors.
