**SB-10052013-4785**

SI B65 10 13  
Audio, Navigation, Monitors, Alarms, SRS

**Enabling and Replacing New OC3 Seat Mat**

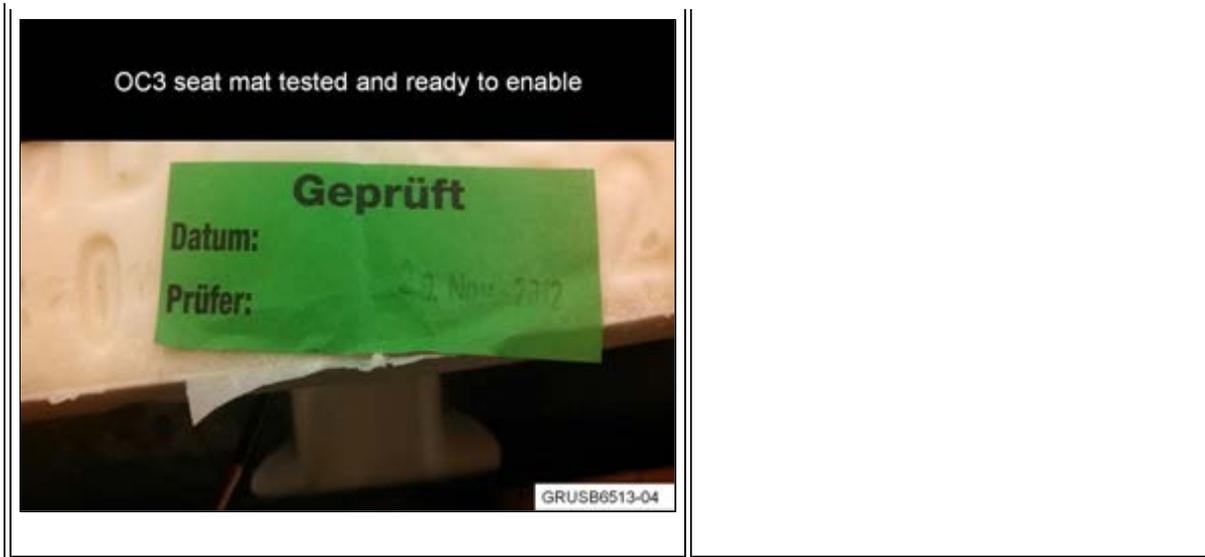
<p>Inspect the new part prior to installation; you should have same label as shown on the spare part to the left. With this label, the OC3 seat mat is ready to enable by following the procedure below.</p>
--	--
