**SB-10052014-4710**

SI B65 11 13  
Audio, Navigation, Monitors, Alarms, SRS

**CIS Seat Mat Replacement**

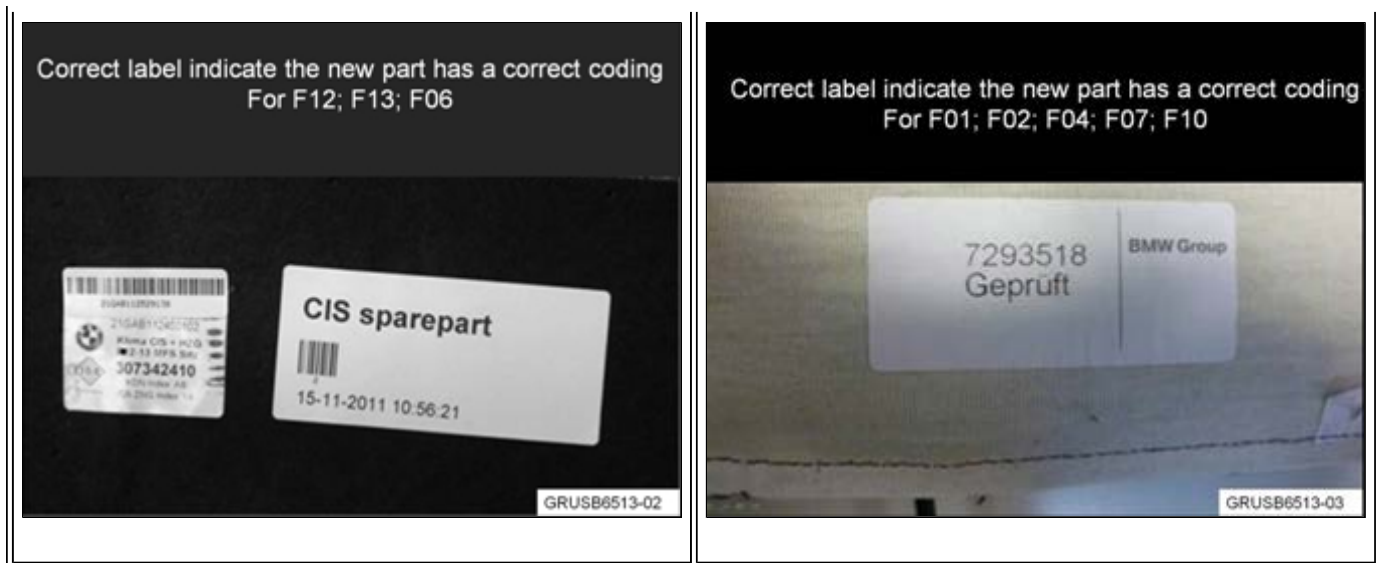
The pictures below are for a CIS seat mat that has the correct coding. The label should contain “CIS sparepart” or the German word “Geprüft” (tested).

Install the replacement CIS mat in the vehicle and code the ACSM (Advanced Crash Safety Module) with ISTA/P.

If the correct label is present; the new mat failed to enable; and the below faults are present, create a PuMA case for assistance. Make sure to attach a digital picture of the new seat mat to the case, as well as the original reason why the seat mat is being replaced.

If there is no label on the seat mat, reorder the new seat and submit a TTS PuMA case to the Parts Consultant Group, requesting assistance in obtaining the correct seat mat.
