**SB-10052017-4197**

**Title:** TerraStar Transmission Shift Cable Routing

**Applies To:** Terrastar Trucks
**DESCRIPTION**

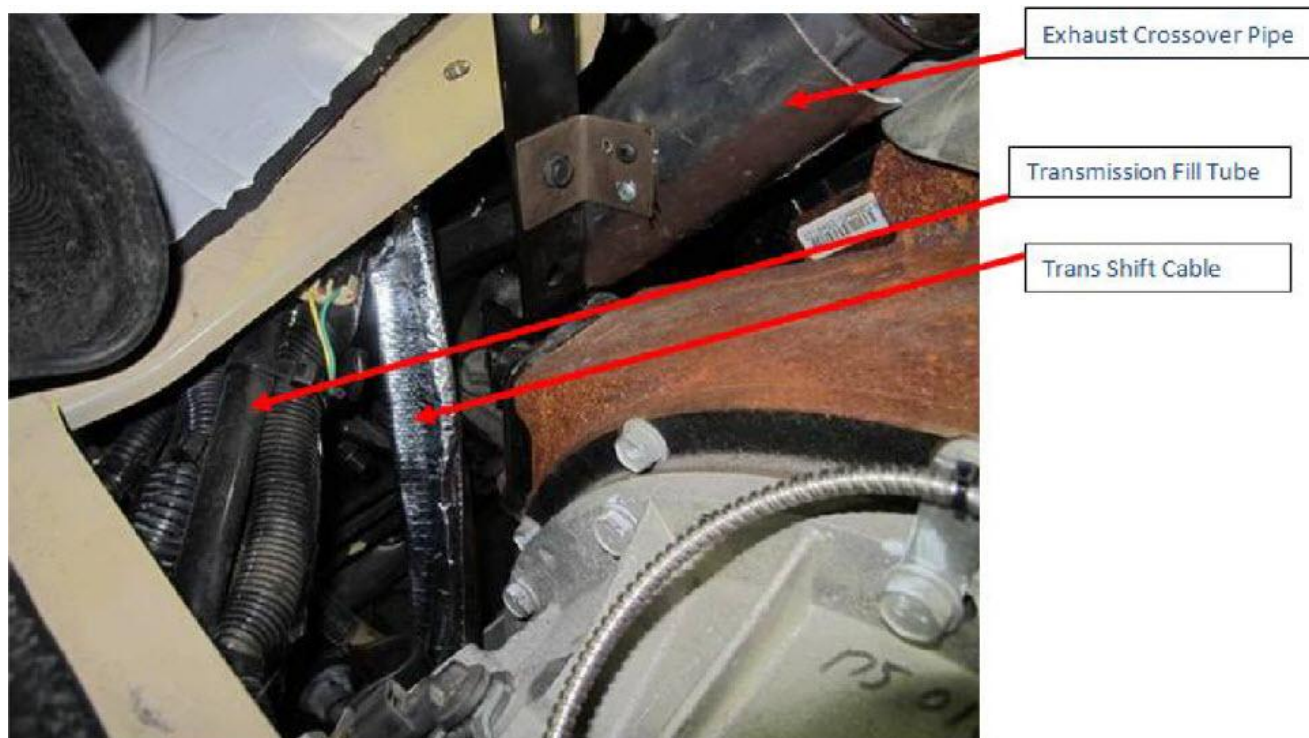
On 2010 through 2012 model year TerraStars, the shift cable may be routed incorrectly causing damage to the shift cable. This can cause difficulty selecting the desired transmission range, or if not resolved quickly, damage to the column gear shift assembly.

**Incorrect Routing** - Transmission shift cable is routed to the inside of the transmission fill tube.
