Service Bulletin

Bulletin No.: PI0931

Subject: Service Engine Soon (SES) Light On with DTCs P0171, P1101, and/or P0101 Set

Models: 2013 Buick Verano
Equipped with 2.0L Engine (RPO LHU)

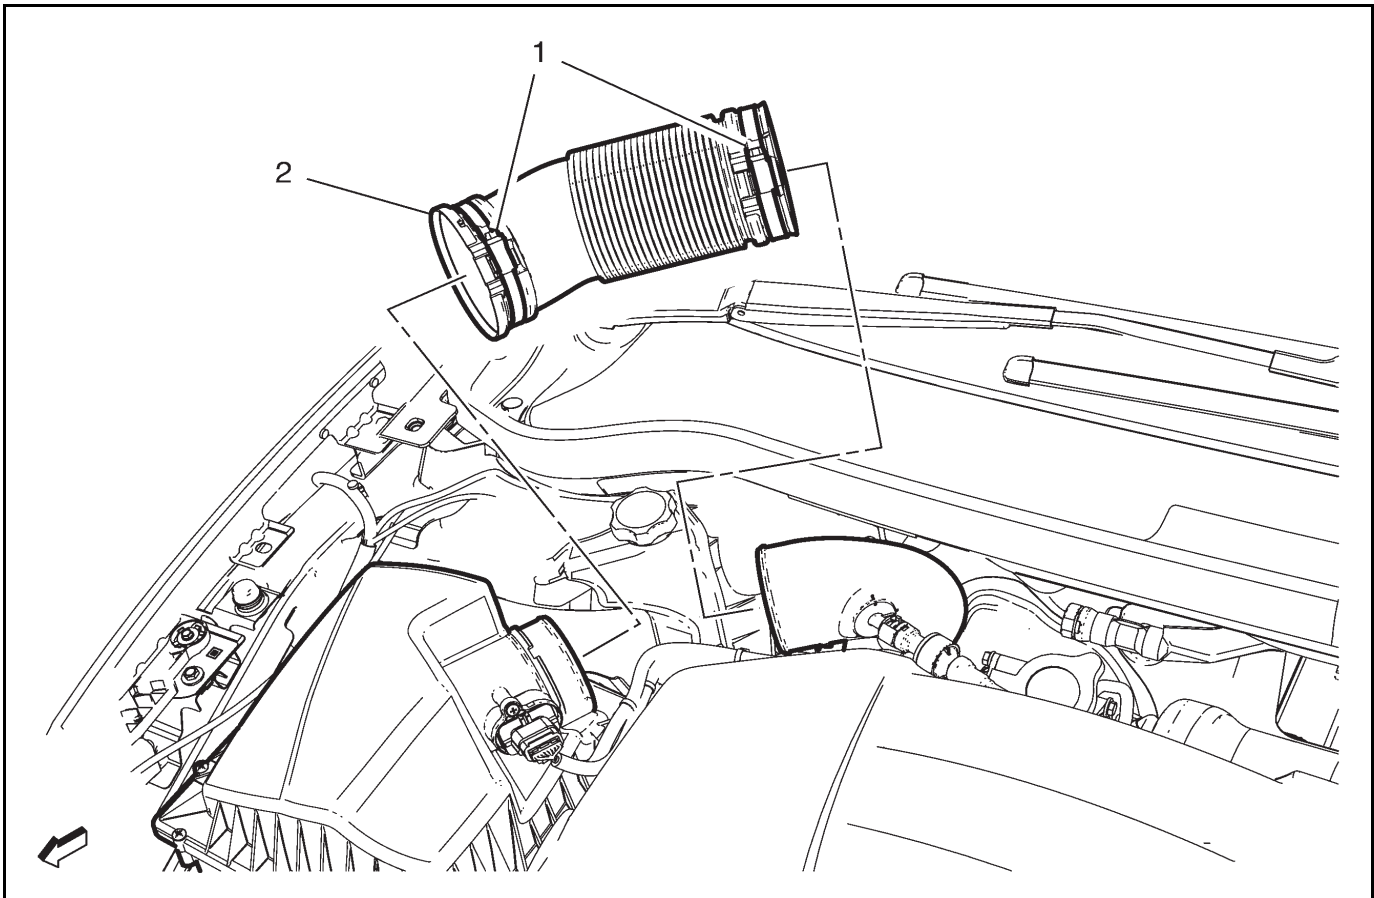
2699465

This condition may be caused by loose clamps on the air cleaner duct (1) as shown in the illustration above.

Inspect both clamps on the air cleaner outlet duct to ensure that the clamps are secured tightly.
