# Technical Bulletin

Model(s)	Year	Eng. Code	Trans. Code	VIN Range From	VIN Range To
Passat	2012 - 2013	All	All	All	All

69 13 02 March 15, 2013 2032959

**Airbag Warning Lamp – Front Side Airbag Pressure Sensor Interruption/ Short to B+**

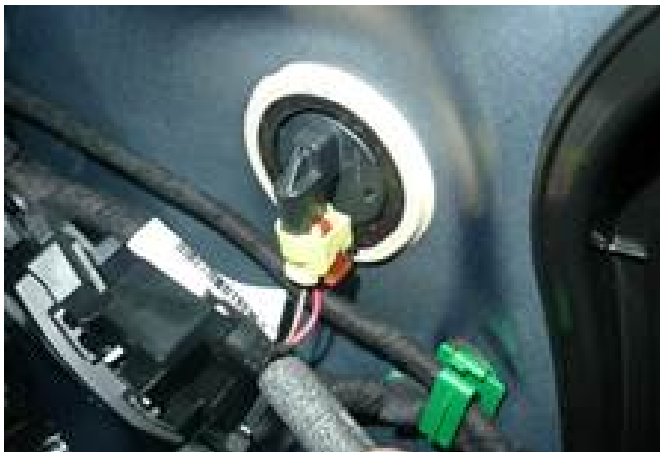
**Figure 1**

**If Vehicle only has pressure Sensor Faults B101715 OR B103615 showing in GFF:**

- Disconnect battery negative cable.
- Remove door panel and ensure secondary lock is fully seated on the pressure sensor.
- Verify pressure Sensor (5K0.959.354) is properly installed in the front door.

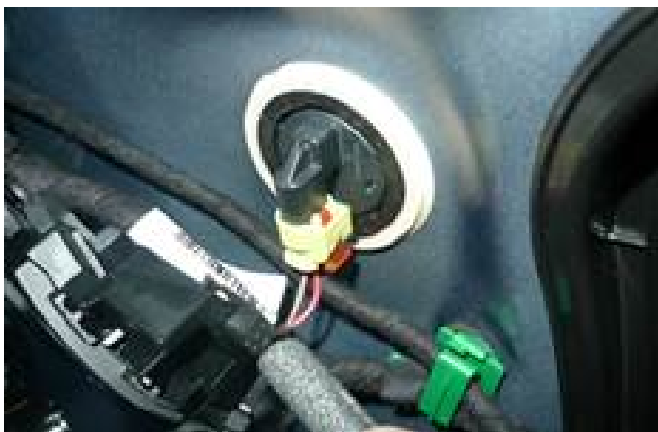
Figure 4

If Vehicle has pressure Sensor Faults B101715 OR B103615 AND Door Faults in the Electronic Control Module:

- Disconnect battery negative cable.
- Remove door panel and ensure secondary lock is fully seated on the pressure sensor.
- Verify pressure Sensor (5K0.959.354) is properly installed in the front door.
