Service Bulletin

Bulletin No.: PIC5515C

Subject: Diagnostic Tip - Ratchet Click or Grind Noise In Front Of Vehicle Traveling Straight At Slow Speeds

Models: 2010 - 2014 Chevrolet Camaro

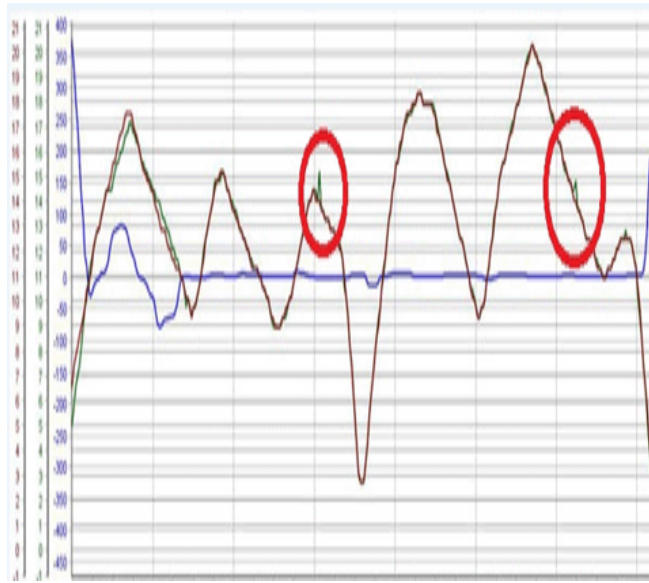
2874501

3. Review EBCM > Antilock Braking Data Session Logs in GDS2, specifically monitoring the WSS (Wheel Speed Sensor) parameters for one of the WSS inputs to either spike up or drop down in a speed inconsistent with the speed reading of the other 3 wheel speed sensors. Typically, a 3 mph or greater variance may be detected in one or more data session logs which will indicate which WSS and hub bearing need further inspection. In rare cases, it could be as little as 1 mph variance between WSS. It is suggested to use the Line Graph to plot out the Steering Angle Sensor (to know when the car is going straight) and both rear WSS parameters first. To do so, select the parameters you wish to plot by clicking on the parameters in the Diagnostic Display Data Display Tab, then click on the padlock to move that parameter to the top of the list. Once the parameters are selected, move to the Line Graph Tab to view an overlaid plot of the selected parameters. The front WSS parameters can be viewed later if the cause is not found in the rear, but the cause is more common to be found with the rear parameters. You must zoom in to view the fine detail needed to isolate the cause as this is only a slight difference spiking down or up from the other WSS.

In the example above, the vehicle is travelling straight (Steering Column Position in Blue); the Left Rear WSS (Green) is spiking; while the Right Rear WSS (red) is not.

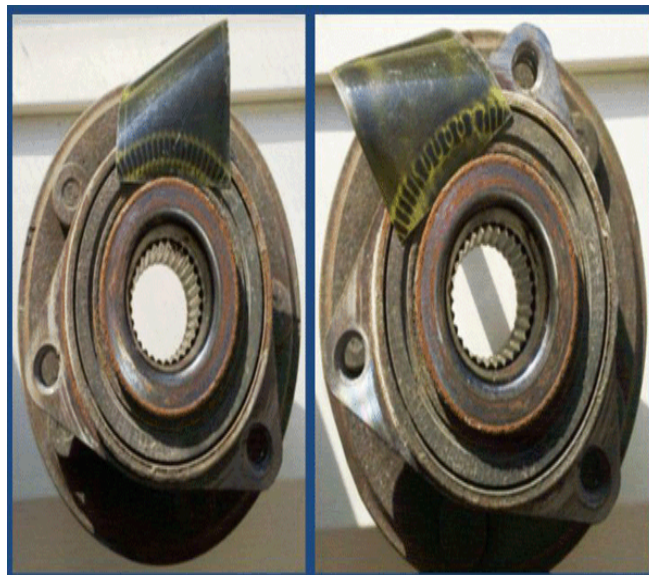
2870569

Important: There is some confusion over where the encoder is located on the hub. It is the brown rubber ring, it is not located behind this ring and this ring is NOT just a bearing seal. It is the encoder.

Note: This photo depicts a condition of the encoder magnetic poles not alternating properly. Instead of the magnets being laid North, South, North, South, as the photo on the left illustrates, the poles may have been laid out of sequence as illustrated by the photo on the right. The magnetic paper is not readily available in most areas so this photo is only being used to illustrate that not all conditions are visible to the naked eye and that if this condition were present then swapping the WSS would not aid in isolating this cause. It may be necessary, as explained below, to swap the hub bearing from side to side to identify the condition shown in this photo.

* If there is no evidence of physical damage, contamination or debris it is acceptable to swap the hub bearings from side to side, test drive the vehicle again and confirm the problem followed the hub. If the problem follows the hub, replace the hub. If problem stays with the WSS, replace the WSS.
