Service Bulletin

Bulletin No.: PIC5822A

Subject: Water On Floor And/Or Carpet

Models: 2010 - 2014 Buick LaCrosse
2011 - 2014 Buick Regal
2013 - 2014 Cadillac XTS
2013 - 2014 Chevrolet Malibu
2014 Chevrolet Impala

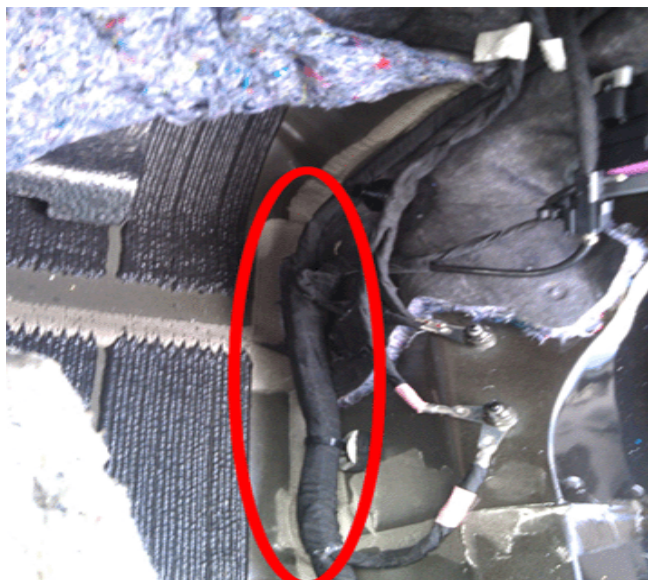
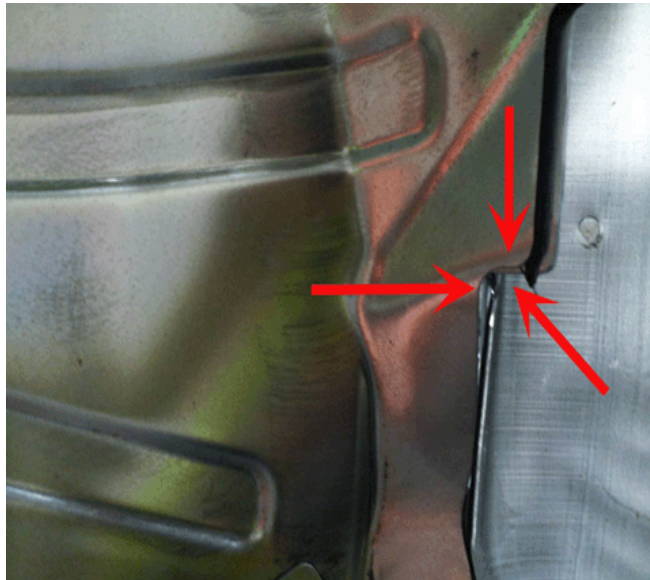
3603379

A customer may comment of mildew odor or water on front floor on either side of the vehicle.

Technician should pull back carpet and insulator as shown in pictures below for the suspect side of the vehicle (passenger side shown). Remove the front wheelhouse liner and spray water into the wheelhouse of the affected side and check for water in the area indicated in photo shown below. Water will enter around applied sealer as cavity fills. The front wheel house flange may have a void in the sealer. Seal the void using a thumb grade sealer (service manual calls for "heavy-bodied caulking material") pushed into the void from the wheel opening. For location of flange please reference the graphics below.
