Service Bulletin

Bulletin No.: PIC5822

Subject: Water On Floor And/Or Carpet

Models: 2013 Chevrolet Malibu

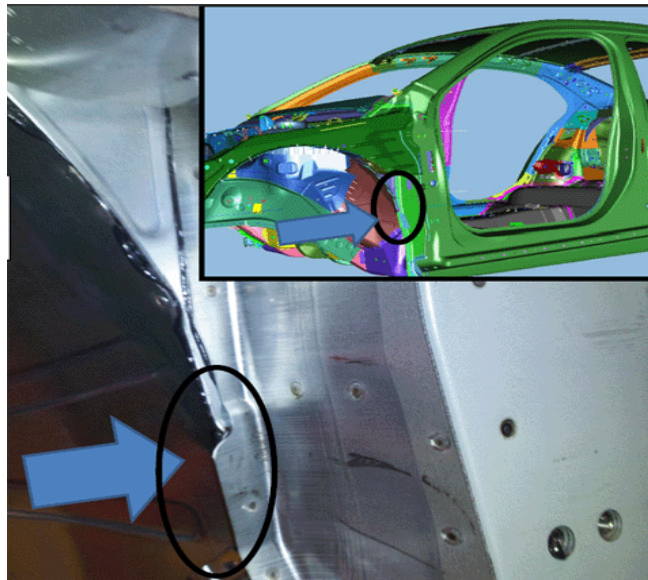
3339515

Front wheel house flange may have a void in the sealer.

Seal the void using a thumb grade sealer (also referenced as a "heavy-bodied caulking material" in SI) pushed into the void from the wheel opening. For location of flange see the graphics below.
