## Technical Information Bulletin

**14-023**

K270/K370 CAC Pipe to Frame Clearance

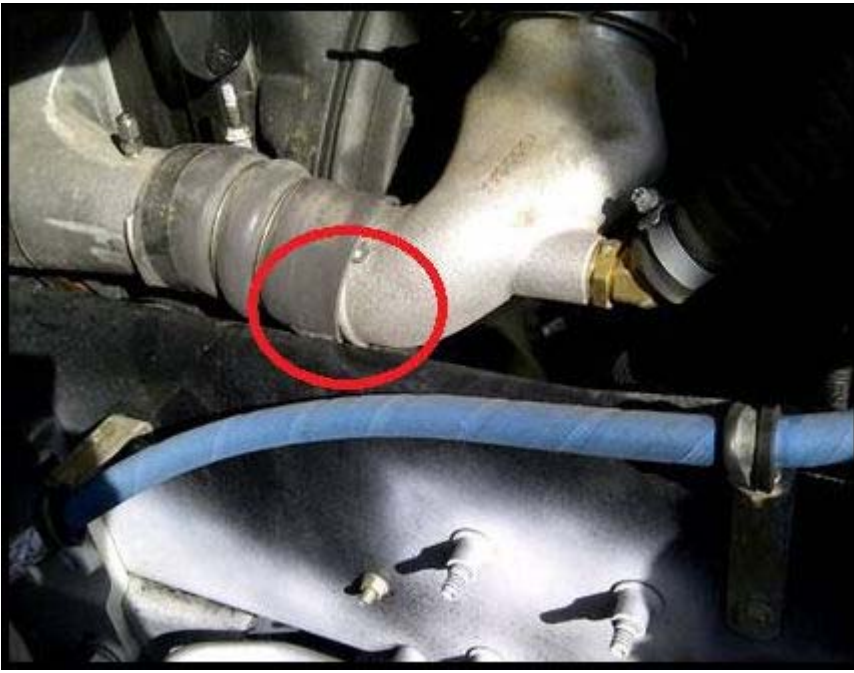
Inspect interface between the cold air side charge air cooler pipe and frame rail.

- If the pipe has 7mm clearance or more, no repair is necessary; 7mm includes consideration for bushing compression during operation. File Quick Claim 14-23a for reimbursement of labor and to record that the campaign inspection has been completed.
- If the pipe has less than 7mm clearance, replace the original equipment front engine mounts, part number AFRC027 (left) and AFRC028 (right), with replacement mounts A11-1990 (left) and A11-1990R (right). Torque engine mount to engine casting bolts 75-87lb-ft. Torque front engine leg to bushing 125 lb-ft +/-10 lb-ft.
