# Service Bulletin

Bulletin No.: PIP5100A

**Subject:** Allison LCT1000 Range Inhibit Or No Forward Reverse P0701 P0729 P0731 P0732 P0733 P0734 P0735 P0751 P0756 P0761 P0877 Or P2723 May Be Set

**Models:** 2011-2014 Chevrolet Silverado  
2011-2014 GMC Sierra

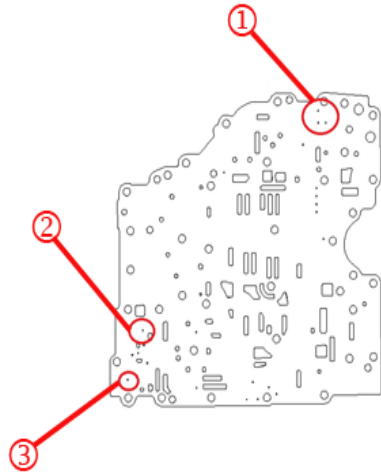
3632300

- Modulated main feed orifice- P0701 P0729 P0731 P0732 P0733 P0734 P0735 P0751 P0756 P0761 may set if this orifice is blocked.
- PCS1 feed hole-An intermittent or no reverse condition can be exhibited when the PCS1 feed is blocked along with P2723 setting.
- Reverse pressure orifice-Drive range may be inhibited along with P0877 setting.

The most common areas of blockage are shown in the picture below.

**Note:** Low main pressure (50 psi) continuous or intermittent regardless of modulated main pressure control solenoid current may be caused by the modulated main pressure control solenoid feed orifice being blocked.

Call out 1  
Reverse Pressure Orifice.

Call out 2  
Modulated main feed orifice.

Call out 3  
PCS1 Feed.

Always closely inspect the separator plate for this condition anytime the valve body is removed.

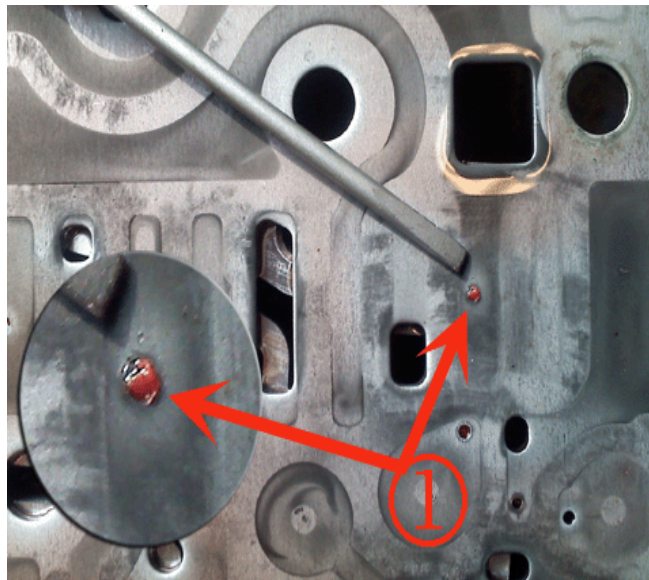
3287575

Many aftermarket spin-on filters are shipped with a protective shrink-wrap packaging that may inadvertently be introduced into the transmission during filter installation.

This can contribute to a condition where the valve body separator plate orifices can become plugged.

Call out 1  
Example of blockage.
