SERVICE BULLETIN

BR12-006

February 8, 2013

2013 ALTIMA SEDAN; DTC C1197 STORED

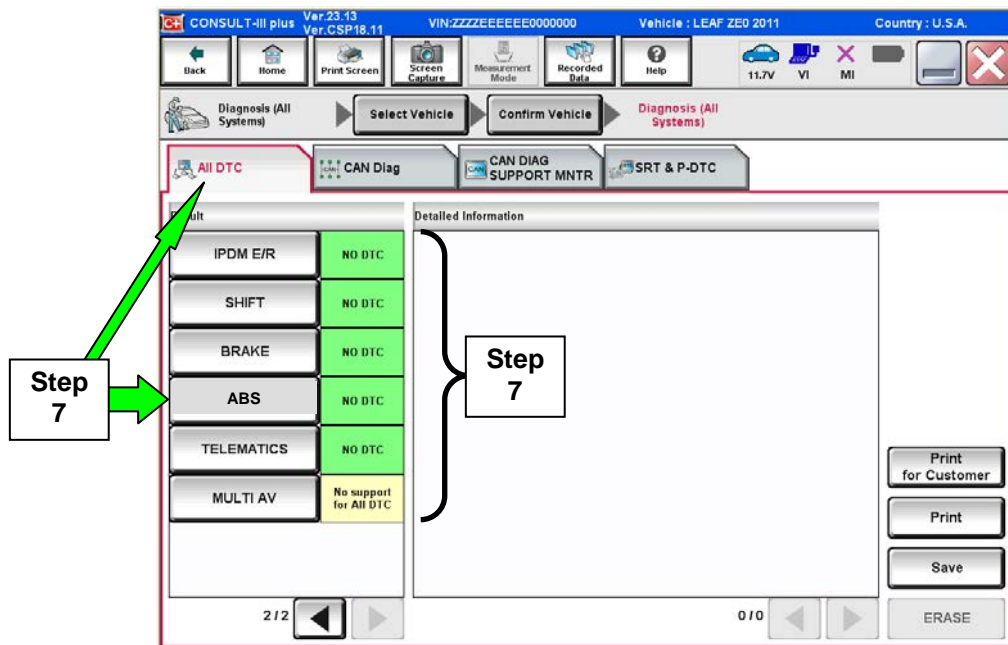
Figure 4

7. From the **All DTC** tab, verify there are no DTCs stored, and then select **ABS**.

- If there are any DTCs other than C1197, diagnose, perform repairs, and then erase DTCs **before** continuing. Refer to ASIST for further diagnosis.

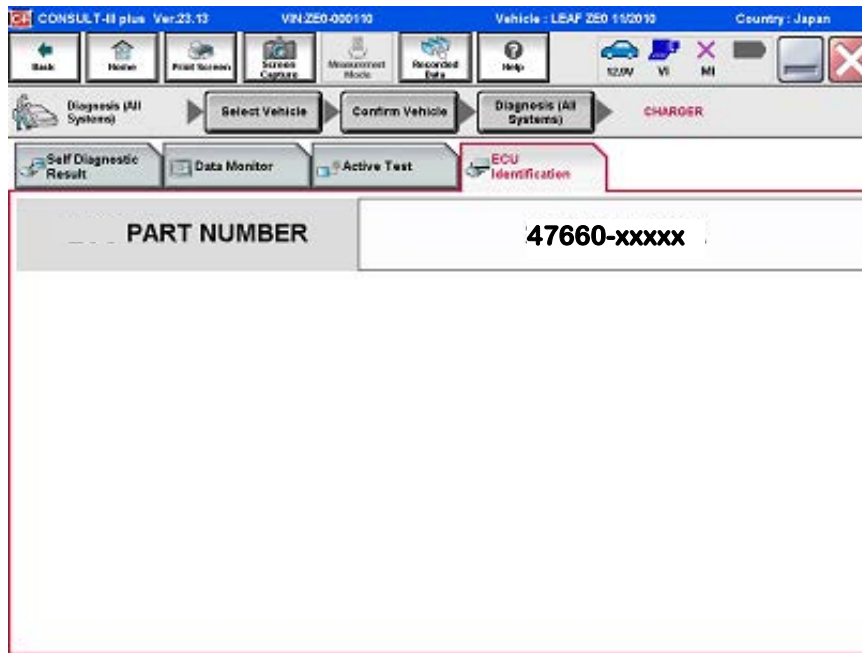
Figure 5

8. When you get to the screen shown in Figure 5, confirm this bulletin applies as follows:
- A. If the vehicle's VIN and production date were not already checked, check it now.
- If the vehicle was built **BEFORE** one of the VINs and dates below, continue to step 8B.

- C. Compare the P/N you wrote down to the numbers in the **Current ABS CU Part Number** column in **Table A** below.
- If there is a match, this bulletin applies. Continue with the reprogramming procedure on the next page.
 - If there is not a match, reprogramming does not apply. Return to ASIST for further diagnostic information.

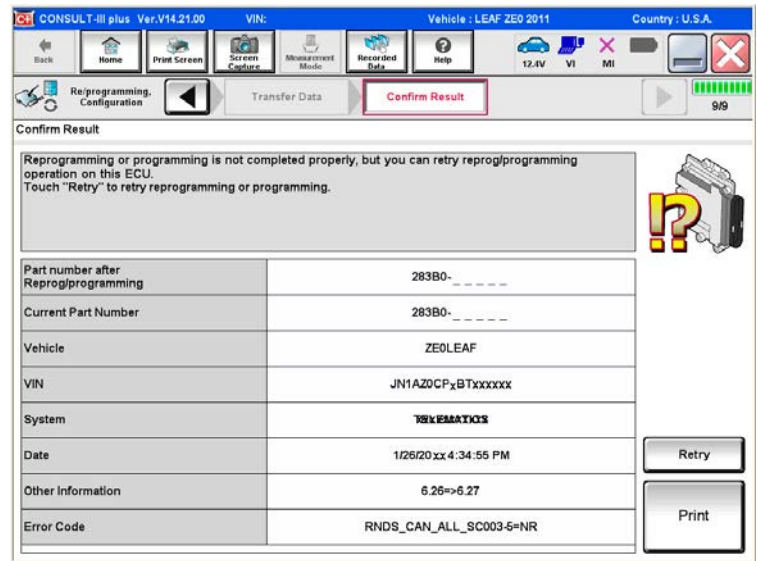
Figure 20a

If reprogramming does not complete and the “!?” symbol displays as shown in Figure 20a:

- Check battery voltage (12.0 – 15.5V).
- Ignition is ON, Ready Mode is OFF.
- External Bluetooth® devices are OFF.
- All electrical loads are OFF.
- **Select Retry and follow the on screen instructions.**

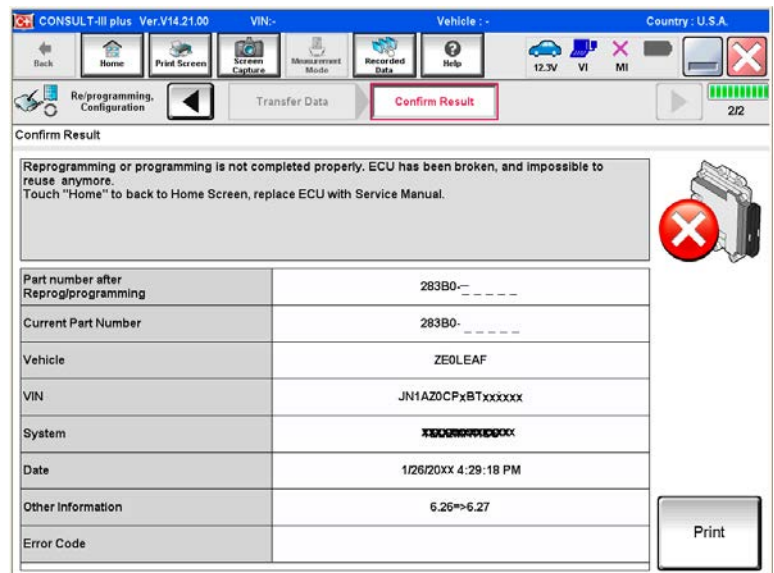
Figure 21a

If reprogramming does not complete and the “X” symbol displays as shown in Figure 21a:

- **Do not disconnect the plus VI or shut down C-III plus if reprogramming does not complete.**
- Check battery voltage (12.0 – 15.5V).
- CONSULT A/C adapter is plugged in.
- Ignition is ON, Ready Mode is OFF.
- Transmission in Park.
- All C-III plus / plus VI cables are securely connected.
- All C-III plus updates are installed.
- **Select Home, and then restart the reprogram procedure from the beginning.**
