# Program Bulletin

## CUSTOMER SATISFACTION PROGRAM

**SUBJECT:** Driver's Seat Rear Blocking Clips May Be Missing

**MODELS:** 2013 Buick Encore  
Equipped with Driver's 6-Way Power Seat (AG9) and without Memory Seat Feature (AAG)

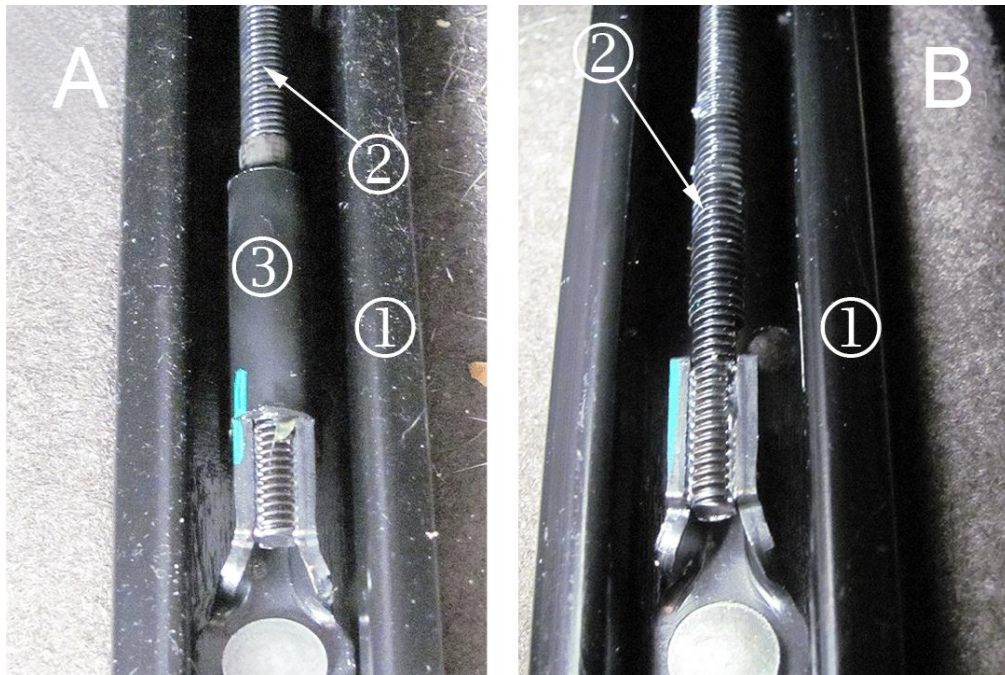
3400820

There should be about a 50.8 mm (2 in) section of the adjuster screw threads (2) that are NOT visible. A seat travel restriction feature called a blocking clip (3) should be installed. The “A” portion of the photograph shows the blocking clip (3) installed. The blocking clip is missing in the “B” portion of the photograph.

2. Examine the rear portion of the inboard and outboard seat tracks (1) to determine if the blocking clips (3) are installed.
  - If the blocking clips (3) are installed, proceed to step 4. No further action is required.
  - If the blocking clips (3) are NOT installed, proceed to step 3.
