# SERVICE CAMPAIGN BULLETIN

NTB13-052a

## VOLUNTARY SERVICE CAMPAIGN 2013 ALTIMA SEDAN HEATED SEATS

**CAMPAIGN ID:** PC212**APPLIED VEHICLE:** 2013 Altima Sedan (L33)**Check Service COMM to confirm campaign eligibility.**

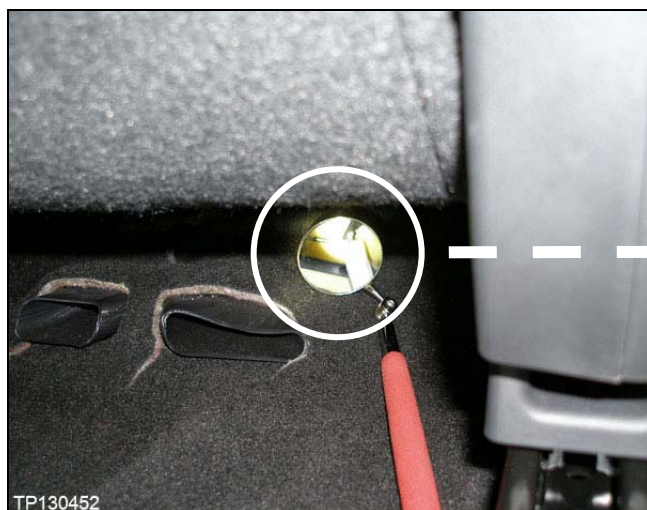
Figure 1; seat viewed from bottom rear

1. Move both front seats fully forward, and then adjust the seatbacks forward.
2. From the rear of the front seats using a mirror and flashlight, locate the 3-wire harness connector under the seat frame assemblies of BOTH front seats (see Figure 1).

**NOTE:** There is only one 3-wire harness connector under each seat frame assembly.

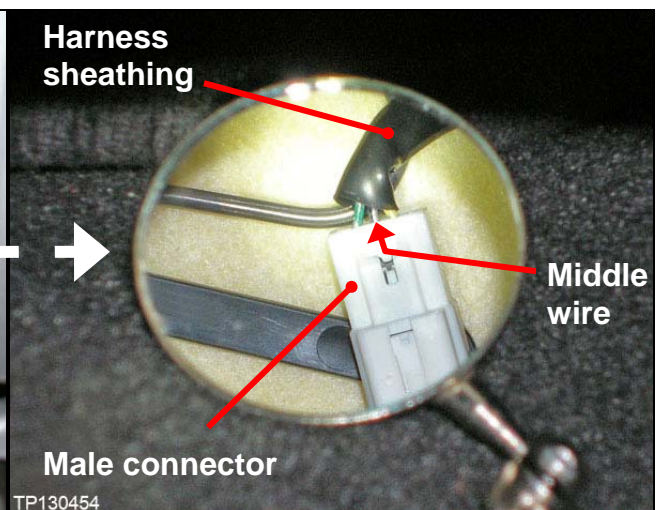
Figure 2

- Look **ONLY** at the male side of the connector where the wire colors are green, yellow, and black.
- **IGNORE** the wires on the female side of the connector.
- The harness sheathing may need to be pulled back for good viewing.
- See next page for a detailed picture.

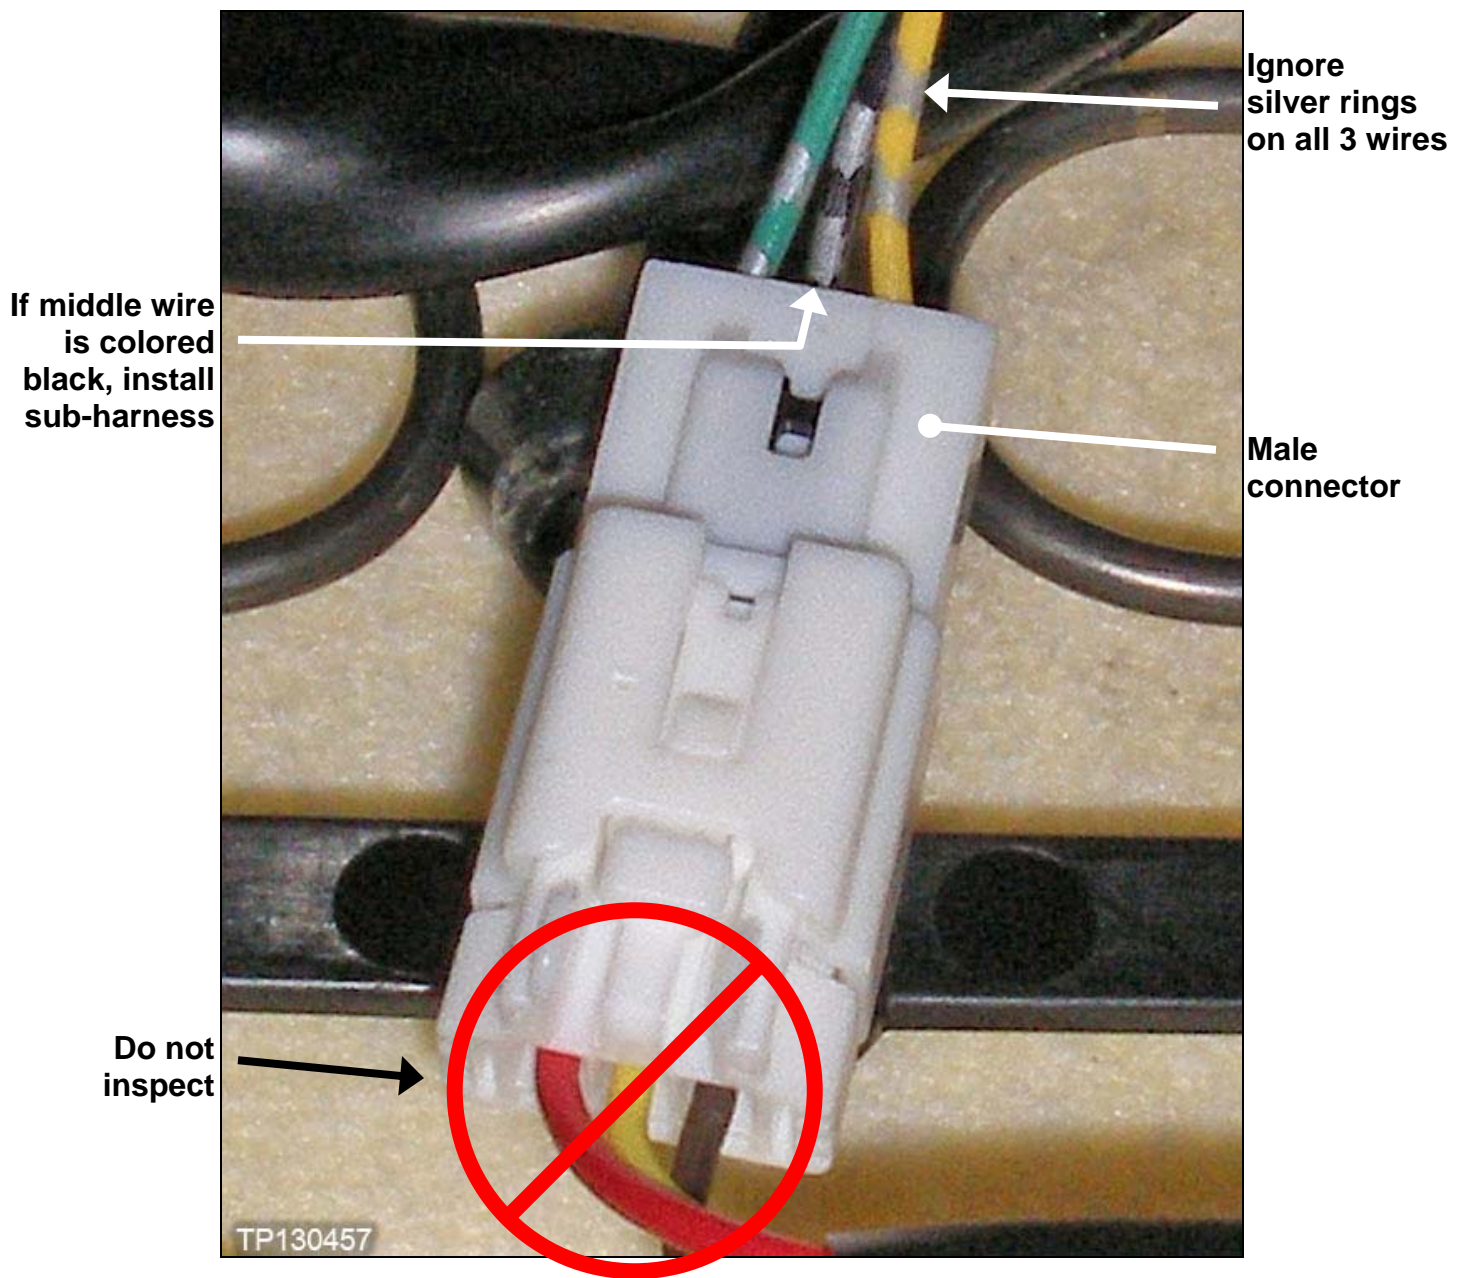
Figure 3; picture taken with seat lifted for easier viewing only.

3. For seats where the middle wire is black (see Figure 3): Install a sub-harness listed in **PARTS INFORMATION**.
  - Go to **Install Sub-harness(es)** on the next page.
4. When the middle wire is NOT black on BOTH seats: No further work is needed. Go to **CLAIMS INFORMATION**.

Your vehicle's heated seat function may not perform to design intent for front driver and passenger seats. Due to incorrect wire pin placement in the seat sub harness, when the switch is placed on High, only the seat cushion will warm up. When the switch is placed on Low, only the seat back will warm up. This is not a safety issue, and the vehicle still meets and/or exceeds all applicable safety standards.
