Michael A. Berardi
Director
Service Engineering Operations
Ford Customer Service Division

May 24, 2013

SUBJECT: **DEMONSTRATION / DELIVERY HOLD - Application Performance Upgrade 13A01**
– *Supplement #1*
Certain 2012-2013 Focus Electric, 2013 C-MAX Hybrid and C-MAX Energi, and 2013 Fusion Hybrid Vehicles Equipped with MyFord Touch®
Application Performance Upgrade

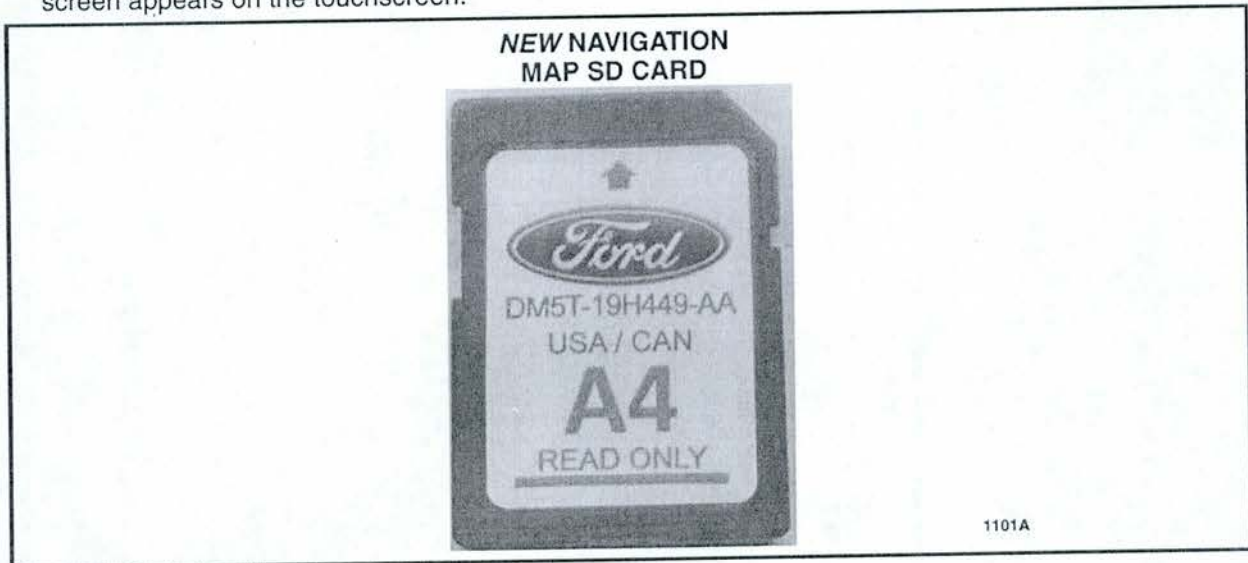
FIGURE 2

NOTE: After the reprogramming procedure completes, an SD card fault will appear on the screen.
This is normal.

3. Remove the A3 level Navigation Map SD Card from the vehicle's map card slot.
4. Tap "SD Nav" on the touchscreen to clear the SD card fault.
5. Install the *new* A4 level Navigation Map SD Card into the vehicle's map card slot. See Figure 2. Wait for the *new* Navigation Map SD Card to be recognized and tap "OK" when the "SD Card Detected" screen appears on the touchscreen.

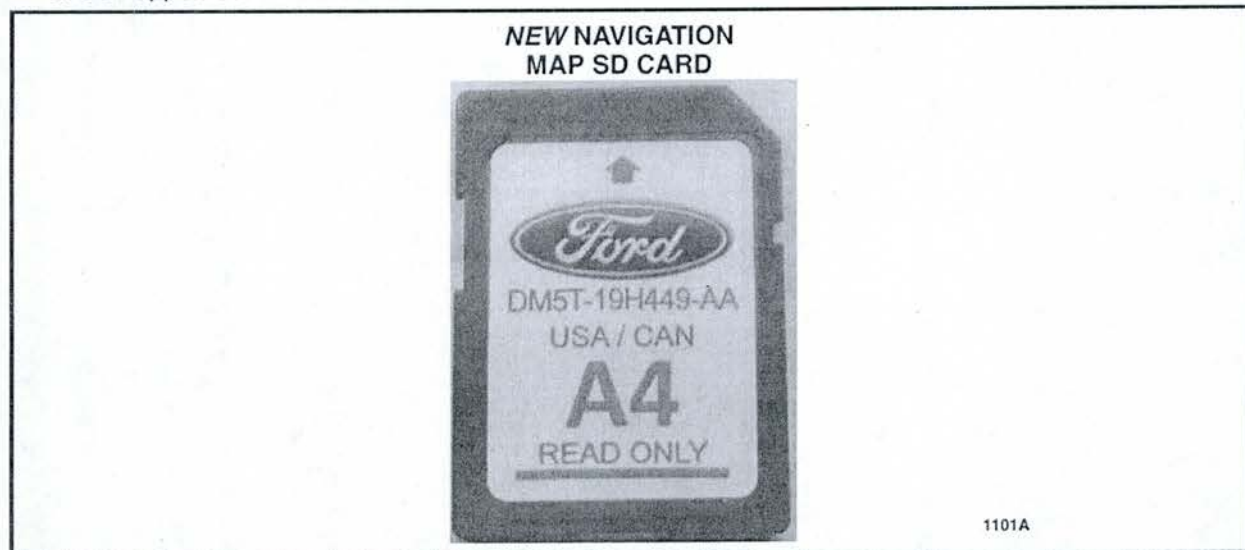
FIGURE 2

NOTE: After the reprogramming procedure completes, an SD card fault will appear on the screen.
This is normal.

5. Remove the A3 level Navigation Map SD Card from the vehicle's map card slot.
6. Tap "SD Nav" on the touchscreen to clear the SD card fault.
7. Install the *new* A4 level Navigation Map SD Card into the vehicle's map card slot. See Figure 2. Wait for the *new* Navigation Map SD Card to be recognized and tap "OK" when the "SD Card Detected" screen appears on the touchscreen.

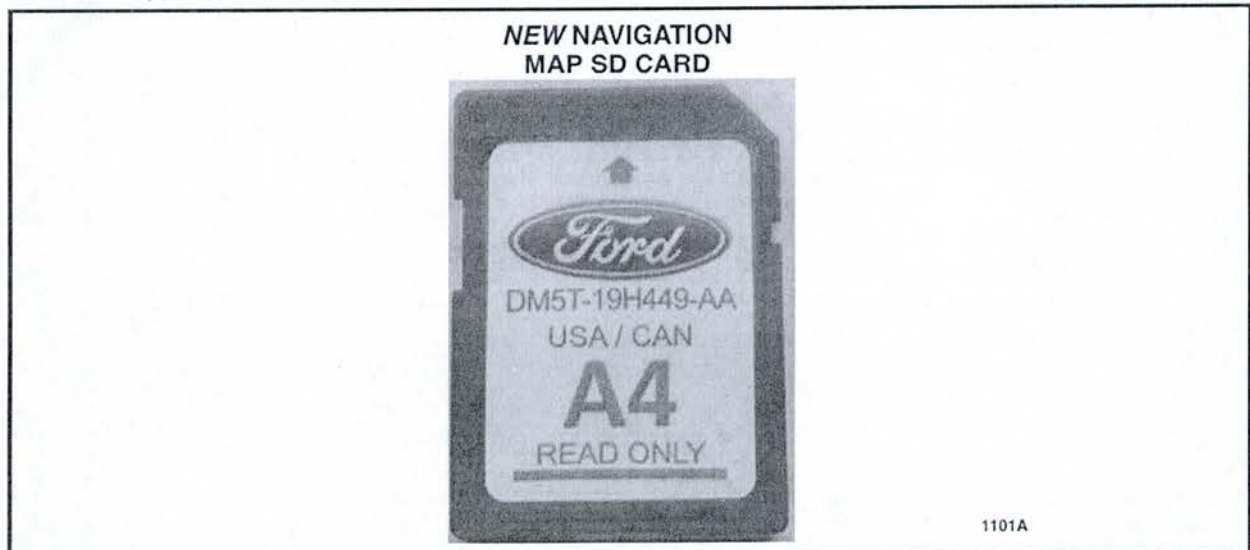
FIGURE 3

NOTE: After the reprogramming procedure completes, an SD card fault will appear on the screen. This is normal.

6. Remove the A3 level Navigation Map SD Card from the vehicle's map card slot.
7. Tap "SD Nav" on the touchscreen to clear the SD card fault.
8. Install the *new* A4 level Navigation Map SD Card into the vehicle's map card slot. See Figure 3. Wait for the *new* Navigation Map SD Card to be recognized and tap "OK" when the "SD Card Detected" screen appears on the touchscreen.
