Michael A. Berardi
Director
Service Engineering Operations
Ford Customer Service Division

April 2, 2013

SUBJECT: DELIVERY HOLD - Customer Satisfaction Program 13B02
Certain 2013 Model Year Fusion Vehicles Equipped with a Moon Roof
Headliner Wrinkles

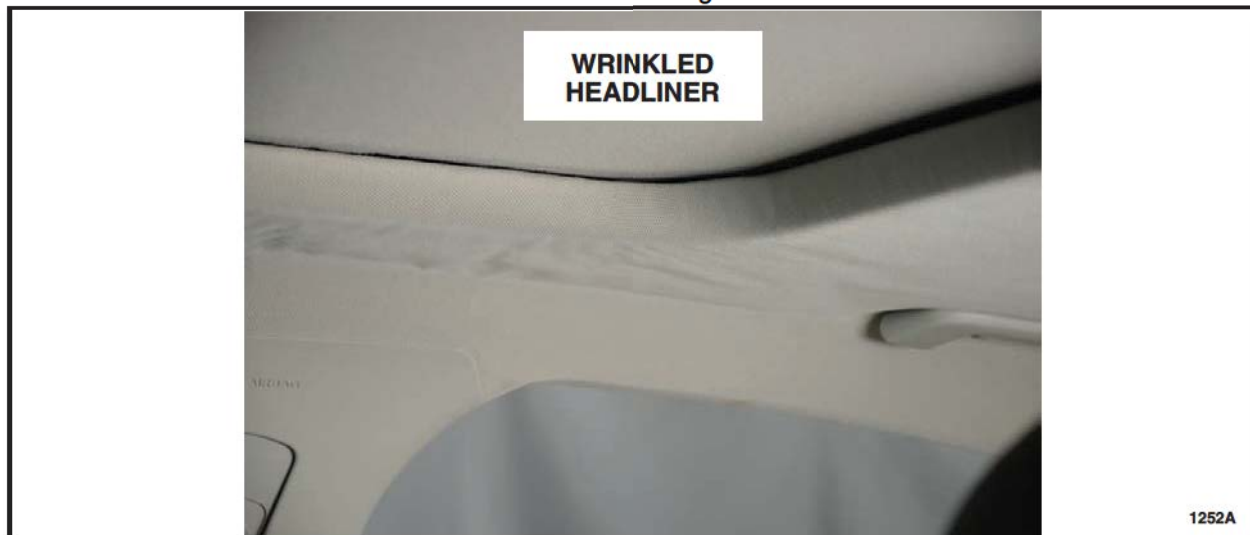
FIGURE 1

Differing rates of thermal expansion exist between the headliner substrate, glue, and other components bonded to the backside of the headliner, which can result in a wrinkle condition around the moon roof opening. Note that the wrinkle condition is accentuated by high and low ambient temperature cycles.

For vehicles built on or after October 11, 2012, dealers must inspect the headliner for the presence of wrinkles around the moon roof opening to determine if the headliner must be modified or replaced. See Figure 1.

- If wrinkles are present, the headliner must be replaced.
- If wrinkles are not present, the headliner must be modified to prevent wrinkles from occurring in the future. The modification involves lowering the headliner and cutting reliefs into the blocks and supports glued to the backside of the headliner. The reliefs allow the components to expand and contract and at different rates without wrinkling the headliner material.
