Michael A. Berardi
Director
Service Engineering Operations
Ford Customer Service Division

June 17, 2013

SUBJECT: **DELIVERY HOLD - Customer Satisfaction Program 13B02 – Supplement #1**
Certain 2013 Model Year Fusion Vehicles Equipped with a Moon Roof
Headliner Wrinkles

CERTAIN 2013 MODEL YEAR FUSION VEHICLES EQUIPPED WITH A MOON ROOF — HEADLINER WRINKLES

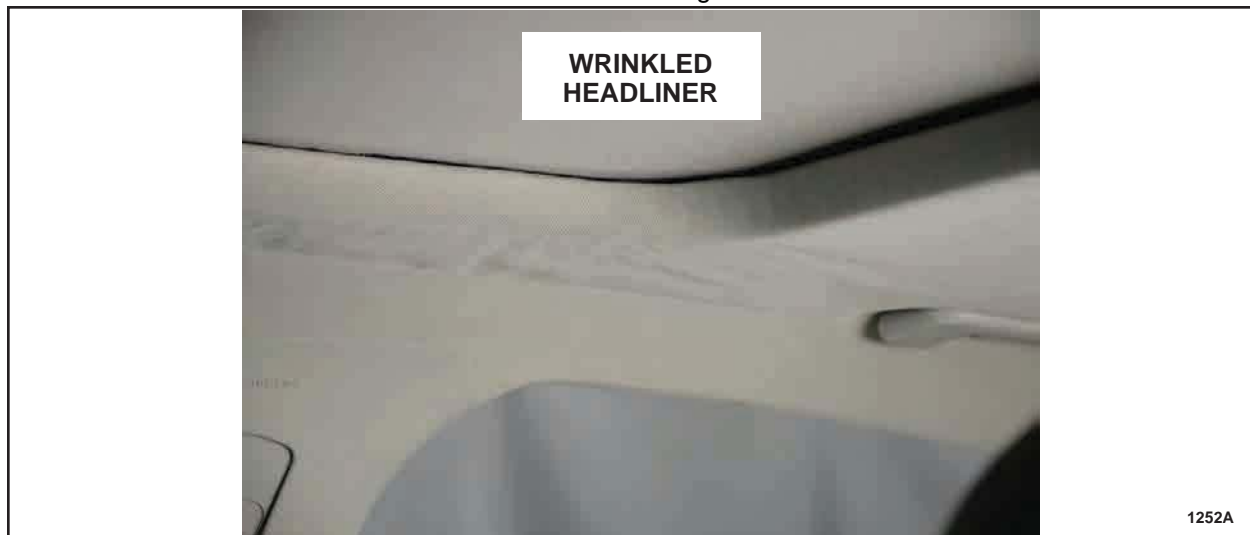
FIGURE 1

Differing rates of thermal expansion exist between the headliner substrate, glue, and other components bonded to the backside of the headliner, which can result in a wrinkle condition around the moon roof opening. Note that the wrinkle condition is accentuated by high and low ambient temperature cycles.

For vehicles built on or after October 11, 2012, dealers must inspect the headliner for the presence of wrinkles around the moon roof opening to determine if the headliner must be modified or replaced.

- If wrinkles are present, the headliner must be replaced.
- If wrinkles are not present, the headliner must be modified to prevent wrinkles from occurring in the future. The modification involves lowering the headliner and cutting reliefs into the blocks and supports glued to the backside of the headliner. The reliefs allow the components to expand and contract and at different rates without wrinkling the headliner material.

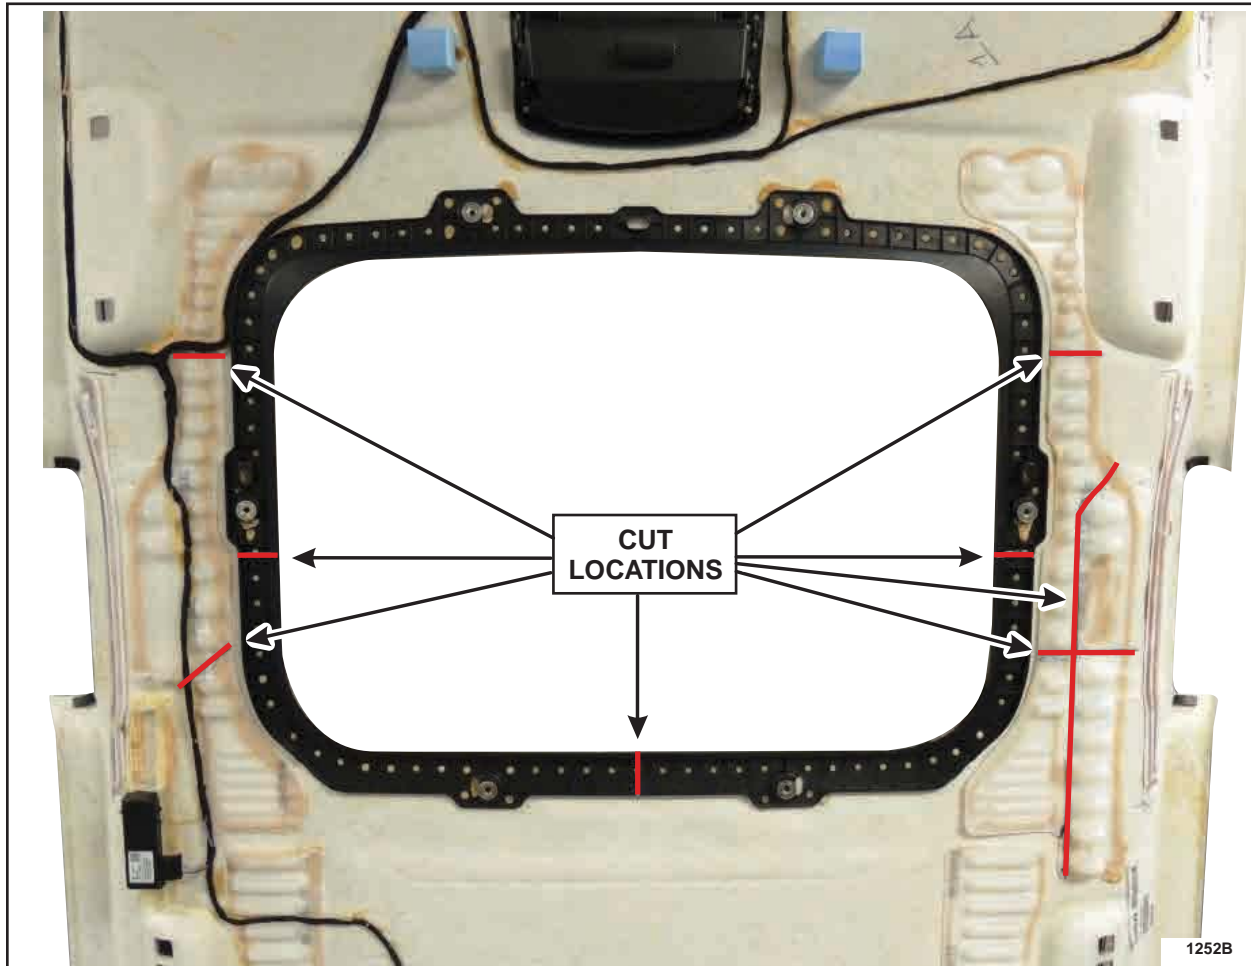
FIGURE 23

NOTE: Modification of the headliner reinforcements will prevent wrinkles by allowing greater flexibility of the substrate material.

1. Mark cut locations on the headliner reinforcement material. See Figure 23.
