Service Bulletin

Bulletin No.: PI0916A

Subject: Floor/Carpet Wet at Front Passenger Side Under Dash, or at Any Front/Rear Footwell Area

Models: 2012-2013 Chevrolet Caprice PPV

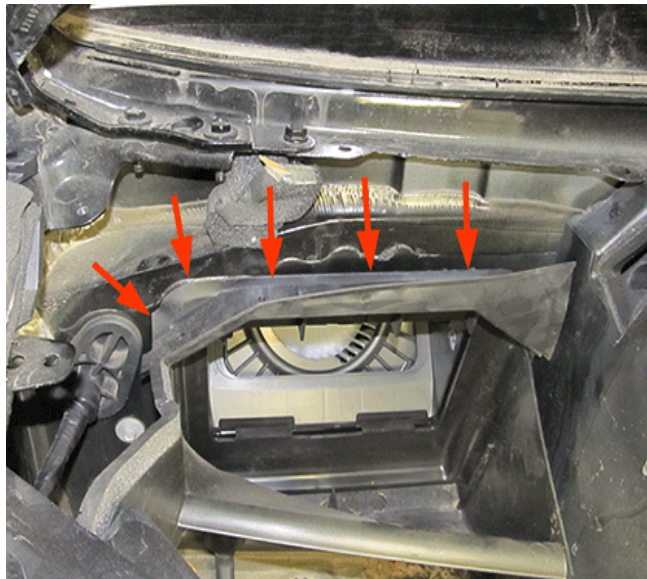
3291073

- Water intrusion in the seam (1) between the HVAC case and the cowl.

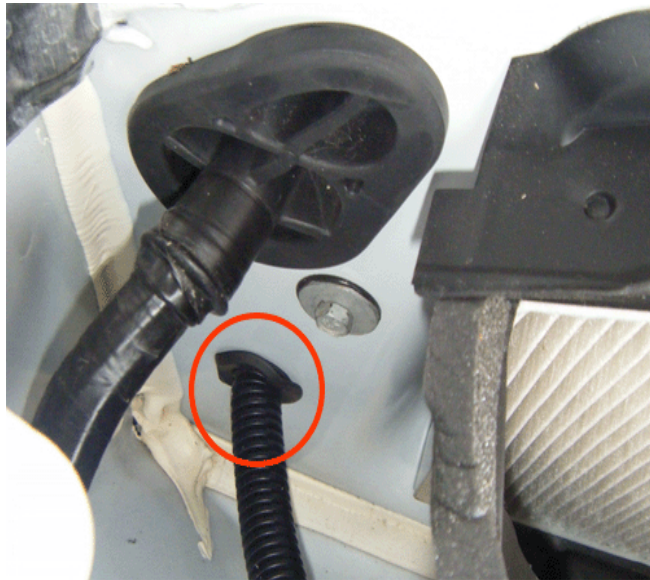
3291074

- For some police equipped vehicles, water may run on the wire harness exiting the HVAC case, then follow along the conduit into a grommet/hole (shown circled in the graphic above) in the cowl, and finally run into the vehicle interior.

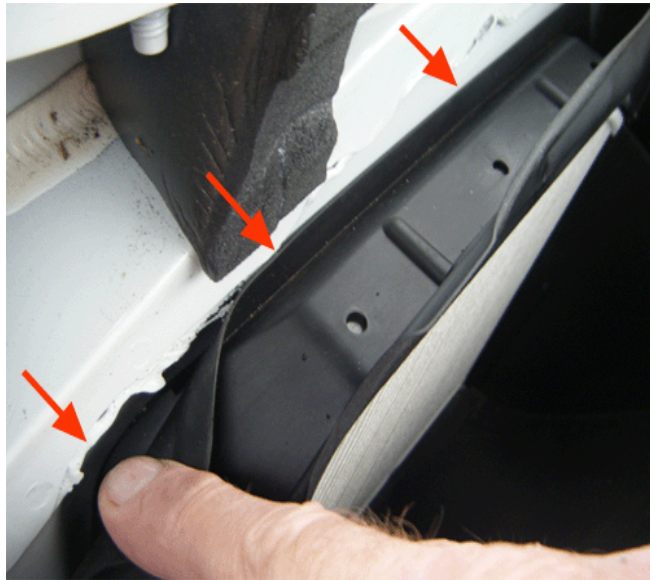
3291076

2. Inspect the seam at the top of the HVAC case, where the case sits against the cowl. The seam is commonly not sealed in this area and water coming off the windshield may find a path behind the case and leak into several places in the interior under the dash.

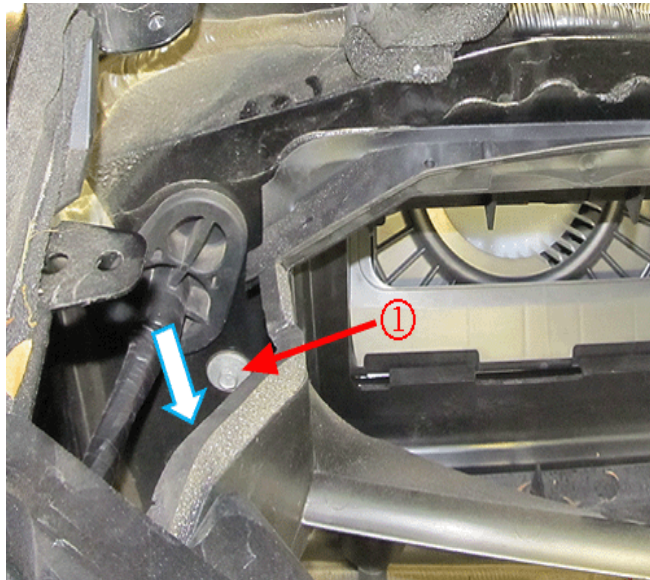
3291078

4. Inspect the cowl area outside the HVAC case for the possible existence of a wiring harness associated with certain police equipped vehicles. If equipped, the grommet/hole location for the harness will be just below the bolt (1) shown in the graphic above.

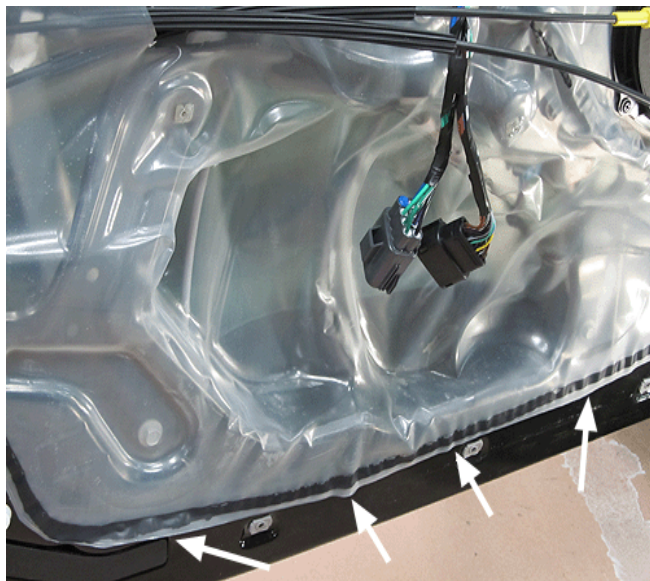
3392287

The cause of this condition may be that water, normally being channeled through a side door, may bypass an improperly sealed water deflector and create a leak path into the vehicle. Because of the increased mirror/window switch wiring harness content, this condition most commonly occurs at the driver door, but may occur at any front or rear side door.

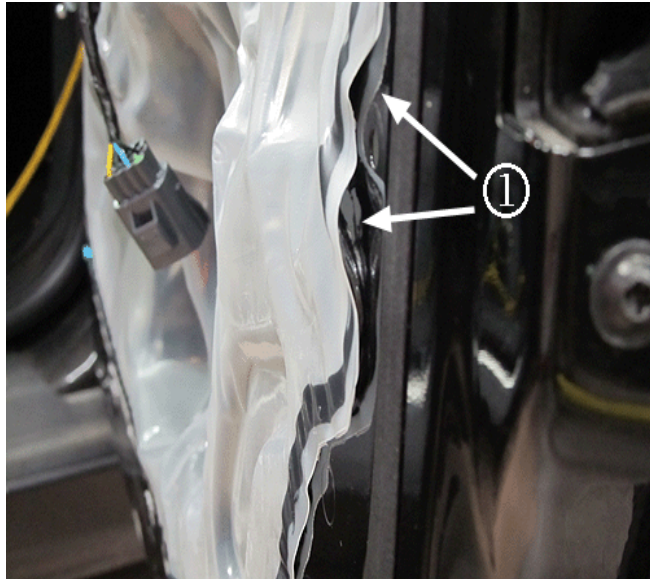
3392291

2. Inspect the door water deflector for any puckers/gaps (1) where the butyl adhesive may have pulled away from the inner door surface.

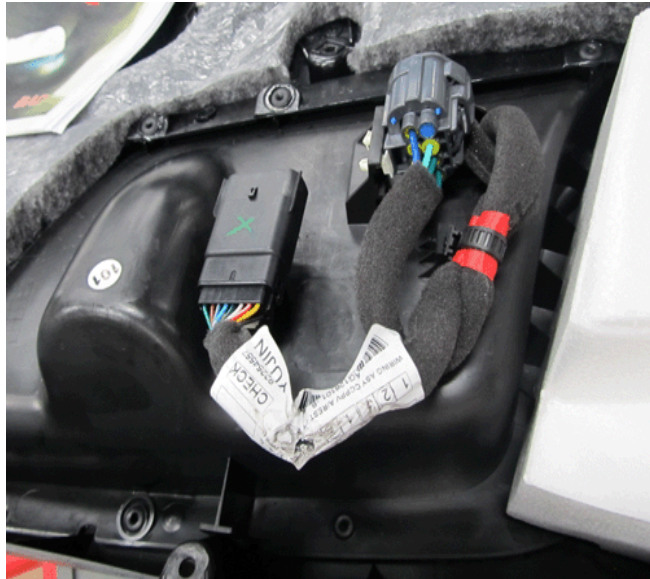
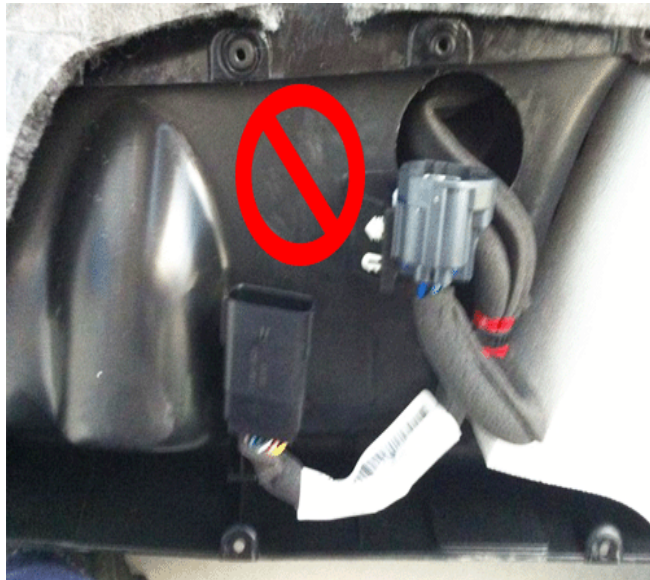
Important: The correct harness routing is shown in the first graphic above. An example of an incorrect routing is shown in the second graphic.

- 8.1. Ensure the harnesses are routed as shown in the first graphic above. It may be necessary to unclip the grey connector and reroute the one harness underneath the other to achieve this.
