Service Bulletin

Bulletin No.: PI0961B

Subject: SERVICE HIGH VOLTAGE CHARGING SYSTEM Message Displayed on Driver

Models: 2011-2014 Chevrolet Volt

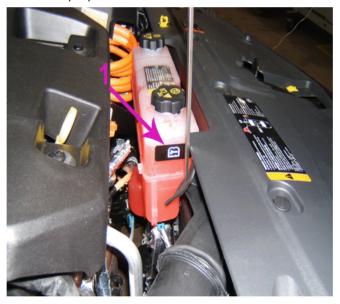
3672187

0.5. Visually inspect the coolant level in the HV battery surge tank and verify that the coolant level is **at the top of the label (1)** on the side of the surge tank.

- ⇒ If the HV battery surge tank coolant level is **not at the top of the label (1)** on the side of the surge tank, Go to the section titled: **Pressure Test Procedure** in this Diagnostic.
- ⇒ If the HV battery surge tank coolant level is at the top of the label (1) on the side of the surge tank, Go to Step 6.
- 0.6.Remove the front compartment front sight shield. Refer to Front Compartment Front Sight Shield Replacement in SI.

- 0.13. Upon completion of the Hybrid/EV battery pack coolant pump bleed procedure, **adjust** the surge tank coolant level to the **top of the label (1)**, by performing this procedure, Drive Motor Battery Cooling System Draining and Filling Removing Excess Coolant From System in SI.
