## PRODUCT SAFETY RECALL

**SUBJECT:** Power Window Master Switch Failure

**MODELS:** 2009 Pontiac Vibe

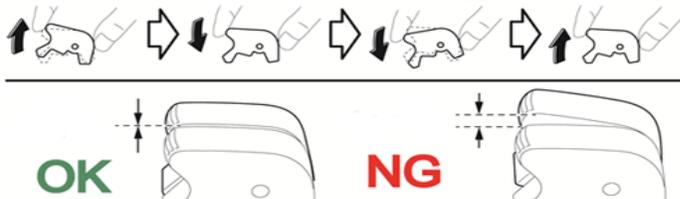
3021149

2. Check all switches (1) that do not have AUTO function (2) for the catching condition.

OK-Good  
NG-No Good

4. Operate each switch in the down direction, and then slowly return the switch using two fingers.
  - If none of the switches are catching, proceed to the Check Resistance of the Switches procedure in the bulletin.
  - If one or more of the switches are catching, replace the accessory switch circuit board. For removal, refer to steps 1-4 of the Check Resistance of the Switches procedure in this bulletin. For installation, refer to the Switch Reassembly procedure in this bulletin. DO NOT reuse the screws that have been removed, new one-way screws MUST be used.

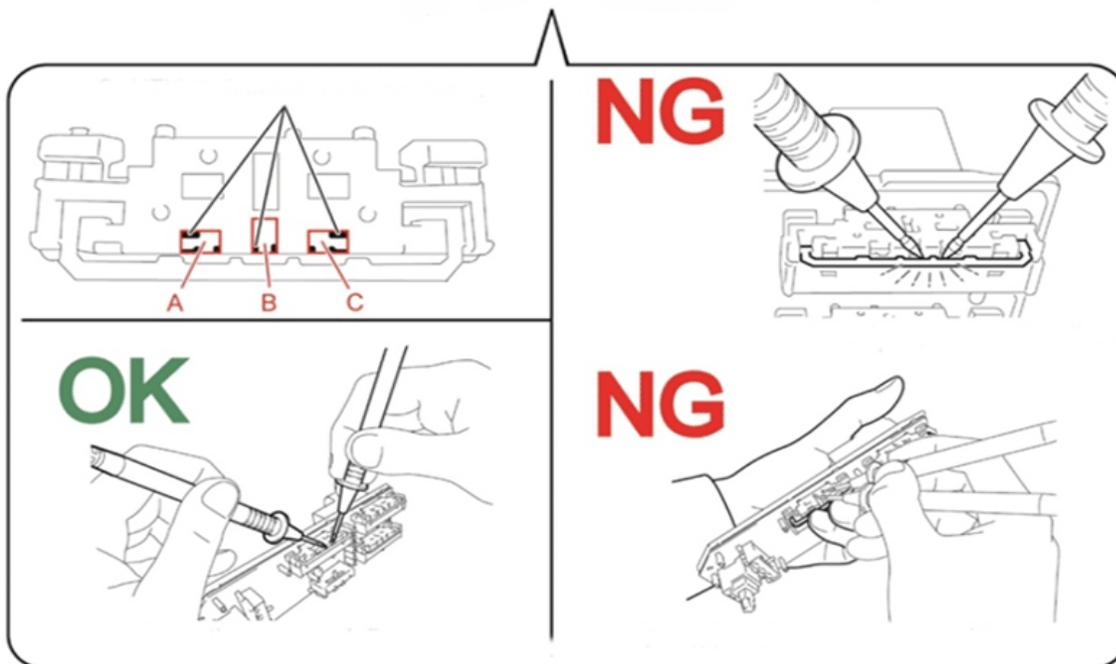
3021162

OK-Good  
NG-No Good

9. Measure the resistance between points A-B and points B-C.

- If the resistance value for ALL switches is infinite, fill the switches with grease. Refer to the Grease Application procedure in this bulletin.
- If one or more resistance value IS NOT infinite, replace the accessory switch circuit board. Refer to the Switch Reassembly procedure in this bulletin.

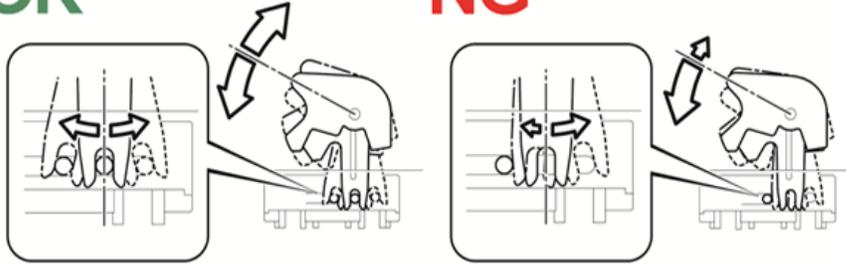
3021212

OK-Good  
NG-No Good

4. While holding the circuit board in the switch case, check the operation of the switches. The movement up/down and lock/unlock position should be equal in both directions.
  - If movement is equal in ALL switches, the circuit board is positioned correctly. Proceed to step 5.
  - If movement in one or more switch IS NOT equal, one or more switch pin is misaligned. Repeat steps 2-4.

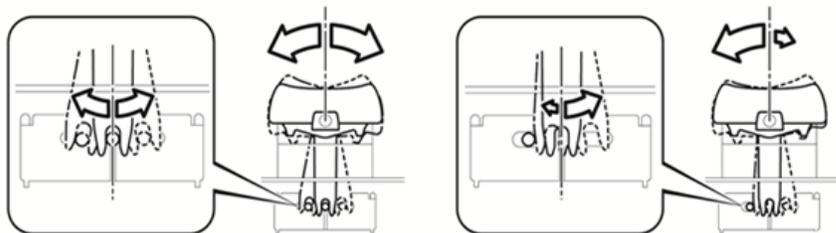
3021213

OK-Good  
NG-No Good
