Program Bulletin

CUSTOMER SATISFACTION PROGRAM

SUBJECT: Clunking Noise When Turning

MODELS: 2013 Chevrolet Cruze

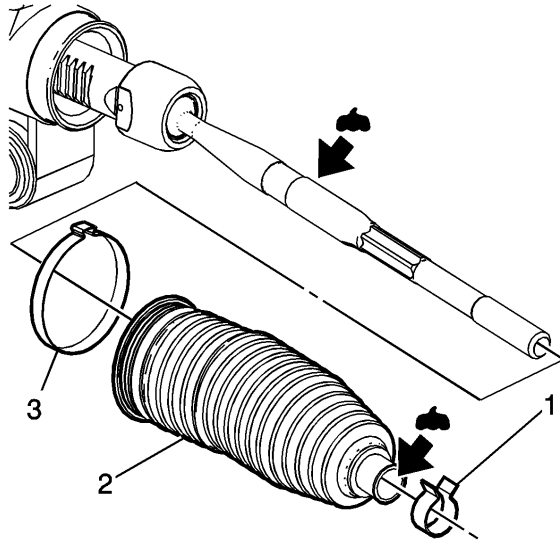
2375391

Note: The steering linkage inner tie rod and the steering gear boot must be free of moisture and debris.

9. Apply lubricant to both inner ends of the steering gear boot (2).

Note: Ensure the larger end of the steering gear boot is firmly seated in the correct location on the steering gear.

10. Install the steering gear boot with the NEW inner boot clamp (3) loosely attached.
