## Argosy Cab Water-Leak Detection and Repair

60-152

Freightliner  
Service Bulletin

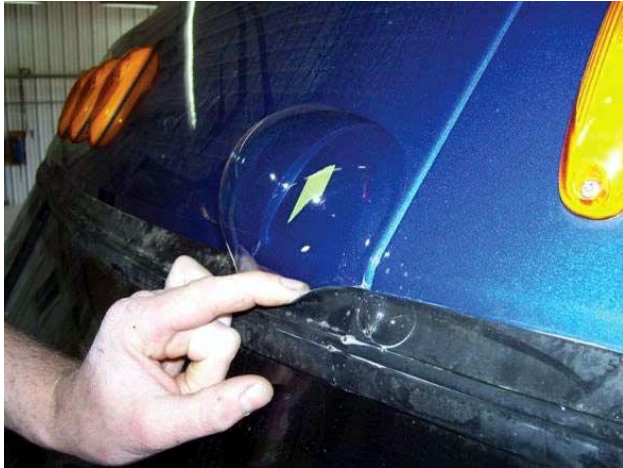
NOTE: Cascadia shown; an Argosy cab leak produces a similar result.

**Fig. 1, Likely Leak Between Windshield Seal and Cab**

Repair leaks in the windshield seal using the approved method and adhesive. Refer to the *Century Class Trucks Workshop Manual*, **Section 60.00** for instructions on windshield seal repair.

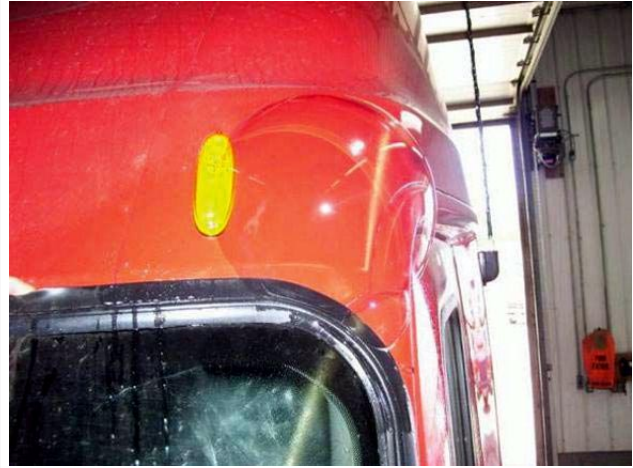
Some Argosy vehicles may allow water to intrude inside the cab. Leaks are most common at the forward corners of the roof cap, above the A-pillars. Water intrusion in this area may result in spaces between the roof cap and the cab, and spaces in the cab structure, to fill with water. Other possible points of intrusion are at the sun-visor mounts, marker lights, windshield seal, front wall to A-pillar interface, roof deflector mounts, and sleeper roof side windows.

Cab/roof seam (coach joint) leaks are often misdiagnosed as sun-visor mount or marker light leaks because they result in water accumulation in the header, and possibly water dripping onto the dash from above. If a sun-visor mount leak or a marker light leak is present, the soapy water method of leak testing described in this bulletin should clearly indicate the location of the leak.

NOTE: Cascadia shown; an Argosy cab leak produces a similar result.

**Fig. 2, Likely Leak Between Roof Cap and Cab**

1. Working on one side of the vehicle at a time, remove the fasteners that attach the side sun visor and visor bracket assembly to the cab. By removing the side sun visor and the aft bracket, the cab/roof seam (coach joint) above the door can be easily accessed.
2. Remove the side visor and the rear side bracket.
3. Clean the seam area with air from a shop air hose, and dry it with a clean shop rag.
4. Apply masking tape to the edges of the roof and cab-side seams from the edge of the front visor bracket (just above the A-pillar) to a point in the seam beyond the B-pillar on the sleeper. Also, apply tape to both sides of the vertical section of the seam just above the rear of the door opening. See [Fig. 4](#).
5. Apply a bead of silicone, part number 48-00094-501, using a caulking gun, to the horizontal and vertical sections of the seam. See [Fig. 5](#). Fill in the seam completely.

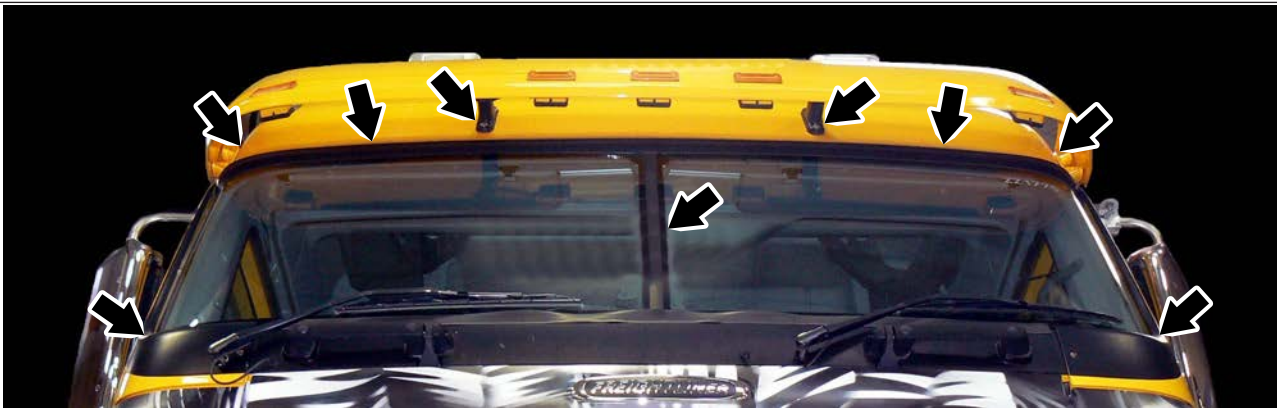
6. Spray the cab and sleeper (if so equipped), with the wash solution, and look for bubbles. See [Fig. 1](#) and [Fig. 2](#) for examples of likely leaks. Inspect all applicable areas shown in [Fig. 3](#) and listed below:
  - windshield center post
  - windshield seal perimeter (especially the upper and lower outboard corners)
  - front wall to A-pillar interface
  - exterior sun-visor mounts
  - marker lights (if mounted on roof)
  - roof deflector mounts (if so equipped)
  - cab/roof seam (coach joint)
  - sleeper roof side windows (if present)

**Fig. 3, Areas to Inspect for Leaks**

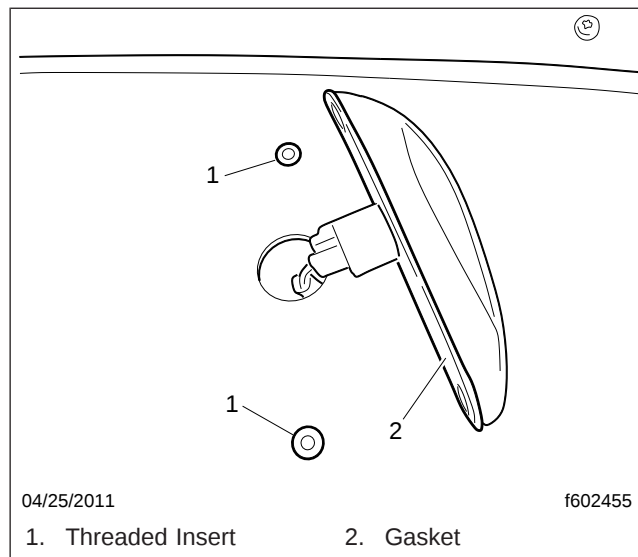
**Fig. 6, Marker Light (shown detached from cab roof)**

**NOTE:** The threaded inserts in the cab have sealed ends, and are a highly unlikely source of leakage. If a leak is found at a sun-visor mount or marker light, it is much more likely to be from the electrical connector hole in the roof cap.

2. Make sure that the sun-visor mount or marker light gasket is in good condition and correctly installed. Replace any damaged gaskets. See **Fig. 6**.

If the leak was at a marker light, install the marker light. Do not under- or over-tighten the screws.
