Technical Service Bulletin

94 Water accumulation in Xenon headlights

94 13 14 2033536/1 April 5, 2013.

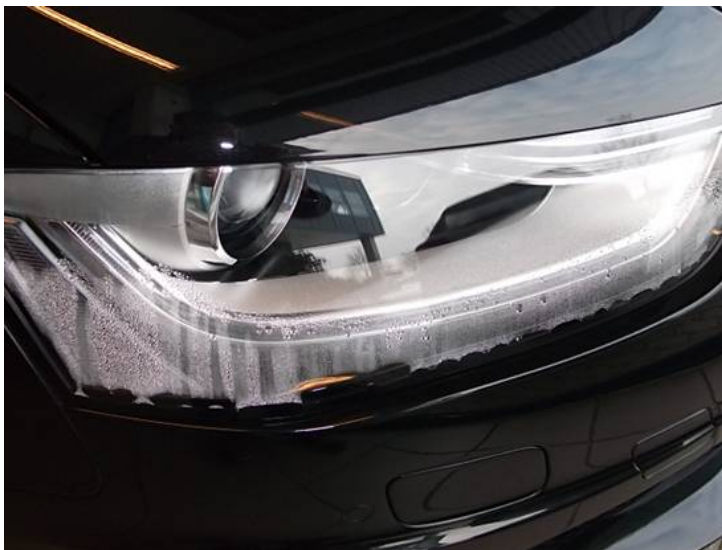
A significant amount of water is collecting at the base of the Xenon headlight lens (Figure 1).

No outside influence, such as rock chips, can be found. The headlights function normally.

Figure 1. Xenon headlight with a significant amount of water collecting at the base of the lens.

Under certain circumstances, water can enter through the headlight adjustment screw (A4), or through the bonding channel between the headlight housing and lens (A5).

Replace the affected headlight(s) only if a visible amount of water can be seen collecting at the base of the headlight lens(es). Refer to ELSAWeb: *Repair Manual*>>*Electrical System*>>*Electrical Equipment*>>*94 Exterior Lights, Switches*>>*Removal and Installation*>>*HID Headlamp, from MY 2012*>>*Headlamp Housing*.

Adjust headlights after installing them back in to the vehicle. Refer to ELSAWeb: *Repair Manual*>>*Electrical System*>>*Electrical Equipment*>>*94 Exterior Lights, Switches*>>*Diagnosis and Testing*>>*HID Headlamp, Adjusting*.
