# Technical Service Bulletin

## 94 Rear lid tail lamp lighting does not switch over to bumper (DTC 03073)

94 13 16 2033675/1 April 29, 2013.

Model(s)	Year	VIN Range	Vehicle-Specific Equipment
Q5	2009-2014	All	NA
Q7	2007-2014	All	NA

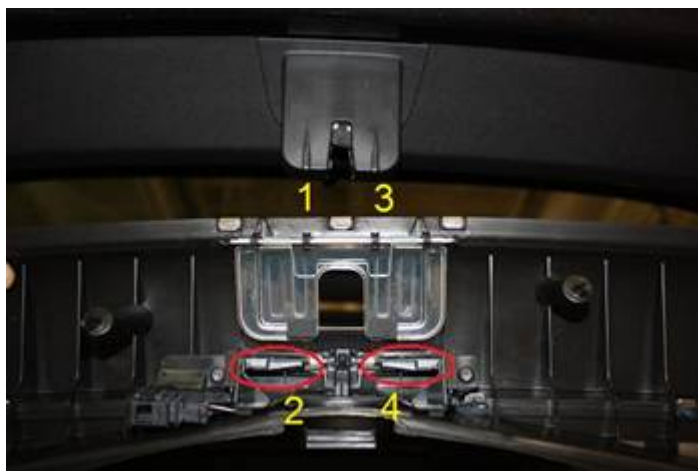
In order for the taillight lighting to switch between the rear lid and the bumper when the lid is operated, the paddle switches on the rear sill trim must contact the opposing lid latch points uniformly.

- Paddle switch G526 (Figure 1, 2) must contact lid latch point 1 (Figure 1, 1), as shown in the image at right.
- Paddle switch G525 (Figure 1, 4) must contact lid latch point 3 (Figure 1, 3), as shown in the image at right.

**Figure 1.** Inside vehicle view of rear lid latch showing location of G526 (2) and G525 (4) on rear sill trim, and contact points (1 and 3).

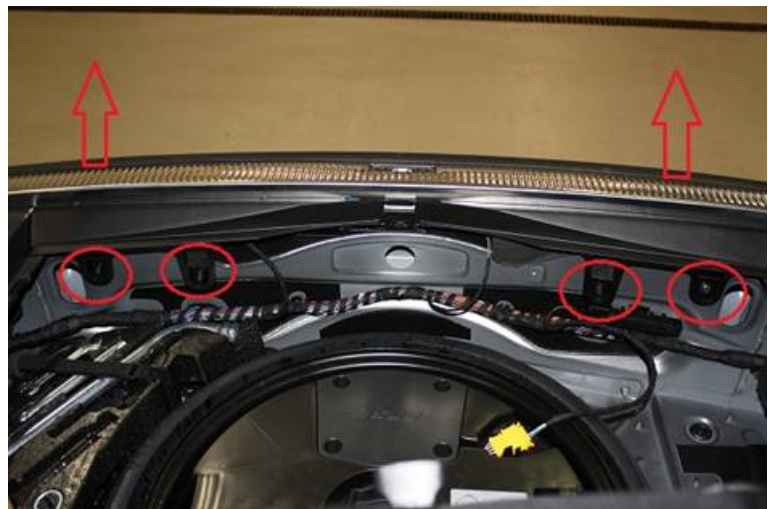
**Figure 2.** Rear cargo area trim plate removal in the Audi Q7. The T25 Torx® screws to be removed are circled in red.

- In the Audi Q7: Remove the four T25 Torx® screws (Figure 2), then carefully pull up on the plate.
- In the Audi Q5: The plate is not held by screws. Carefully lift the plate straight up, noting the four clips retained in the trim.

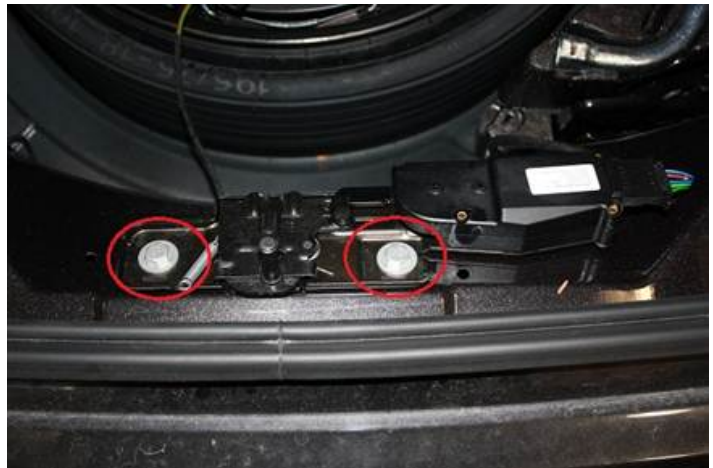
**Figure 3.** Power lid's motorized striker plate bolted mounting.

- Note the current position of the striker plate by using the serrated lines surrounding the bolt or surrounding the nut's integrated washer (Figure 3 - Figure 6).

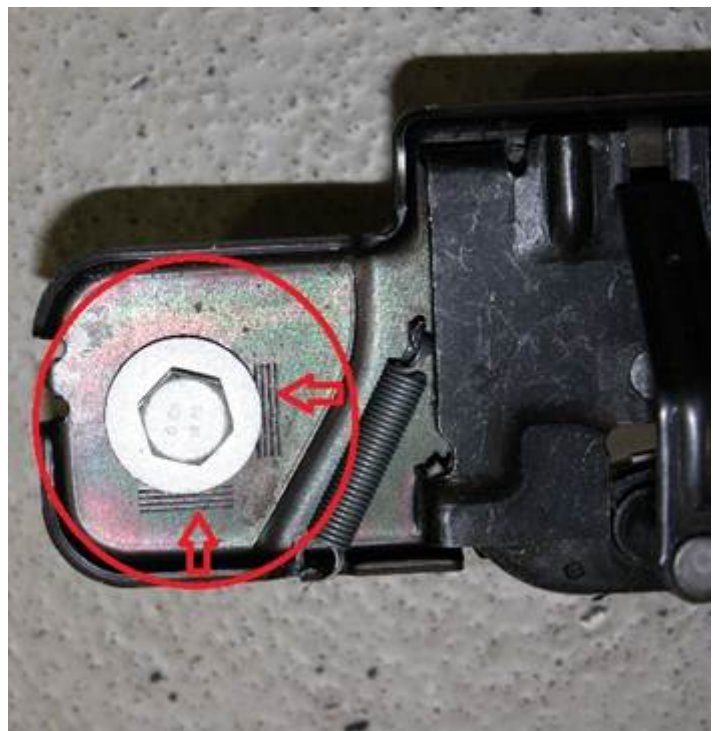
**Figure 4.** Power lid's motorized striker plate adjustability and serrated indicators.

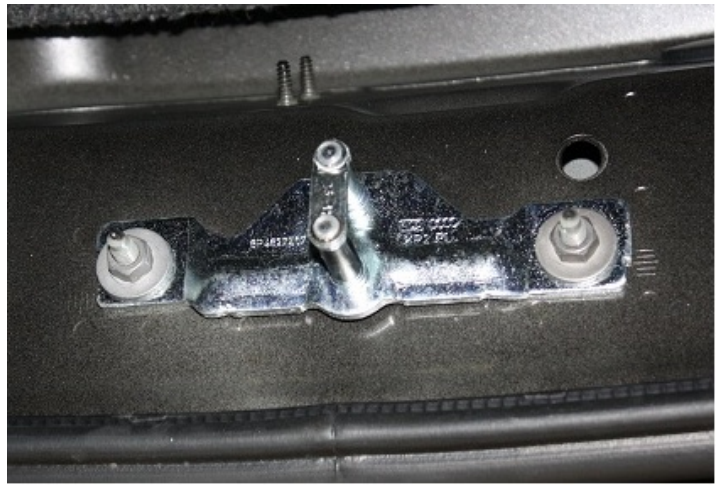
**Figure 5.** Manual lid style striker plate studded mounting.

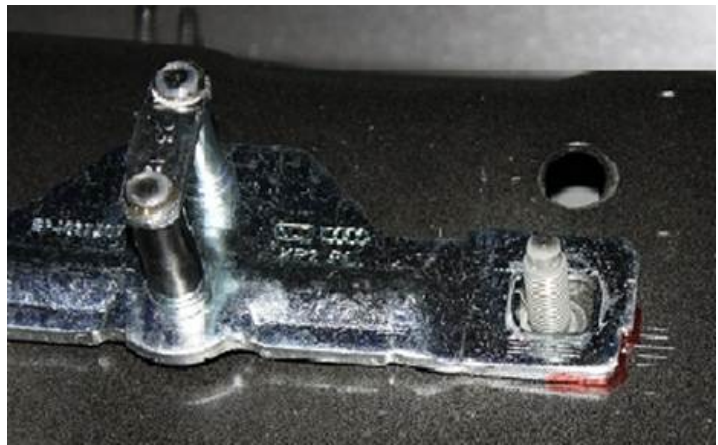
**Figure 6.** Manual lid style striker plate adjustability and serrated indicators.

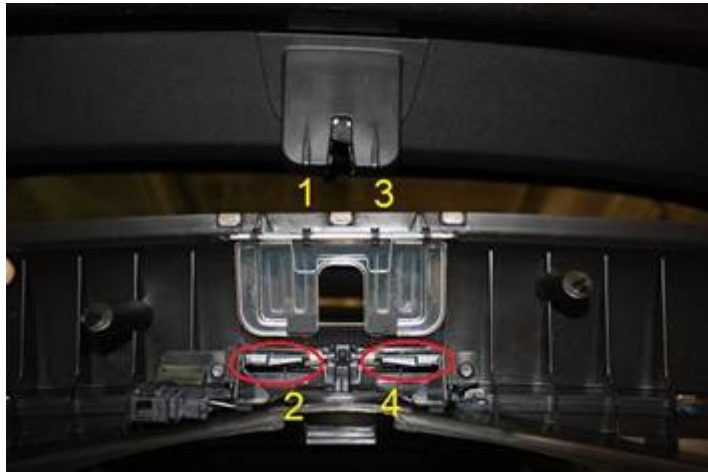
**Figure 7.** Inside vehicle view of rear lid latch showing location of G526 (2) and G525 (4) on rear sill trim, and contact points (1 and 3).

3. Adjust the striker plate until the lid latch is evenly drawn in to actuate the G526 and G525 paddle switches (Figure 7, 2 and 4). Center the striker plate latch to the lid latch.

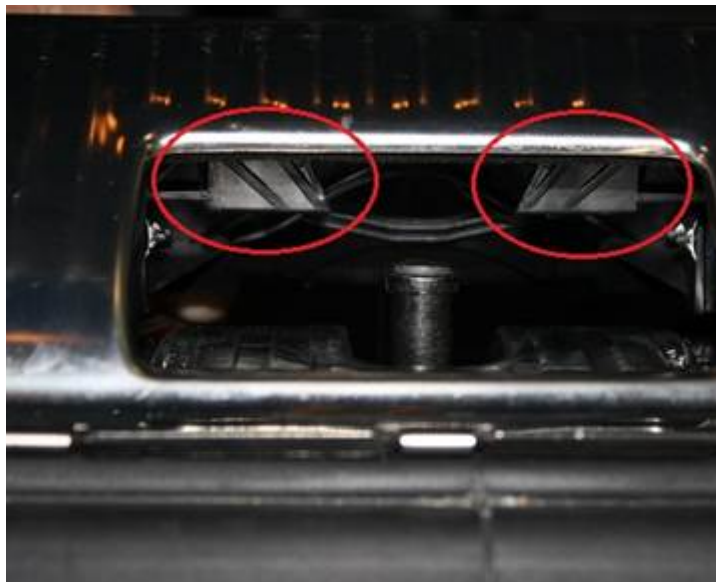
**Figure 8.** Overhead view of paddles contacted by rear lid latch.

**Tip:** Moving the striker plate latch towards the front of the vehicle will bring the lid latch closer to actuating the paddle switches (Figure 8).
