RECALL CAMPAIGN BULLETIN

NTB13-056a

VOLUNTARY EMISSIONS RECALL CAMPAIGN 2007 – 2008 ALTIMA SEDAN AND COUPE ECM REPROGRAM AND MANIFOLD CATALYST

CAMPAIGN ID #: PC131

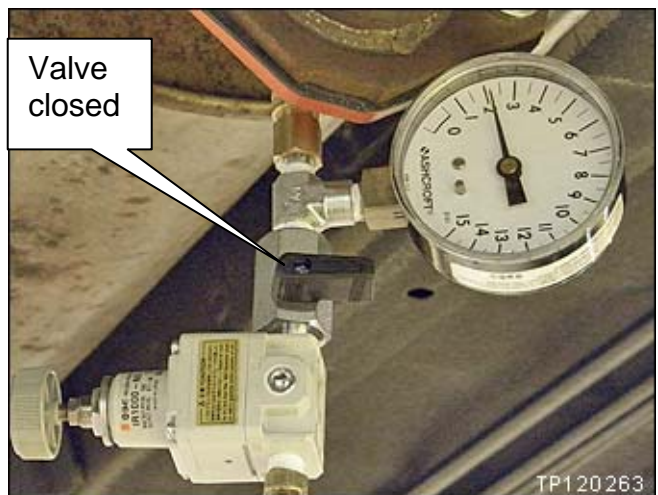
Figure P10

OK: Pressure is 2 psi or above; there is no leak in the front tube or manifold.

NG: Pressure is below 2 psi; there is a leak in the front tube, manifold, or gasket.

- If vehicle has **more than** 50,000 miles, go to Exhaust Manifold Replacement on page 13.
- If vehicle has **less than** 50,000 miles:
 - Remove the exhaust manifold stay – see page 10.
 - If required, replace the upper and lower exhaust manifold covers (heat shields) – see page 10.
 - Reinstall the front exhaust tube.

B. Replace **only** the leaking part (gasket, front exhaust tube, and/or exhaust manifold).

- For all vehicles with **more than 50,000 miles**, **replace the exhaust manifold** even if it does not have a leak.
- Replacement of the exhaust manifold includes removal of the exhaust manifold stay and, if required, replacement of the upper and lower exhaust manifold covers (heat shields).
 - For a leak at the gasket between the exhaust manifold and front tube; refer to page 11 (**Front Exhaust Tube Replacement**) and replace only the gasket.
 - For a leak at the gasket between the exhaust manifold and engine head; refer to page 13 (**Exhaust Manifold Replacement**) and replace only the gasket.
 - For a leak in the front tube; refer to page 11 (**Front Exhaust Tube Replacement**).
 - For a leak in the exhaust manifold; refer to page 13 (**Exhaust Manifold Replacement**).
