# Cascadia Chassis Side Fairing Lower Air Deflector Retention

31-32

**Freightliner  
Service Bulletin**

**Description of Revisions:** *This bulletin replaces the version dated March 2013. The Cause Code has been corrected to 12.*

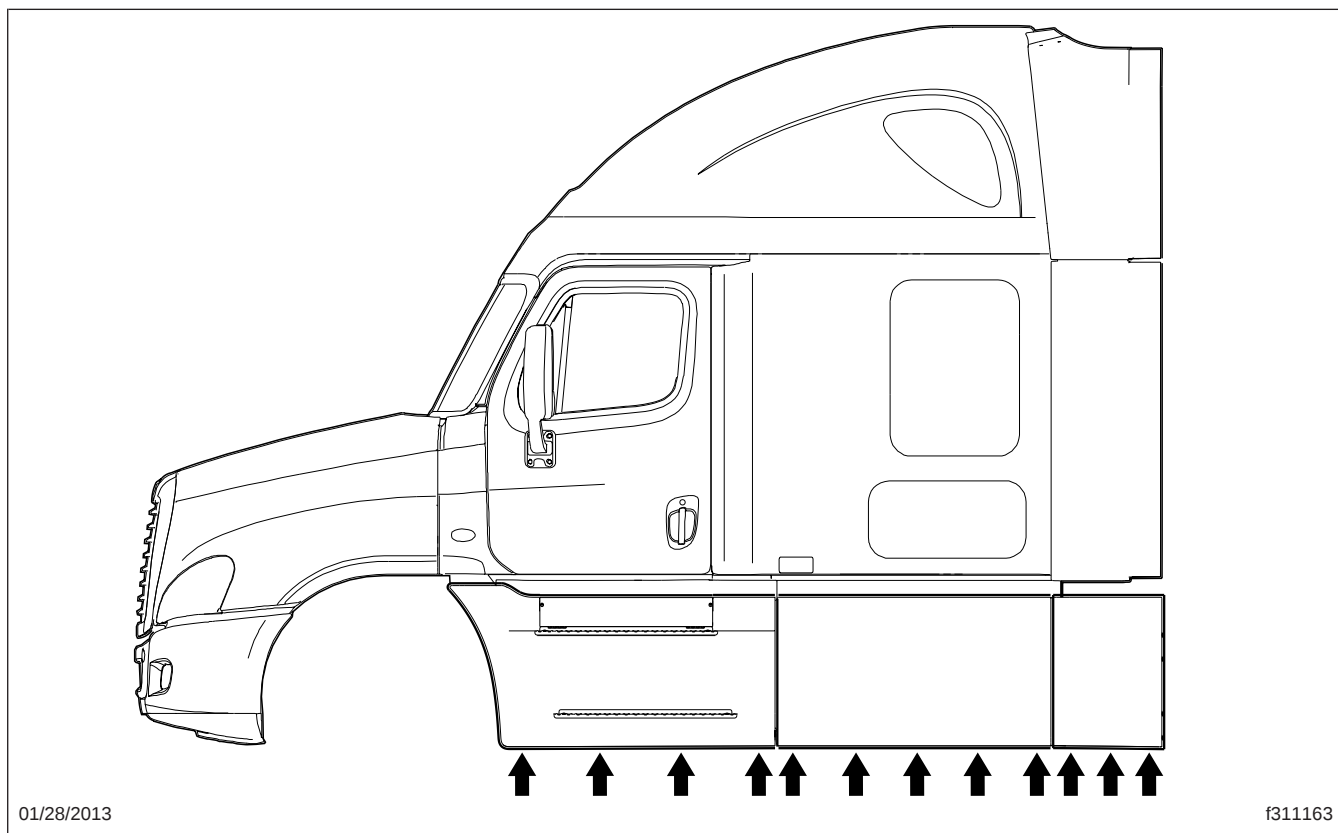
**Fig. 1, Rivet Spacing**

The chassis side fairing lower air deflectors are attached with C-clips that could become loose if dislodged or disturbed. In certain circumstances, a deflector may separate from the truck. To improve the retention of an air deflector, rivets can be added as described in the following work instruction.

Drill the ends of each fairing, at points spaced evenly between the ends, to accommodate four rivets for a front fairing, five rivets for a center fairing, and three rivets for a rear fairing; see [Fig. 1](#). See [Table 1](#) for rivet part information.
