Service Bulletin

Bulletin No.: PI0388C

Subject: Seat Belt Webbing/Latch Plate Becomes Twisted

Models: 2011-2013 Buick Enclave, LaCrosse, Regal
 2011-2013 Cadillac CTS, SRX
 2013 Cadillac XTS
 2011-2013 Chevrolet Equinox, Malibu, Traverse, Volt
 2012-2013 Chevrolet Sonic
 2011-2013 GMC Acadia, Terrain

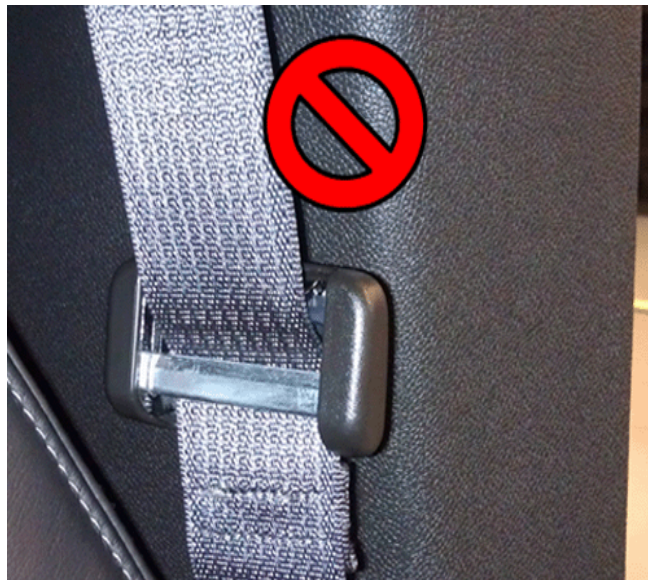
3418125

As shown in the graphic above, some customers may comment that the driver or passenger side seat belt is twisted or the latch plate is facing backward on the webbing. Note that the tip of the latch plate is **incorrectly** positioned outboard of the webbing when stowed.

The slot in the latch plate is opened enough to allow it to slide freely on the seat belt. The opening also allows the seat belt webbing to twist in the latch plate.

Do not replace the seat belt retractor assembly. The latch plate can be repositioned properly on the webbing by following the steps below:
