Technical Service Bulletin

01 MIL on (DTC P0300, P130A, and/or P0301 through P0304)

01 13 95 2033561/1 May 13, 2013.

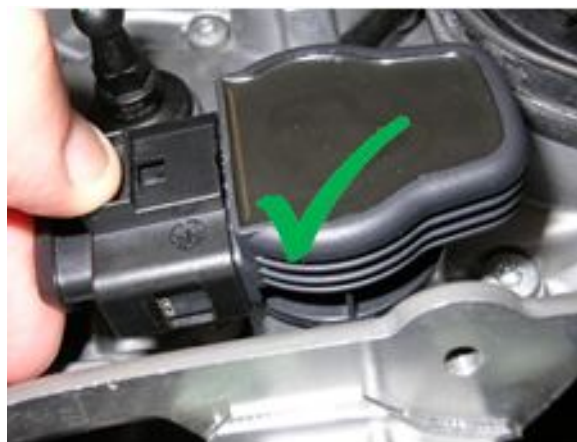
Figure 1. Correct method of disconnecting the ignition coil.

1. Confirm that misfire faults are stored in the ECM memory.
2. Disconnect the connectors from the ignition coils by first pushing the connector towards the ignition coil, then pulling the release tab with thumb, then pulling the connector off the ignition coil (Figure 1).

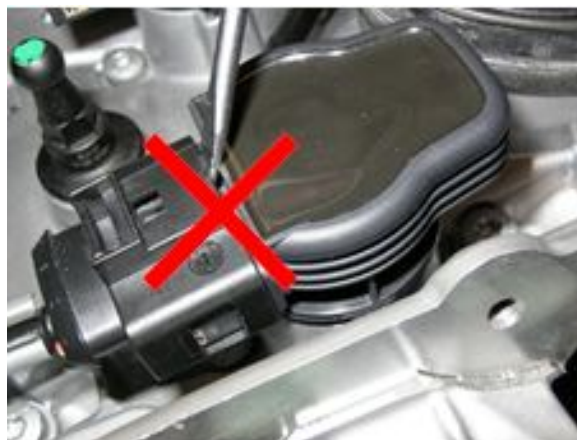
**Note:** Never use a screw driver, pick or any other tool to unlock and remove the connector, as damage to the connector may occur (Figures 2 and 3).

Figure 2. Incorrect method of disconnecting the ignition coil.

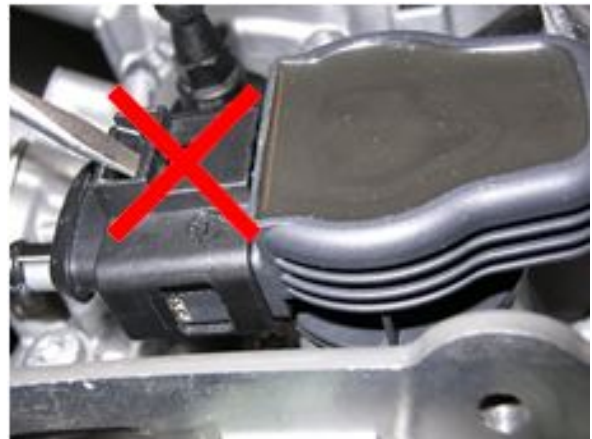
Figure 3. Incorrect method of disconnecting the ignition coil.

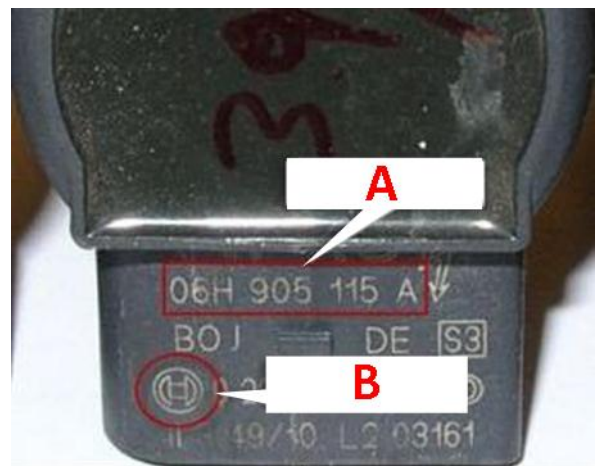
3. Check the part number of the coils (Figure 3). If one of the following part numbers is installed, all four ignition coils will need to be replaced:

- 06H 905 115
- 06H 905 115 A
- 06H 905 115 B

Figure 3. A) part number, B) Bosch symbol.

4. Replace all four ignition coils with part number **07K905715F** (ELDOR).
