# Program Bulletin

## CUSTOMER SATISFACTION PROGRAM

**SUBJECT:** Front and Rear Door Handles May Stick or Bind

**MODELS:** 2013 Buick LaCrosse, Regal, Verano  
2013 Cadillac SRX  
2013 Chevrolet Cruze, Malibu  
Equipped with Keyless Entry Feature (ATH)

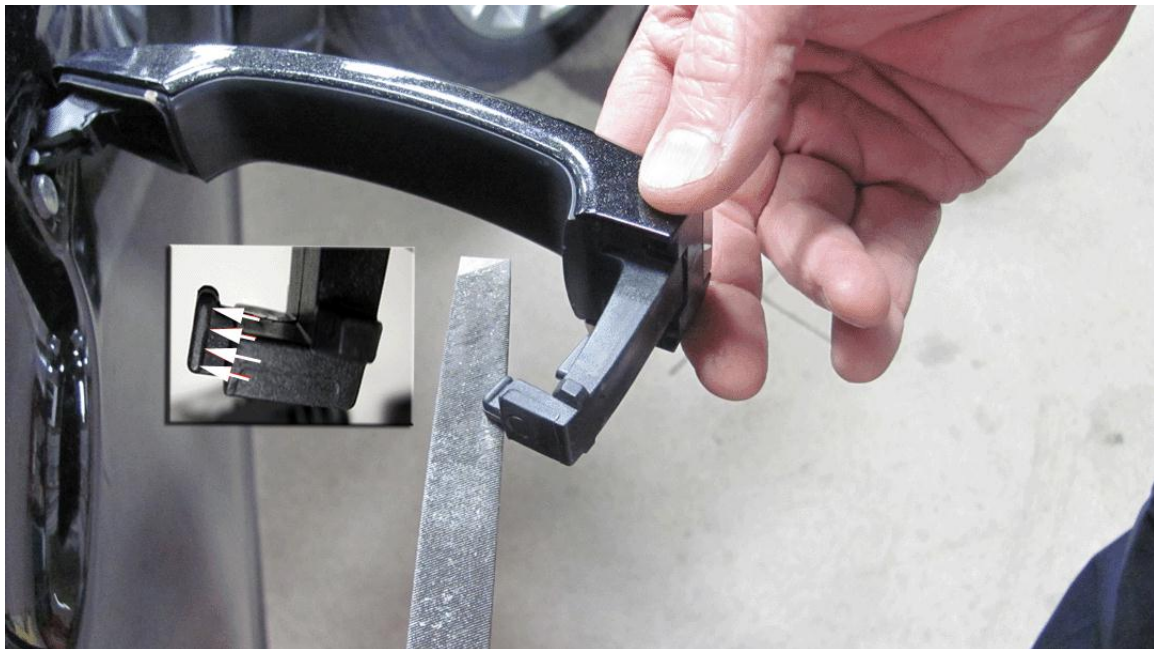
3415788

- If the thickness is between 5.7 mm (0.224 in) and 5.9 mm (0.232 in), the door handle leg does NOT require modification. Proceed to step 8.

**Note:** Removing too much material may create a rattle condition. The final thickness should be 5.7 mm (0.224 in).

- If the thickness is greater than 5.9 mm (0.232 in), use a flat file or fine grade sand paper to remove material from the area identified by the arrows. Remove an equal amount from both sides of the door handle leg. The final thickness should be 5.7 mm (0.224 in). Proceed to step 8 after removing the appropriate amount of material from the door handle.
