Technical Service Bulletin

PSS 96 Lane Change Assistant "Sensors Blocked" warning in DIS

96 13 60 2033943/1 May 23, 2013.

Model(s)	Year	VIN Range	Vehicle-Specific Equipment
A4/S4	2013	All	Lane Change Assistant
allroad	2013		
A5/S5/RS 5	2013

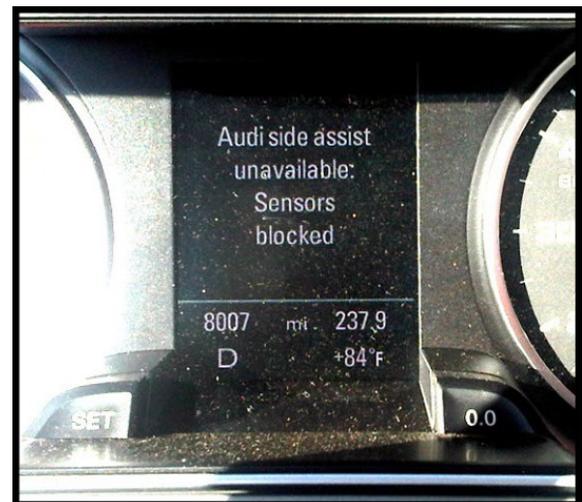
- Audi Lane Change Assistant (Side Assist) deactivates or is sporadically inoperative when the vehicle is driven in slow-moving, stop-and-go traffic or when it is driven for long periods of time on open roads that have no traffic.
- A warning message is seen in the instrument cluster driver information system stating "Audi side assist unavailable: Sensors blocked".

Figure 1. Audi Side Assist warning in DIS

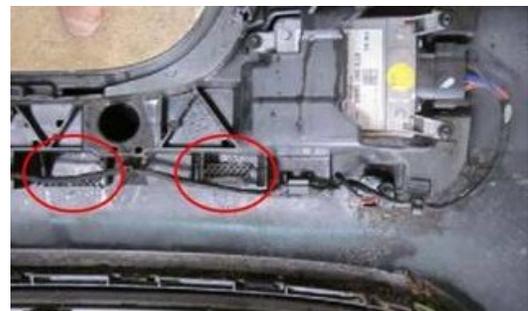
Figure 2. Mounting bracket for one of the ECUs.

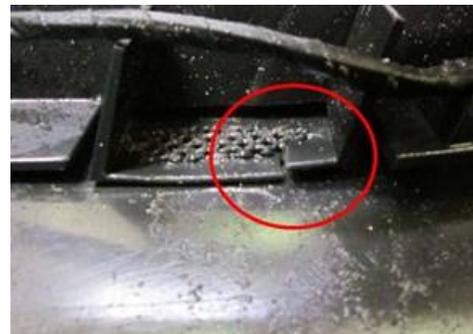
Figure 3. Mounting bracket broken

- The control unit mounting brackets are securely fastened to the lower rear bumper, and they are not loose or broken (Figures 3 and 4).
If a loose bracket is found, repair as necessary using the ElsaWeb Repair Manual. Submit a separate warranty claim, as this TSB does not cover this repair.

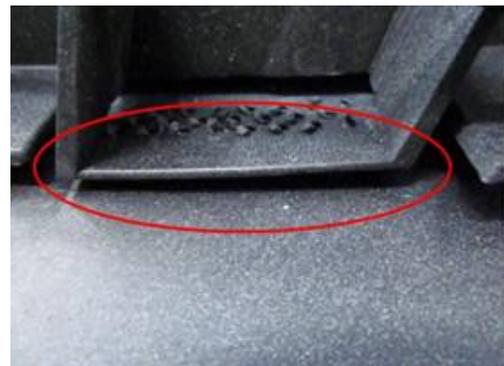
Figure 4. Mounting bracket loose
