## SERVICE BULLETIN

Classification: AT13-007a	Reference: NTB13-064a	Date: June 13, 2013
------------------------------	--------------------------	------------------------

### 2013 ALTIMA V6 SEDAN AND PATHFINDER SHUDDER FROM TORQUE CONVERTER LOCK UP CLUTCH

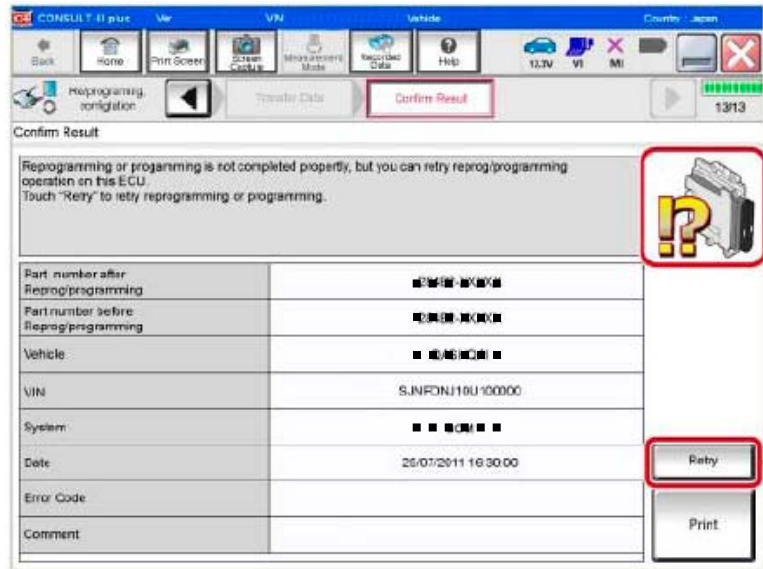
Figure 5

If reprogramming does not complete and the “!?” icon displays as shown in Figure 5:

- Check battery voltage (12.0–15.5 V).
- Ignition is ON, engine OFF.
- External Bluetooth® devices are OFF.
- All electrical loads are OFF.
- **Select retry and follow the on screen instructions.**
- “Retry” may not go through on first attempt and can be selected more than once.

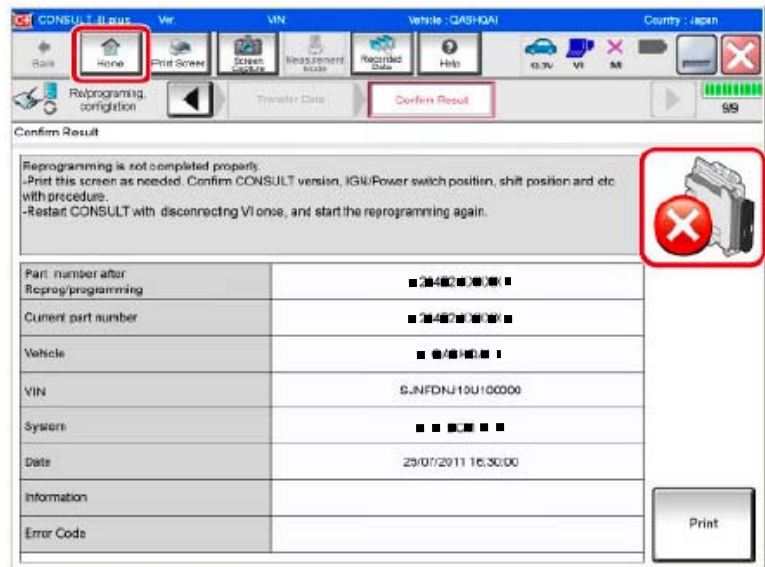
Figure 6

If reprogramming does not complete and the “X” icon displays as shown in Figure 6:

- Check battery voltage (12.0 – 15.5 V).
- CONSULT A/C adapter is plugged in.
- Ignition is ON, engine OFF.
- Transmission is in Park.
- All C-III plus / VI cables are securely connected.
- All C-III plus updates are installed.
- **Select Home, and restart the reprogram procedure from the beginning.**
