Technical Service Bulletin

80 Coolant loss from coolant valve, engine warning light on, "Limp Home" mode active

80 13 03 2033806/2 May 13, 2013. Supersedes Technical Service Bulletin Group 80 number 13-02 dated May 9, 2013 for reasons listed below.

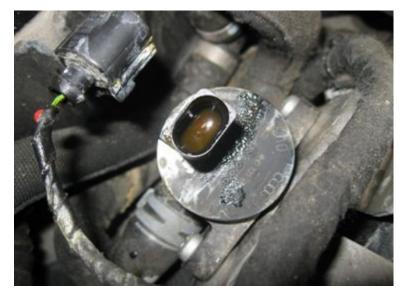
Inspection of the coolant control valves N82, N509, or N488 reveals the presence of coolant inside the electrical connector as shown in the illustration (Figure 1).

Figure 1. Coolant residue in the connector housing of the coolant regulating valve.

- 1. Diagnose the defective coolant valve (N82, N509, or N488) using Guided Fault Finding where stored DTCs are found.
- 2. Replace the defective coolant valve.

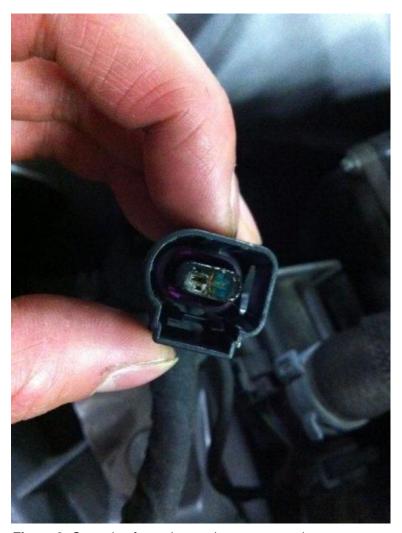
The connectors, wiring harness, and / or connected control units may have been damaged from exposure to coolant (Figure 2).

Figure 2. Corrosion formation on the connector pins.

Tip: Check the connectors, wiring harness, and connected control units for coolant damage. Perform repairs as necessary.
