SB-10052359-3401

SI B13 07 12
Fuel SystemsMay 2013
Technical Service

SUBJECT**N63 and S63 Engine: High-pressure Fuel Injector Replacement Procedures****MODEL**

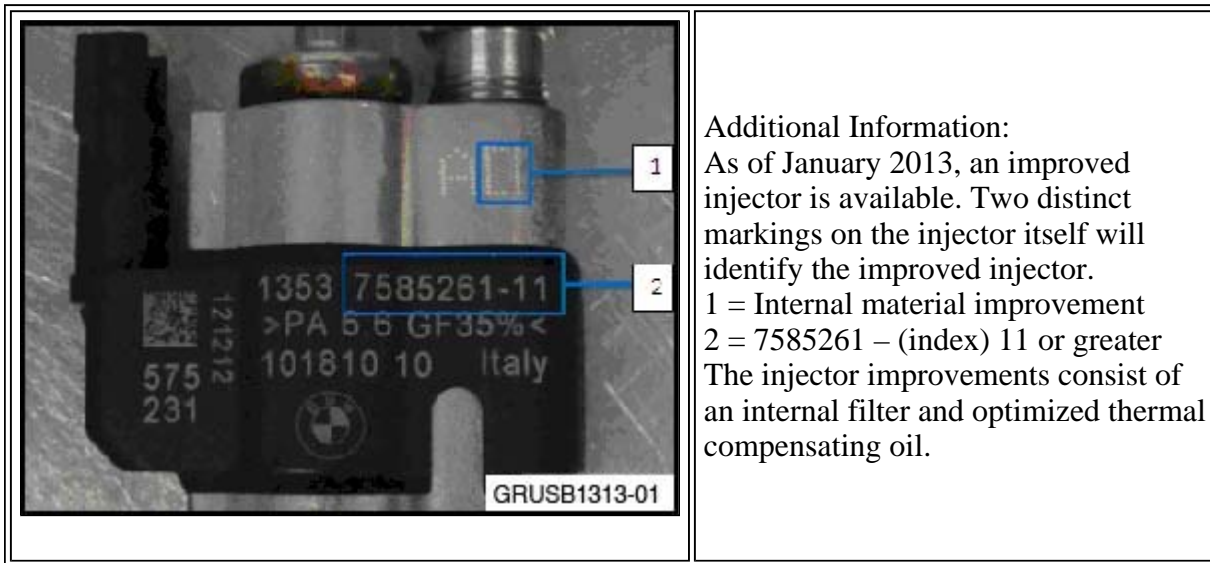
As of January 2013, an improved injector is available. Two distinct markings on the injector itself will identify the improved injector.

1 = Internal material improvement

2 = 7585261 – (index) 11 or greater

The injector improvements consist of an internal filter and optimized thermal compensating oil.

IMPORTANT: Injectors with index 11 and higher have a different calibration and construction than injectors with index 10 and lower.

Due to this difference, the injectors with index 11 and higher and injectors with index 10 and lower cannot be mixed on the same engine bank (i.e., cylinders 1-4 or 5-8).

Once a bank of injectors is at index 11 or higher, the “bank set replacement” requirement no longer applies. For index 11 injector failures, only replace the failed injector.
