DESCRIPTION

On the vehicles affected by this bulletin, a corrective measure is required due to bolts coming loose at the radiator fan clutch tripod attachment to the radiator. Bolts tend to get loose because they are tightened on a part made of rubber. Addition of four (4) locknuts (jam nuts) will prevent bolts to loosen and consequently, the radiator fan from striking the radiator core if the assembly fails.

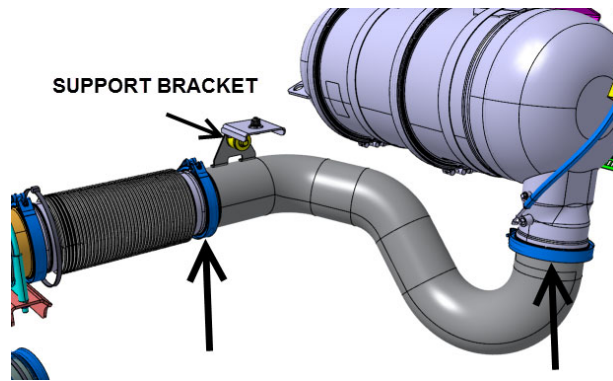
3. **H3 VIP CONVERSION SHELLS.** The section of the exhaust pipe located between the DPF and the flexible section above the turbo must be removed to gain access to the tripod upper support.

a. Clear the two (2) V-band clamps hidden under the insulating blanket at the junction with the DPF and at the junction with the exhaust flexible section.

b. Undo the two (2) V-band clamps identified on the image.

c. Unscrew the nut at the support bracket.

d. Remove this section of exhaust pipe.
