**SB-10052413-6764**

**Title: TerraStar Torsion Bar Retention Cotter Pin Design Change****Applies To: TerraStar built before 1/31/2013****DESCRIPTION**

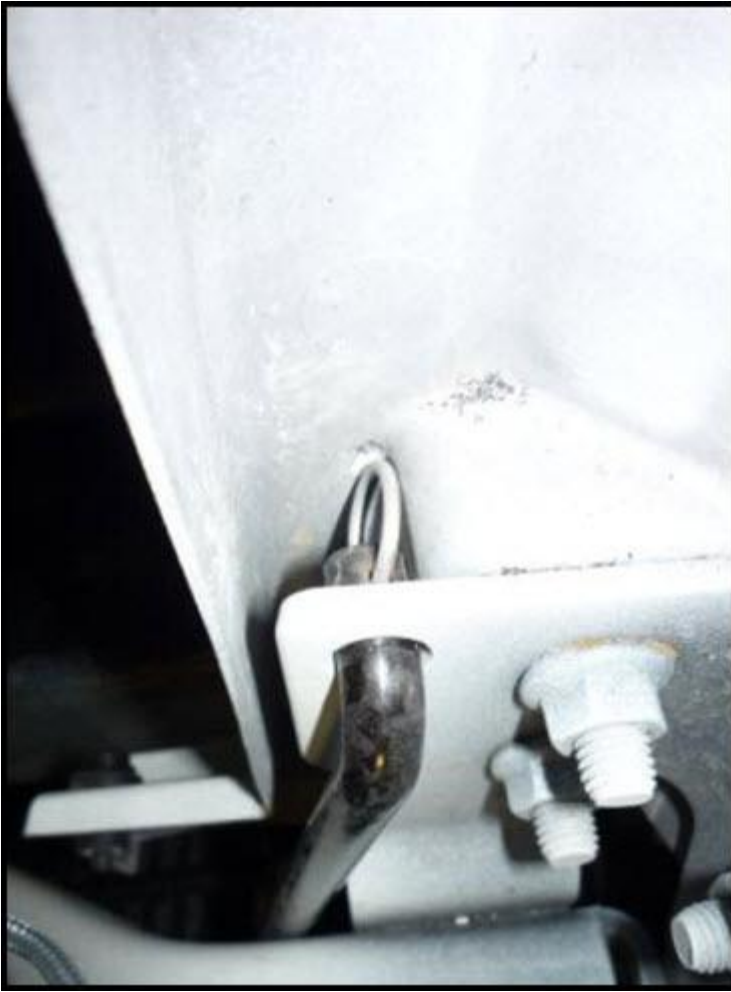
**Figure 3**

3. Pin that has turned and is rubbing on the GOR (*Figure 3*).

A replacement cotter pin with a smaller loop has been put into production as of 1/31/2013. Should it be desired, the cotter pin on the trucks built prior to this date may be swapped with P/N 6102322C1 (the old part number was 3531907C2).

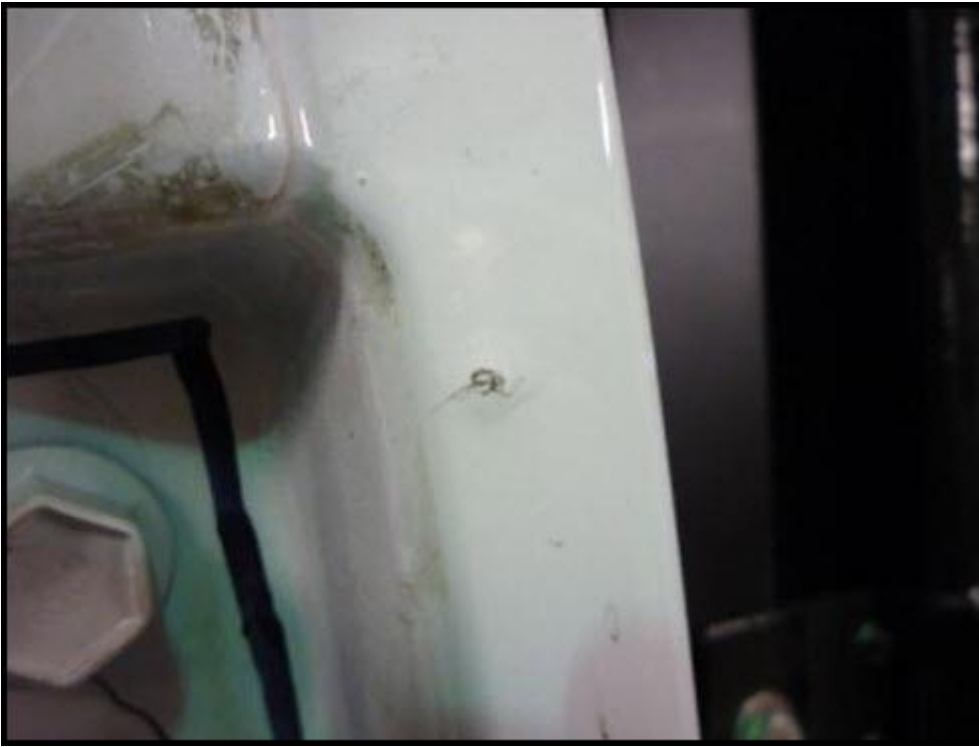
**Figure 4**

There has been a design change to the TerraStar torsion bar retention pin due to the possibility of the pin rotating and then wearing against and/or cracking the Grille Opening Reinforcement (GOR). This is a cosmetic issue that is normally hidden by the grille and the headlamp, however it may be discovered if these parts are removed for service.

4. Evidence of cracking on GOR due to pin (this is normally obscured by the headlamp and grille) (*Figure 4*).

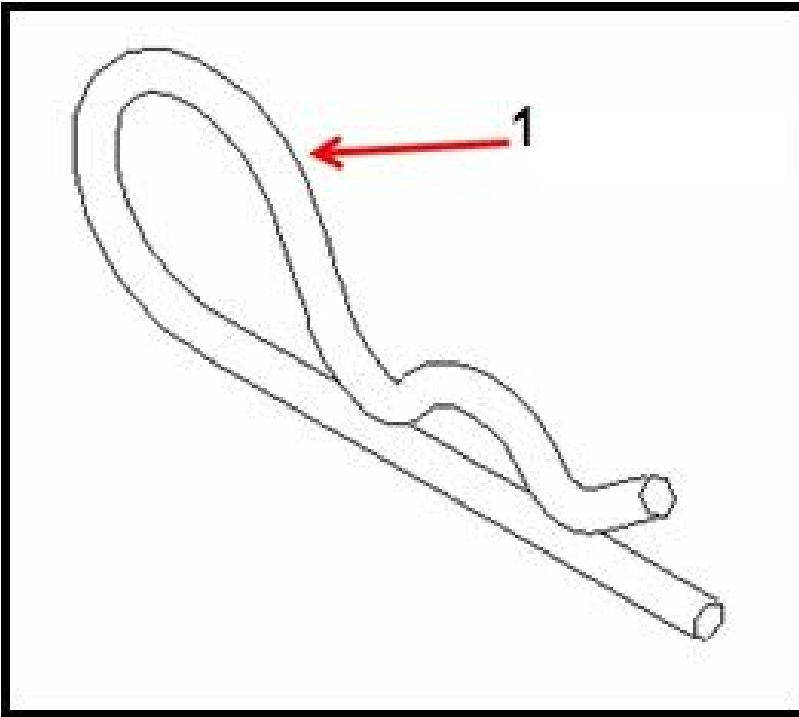
**Figure 5**

5. Differences between old and new cotter pin (*Figure 5*).

1. Loop reduced from 5/8" to 3/8"
