SERVICE BULLETIN

ST12-009b

2013 ALTIMA SEDAN; NOISE FROM THE HYDRAULIC ELECTRIC POWER STEERING (H-EPS)

APPLIED VEHICLE: 2013 Altima Sedan (L33)

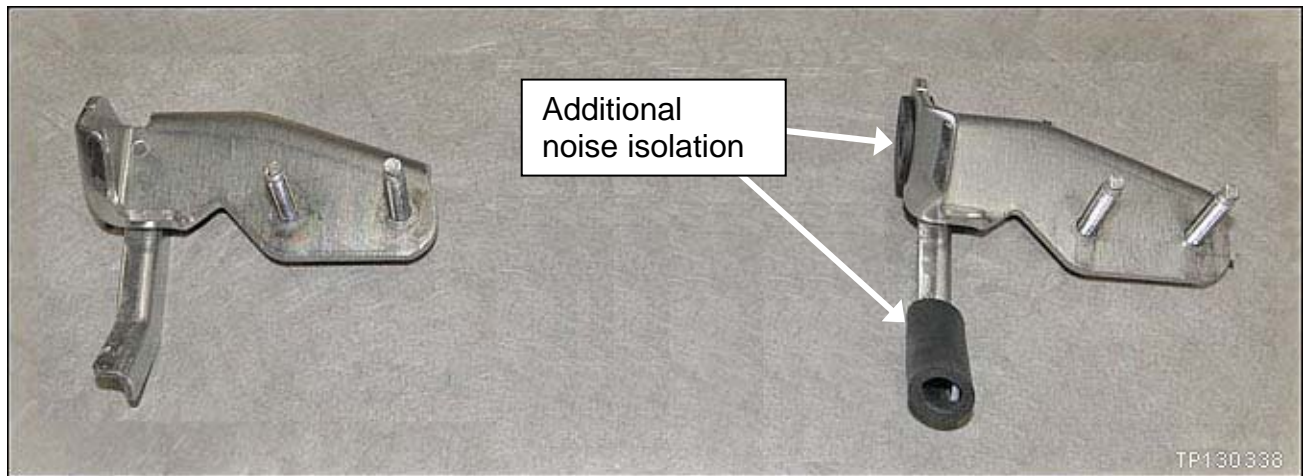
Old style bracket

New style bracket

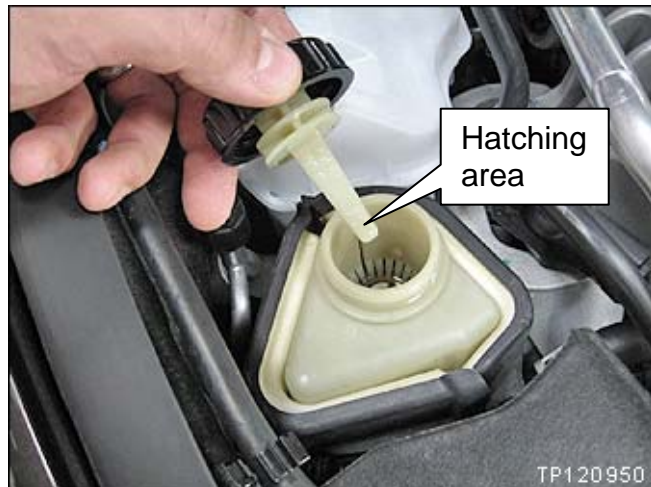
Figure 1

1. Check the Hydraulic Electric Power Steering (H-EPS) fluid level.
 - Check fluid level with the ignition OFF and fluid temperature between 0 – 30°C (32 – 86°F).
 - Power steering fluid level should be within the hatching area of the indicator on the power steering reservoir tank cap.
 - If fluid is needed, use only genuine NISSAN E-PSF or equivalent.

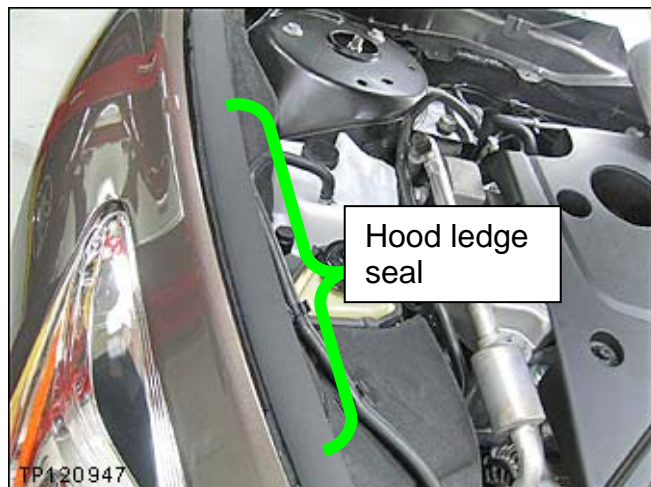
Figure 2

2. Make sure the right front hood ledge seal is installed correctly.
 - Install seal correctly, or
 - If damaged, replace seal, or
 - If missing, install a seal.

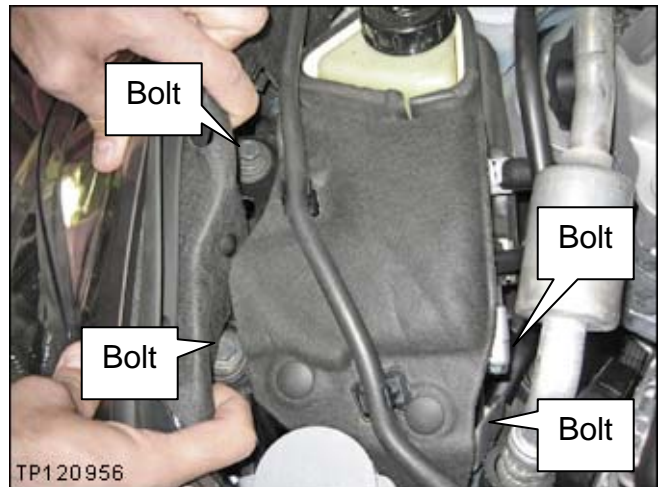
Figure 3

3. Make sure there is no binding on the H-EPS pump mounting isolator as follows:

- a. Loosen the 4 H-EPS pump mounting bolts.
- b. Move the H-EPS pump a small amount from side to side.
- c. Tighten the mounting bolts.

13.5 N•m (1.4 kg-m, **10 ft-lb**)

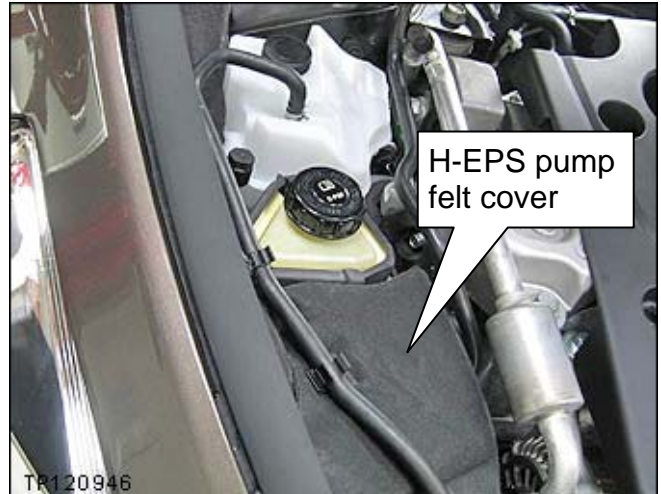
Figure 4

4. Make sure the H-EPS pump felt cover is installed correctly.

- Install felt cover correctly, or
- If damaged, replace felt cover, or
- If missing, install a felt cover.

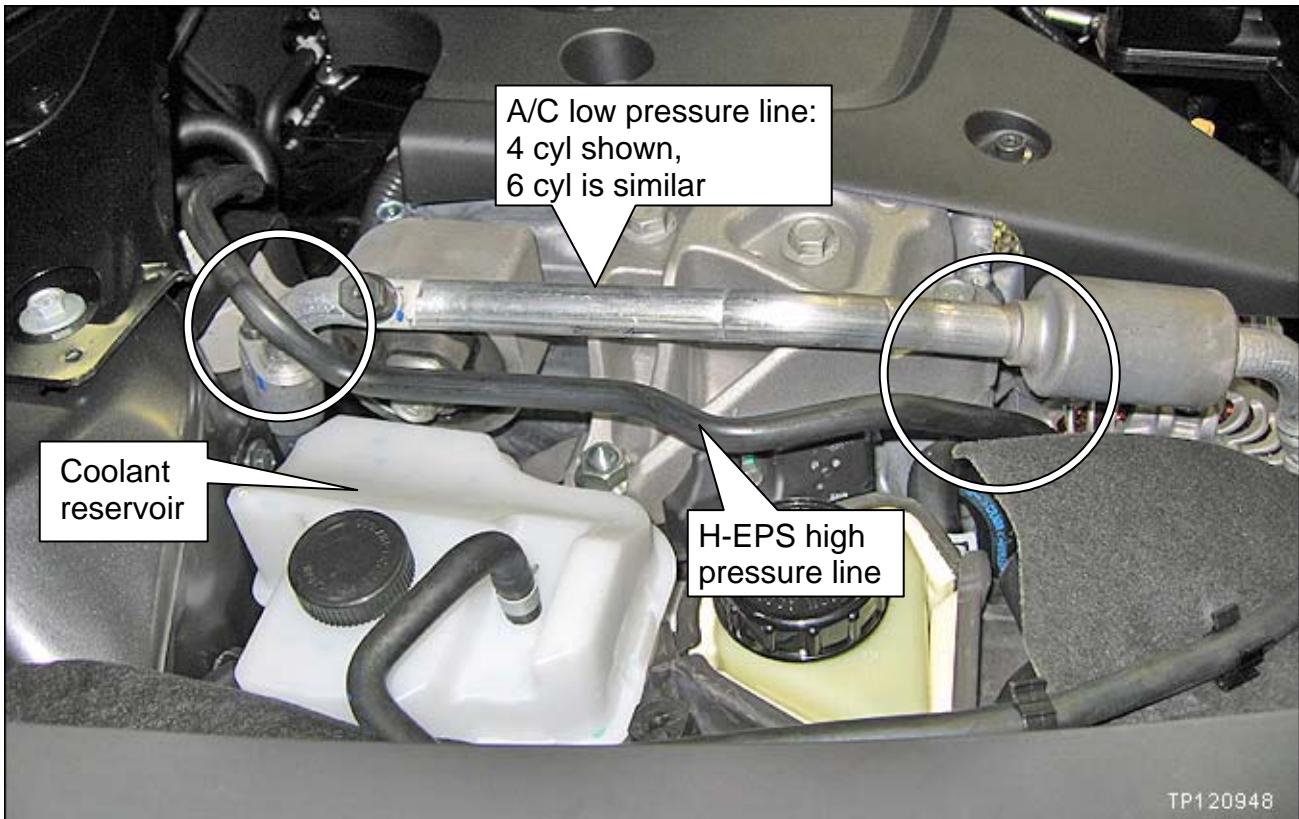
Figure 5

5. Make sure the H-EPS high pressure line and the A/C low pressure line are **not** touching (see Figure 5).
- Check the two locations circled in Figure 5.
 - If the lines are touching, reposition the lines so they are **not** touching.

6. Make sure the H-EPS high pressure line is **not** touching the coolant reservoir (see Figure 5).

- Make sure the coolant reservoir is mounted correctly; its locator boss must be seated in the mounting hole.
- If needed, reposition the H-EPS line so it is **not** touching the reservoir.

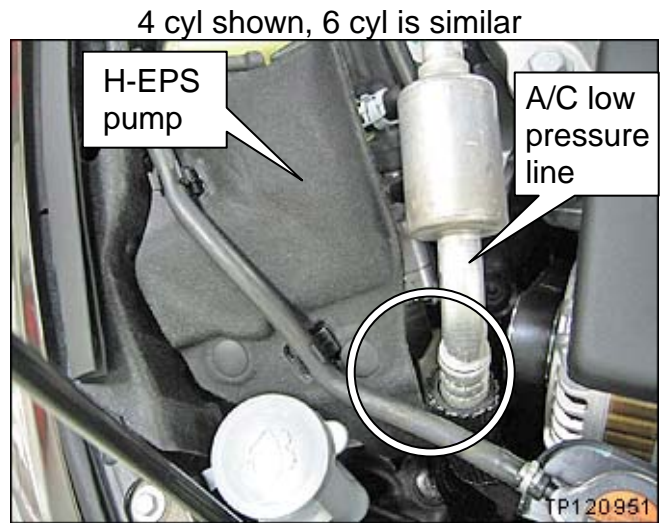
Figure 6

7. Make sure the A/C low pressure line is **not** touching the H-EPS pump.

- Check the location circled in Figure 6.
- If needed, reposition the A/C low pressure line so it is **not** touching the H-EPS pump.

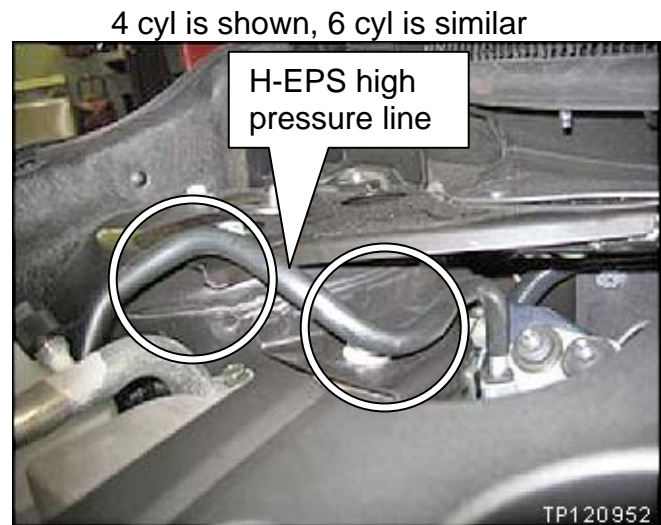
Figure 8

9. Make sure the H-EPS high pressure line is **not** touching the strut tower brace or the torque rod mounting bracket.

- Check the two locations circled in Figure 8.
- If needed, reposition the H-EPS high pressure line so it is **not touching**.

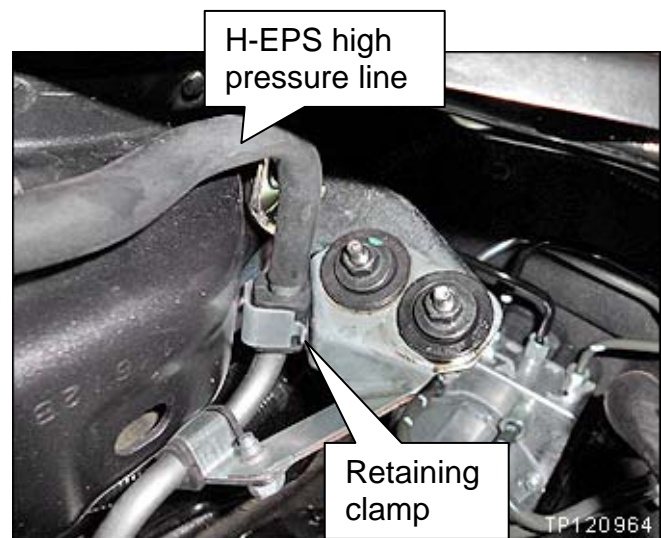
10. **For 4 cylinder models only:**
Check the H-EPS high pressure line retaining clamp shown in Figure 9.

- Make sure the clamp is secured correctly.
- Figure 9 shows a clamp that **is not** secured correctly.
- If the clamp is loose like the one shown in Figure 9, replace the H-EPS high pressure line.

- Refer to the Service Manual for replacement information.

NOTE: If the H-EPS high pressure line needs to be replaced, replace the H-EPS bracket at the same time (see page 15 or 16, as it applies).

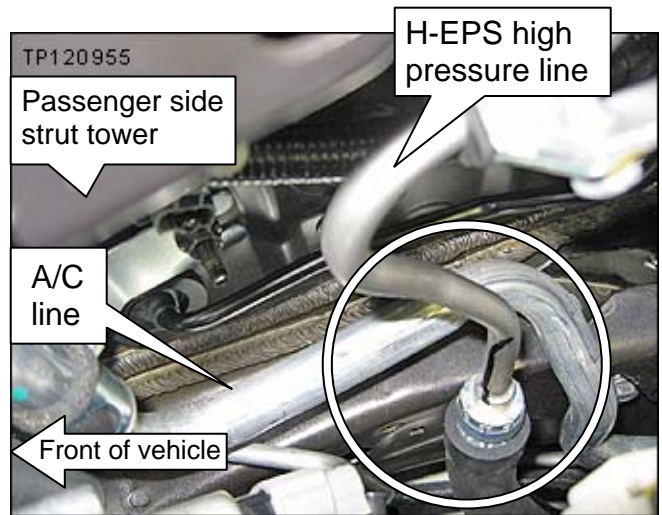
Make sure the H-EPS high pressure line is not touching the A/C line or vehicle body.

NOTE: The view in Figure 10 is downward from the inboard side of the passenger side strut tower.

- Check the area circled in Figure 10.
- If needed, reposition the lines so they are **not** touching.
- If needed, reposition the H-EPS line so it is **not** touching the vehicle body.

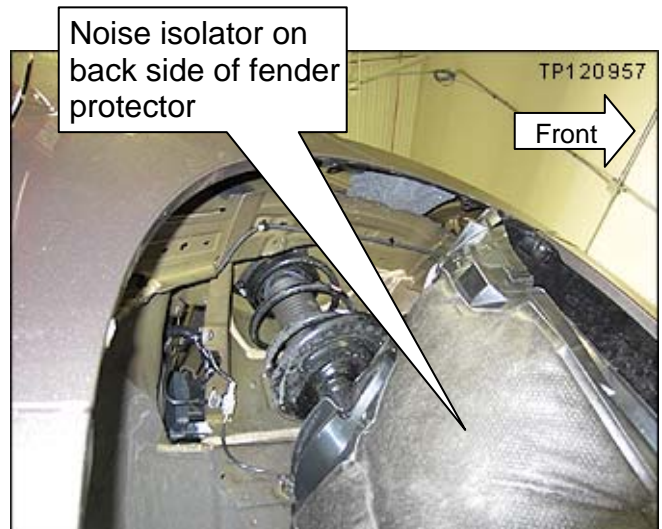
Figure 11

12. Make sure the noise insulator is installed inside the RH (passenger side) front fender protector:

- a. Remove the passenger side front wheel.
- b. Partially remove the fender protector.
 - Refer to the Service Manual as needed.
- c. Confirm the insulator is in place.
 - Make sure the insulator is installed correctly, or
 - If damaged or missing, replace the fender protector with insulator.

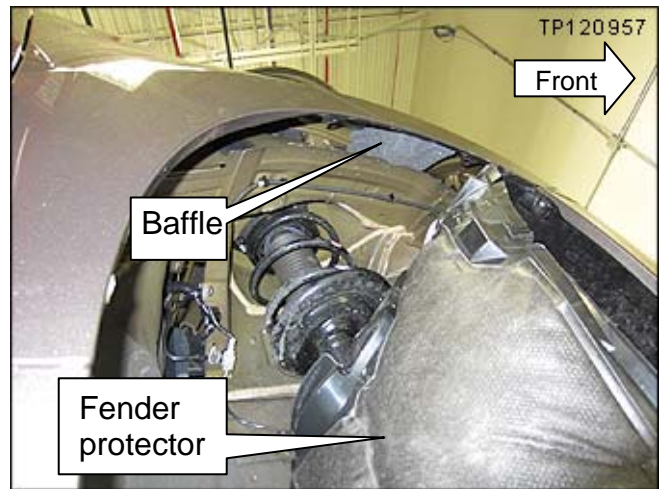
Figure 12

13. Make sure the baffle is positioned properly inside the RH (passenger side) front fender.

- The baffle should be flush against the fender.
- When the fender protector is installed there should be no gap between the fender protector and the baffle.
- If needed, reposition the baffle or install a new one.

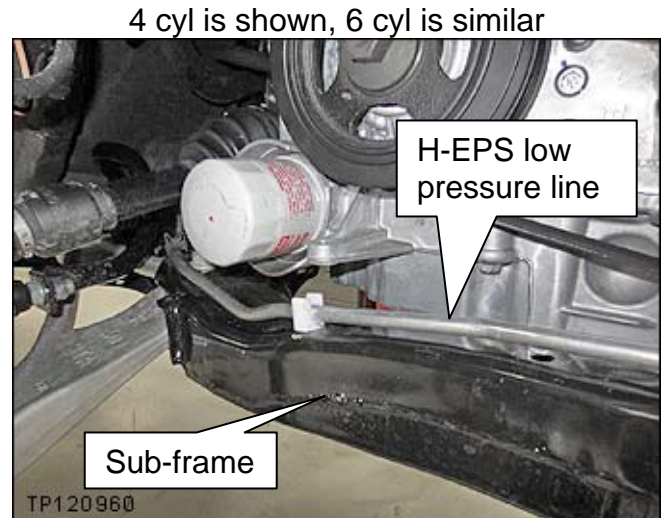
Figure 15

14. Make sure the H-EPS low pressure line is **not** touching the sub-frame near the front of the engine.

- If needed, reposition the H-EPS low pressure line so it does **not** touch the sub-frame.

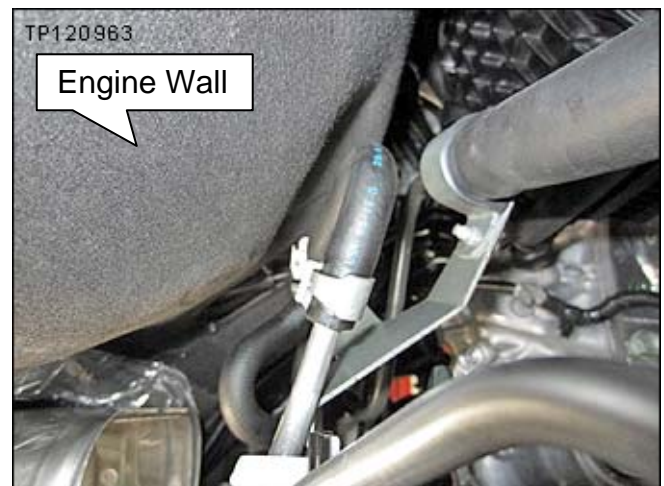
Figure 16

15. **For 4 cylinder models only:** Make sure the H-EPS lines under the vehicle are **not** touching surrounding parts.

- a. Lift the vehicle.
 - b. Visually check the routing of the under-vehicle H-EPS lines.
- If needed, reposition the H-EPS lines so they are **not** touching any surrounding parts.

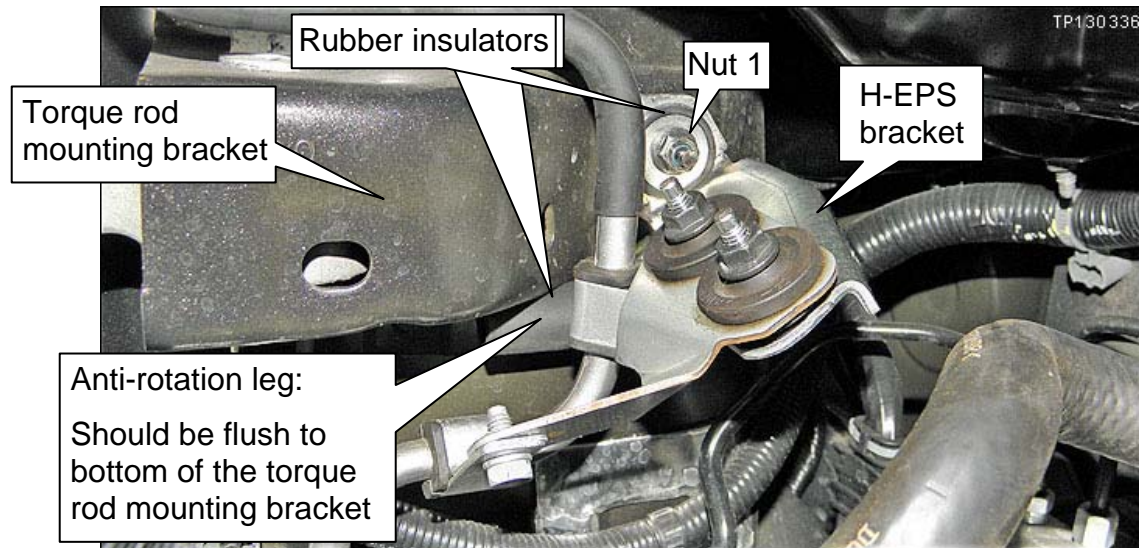
16. Make sure the anti-rotation leg of the H-EPS bracket is flush to the bottom of the torque rod mounting bracket (see Figure 17 and 18 as they apply).

17. Check the torque of Nut 1.

- Nut 1: 8 N•m (0.81 kg-m, **5.9 ft-lb, 71 in-lb**)

- If needed, reposition the H-EPS bracket so the anti-rotation leg is flush to bottom of the torque rod mounting bracket.

1a. Remove the 3 nuts shown in Figure 17.

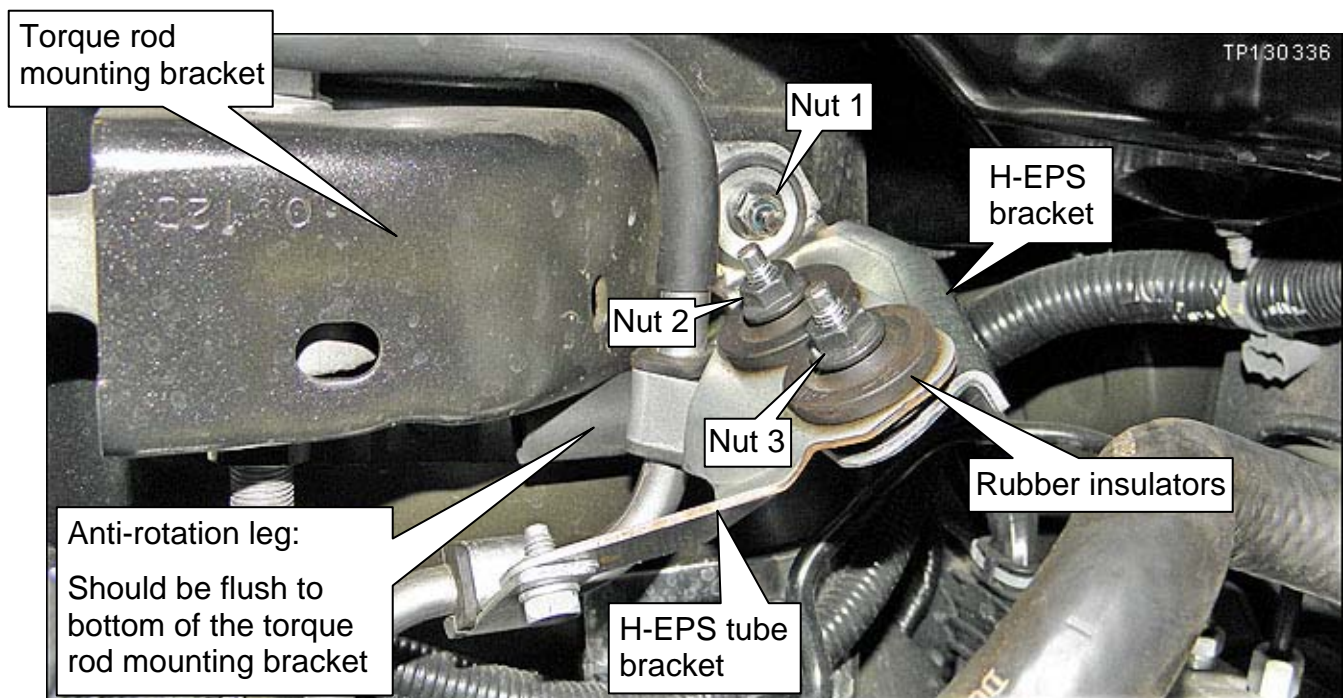
Figure 19

4a. Make sure the H-EPS bracket and the H-EPS tube bracket are not touching (see Figure 19).

5a. Make sure the anti-rotation leg of the H-EPS bracket is flush to the bottom of the torque rod mounting bracket (see Figure 19).

- There should be a gap between the brackets all the way around.
- Make sure the rubber insulators are seated properly.
- If needed, reposition the brackets so they are not touching.

- If needed, reposition the H-EPS bracket so the anti-rotation leg is flush to the bottom of the torque rod mounting bracket.
