SERVICE BULLETIN

ST12-009a

June 17, 2013

2013 ALTIMA SEDAN; NOISE FROM THE HYDRAULIC ELECTRIC POWER STEERING (H-EPS)

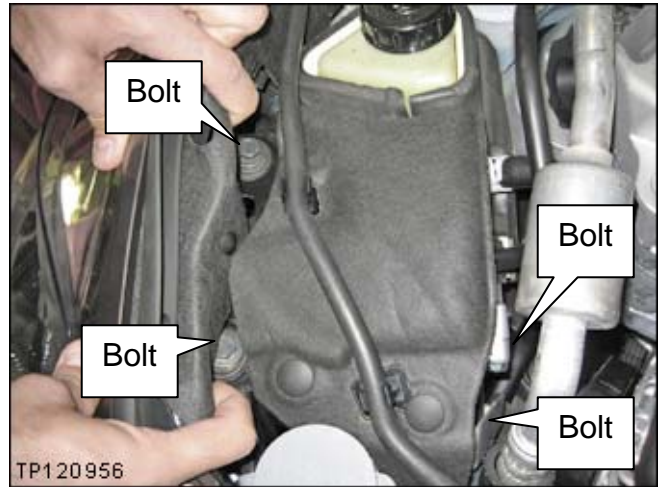
Figure 3

3. Make sure there is no binding on the H-EPS pump mounting isolator as follows:

- a. Loosen the 4 H-EPS pump mounting bolts.
- b. Move the H-EPS pump a small amount from side to side.
- c. Tighten the mounting bolts.

Torque to:

13.5 N•m (1.4 kg-m, **10 ft-lb**)

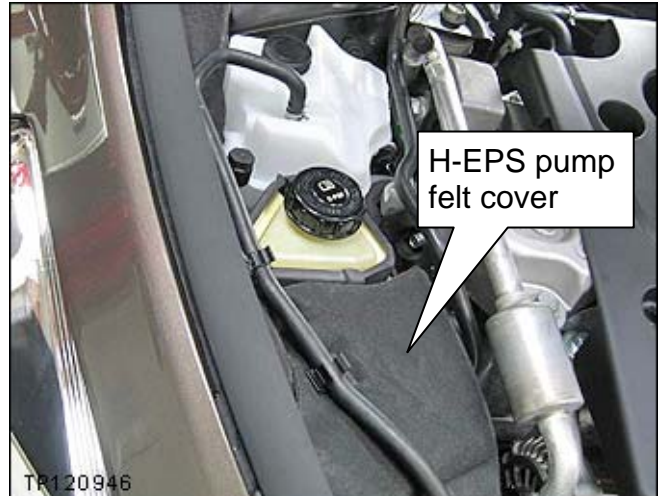
Figure 4

4. Make sure the H-EPS pump felt cover is installed correctly.

- Install felt cover correctly, or
- If damaged, replace felt cover, or
- If missing, install a felt cover.

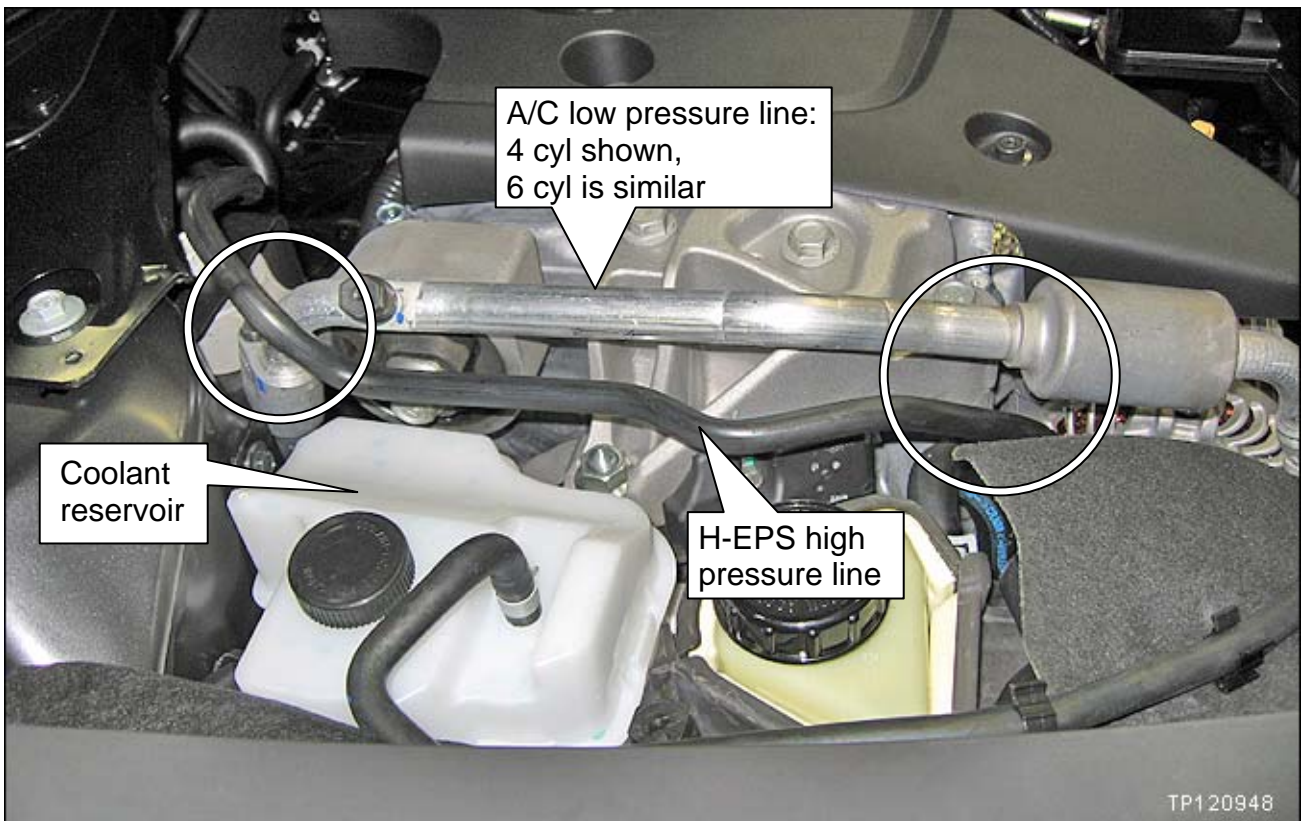
Figure 5

5. Make sure the H-EPS high pressure line and the A/C low pressure line are **not** touching (see Figure 5).
- Check the two locations circled in Figure 5.
 - If the lines are touching, reposition the lines so they are **not** touching.

6. Make sure the H-EPS high pressure line is **not** touching the coolant reservoir (see Figure 5).

If touching:

- Make sure the coolant reservoir is mounted correctly; its locator boss must be seated in the mounting hole.
- If needed, reposition the H-EPS line so it is **not** touching the reservoir.

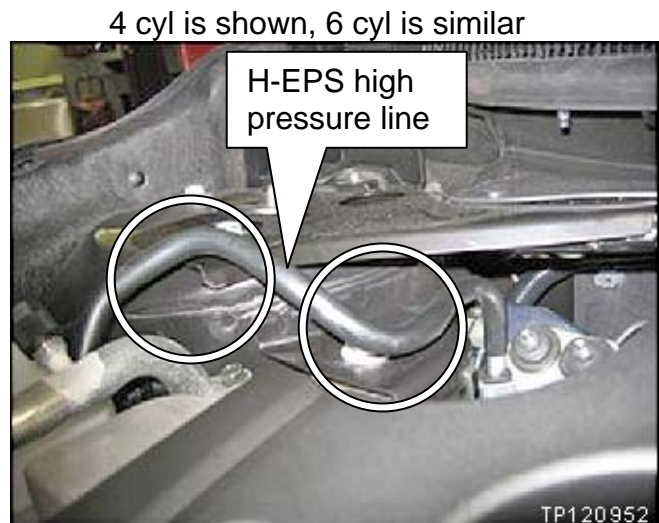
Figure 8

9. Make sure the H-EPS high pressure line is **not** touching the strut tower brace or the torque rod mounting bracket.

- Check the two locations circled in Figure 8.
- If needed, reposition the H-EPS high pressure line so it is **not touching**.

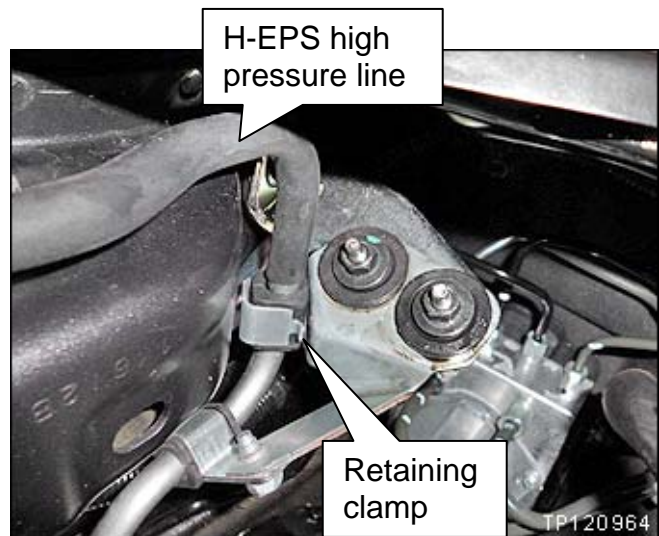
10. **For 4 cylinder models only:**
Check the H-EPS high pressure line retaining clamp shown in Figure 9.

- Make sure the clamp is secured correctly.
- Figure 9 shows a clamp that **is not** secured correctly.
- If the clamp is loose like the one shown in Figure 9, replace the H-EPS high pressure line.

- Refer to the Service Manual for replacement information.

NOTE: If the H-EPS high pressure line needs to be replaced, replace the H-EPS bracket at the same time (see page 15 or 16, as it applies).

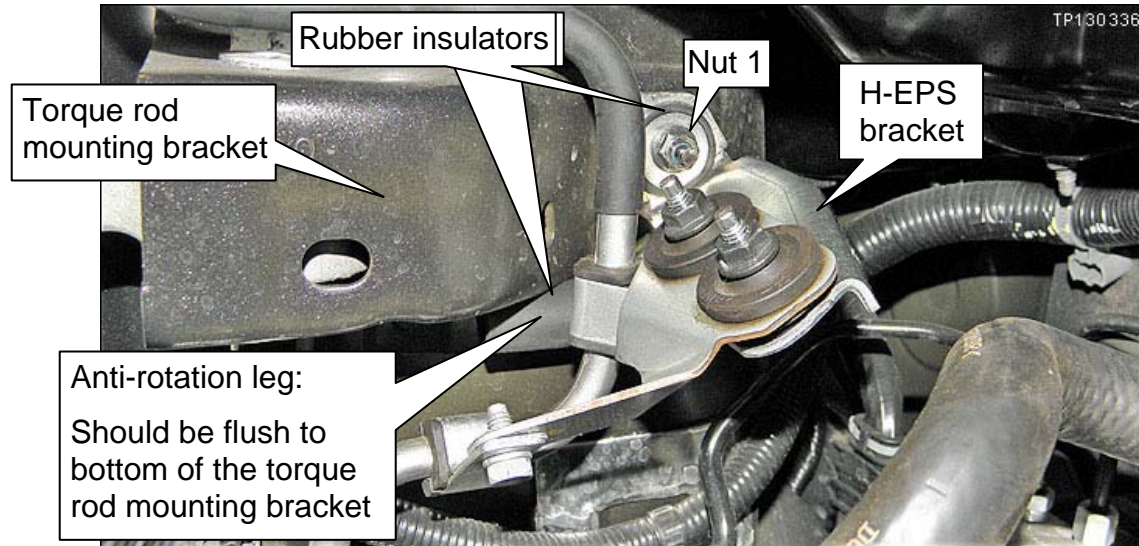
16. Make sure the anti-rotation leg of the H-EPS bracket is flush to the bottom of the torque rod mounting bracket (see Figure 17 and 18 as they apply).

17. Check the torque of Nut 1.

- Nut 1: 8 N•m (0.81 kg-m, **5.9 ft-lb, 71 in-lb**)

- If needed, reposition the H-EPS bracket so the anti-rotation leg is flush to bottom of the torque rod mounting bracket.

1a. Remove the 3 nuts shown in Figure 17.

2a. Remove the old bracket and install the new bracket.

3a. Reinstall the 3 nuts and torque to:

Nut 1: 8 N•m (0.81 kg-m, **5.9 ft-lb, 71 in-lb**)

Nut 2 & 3: 4.9 N•m (0.49 kg-m, **3.6 ft-lb, 43 in-lb**)

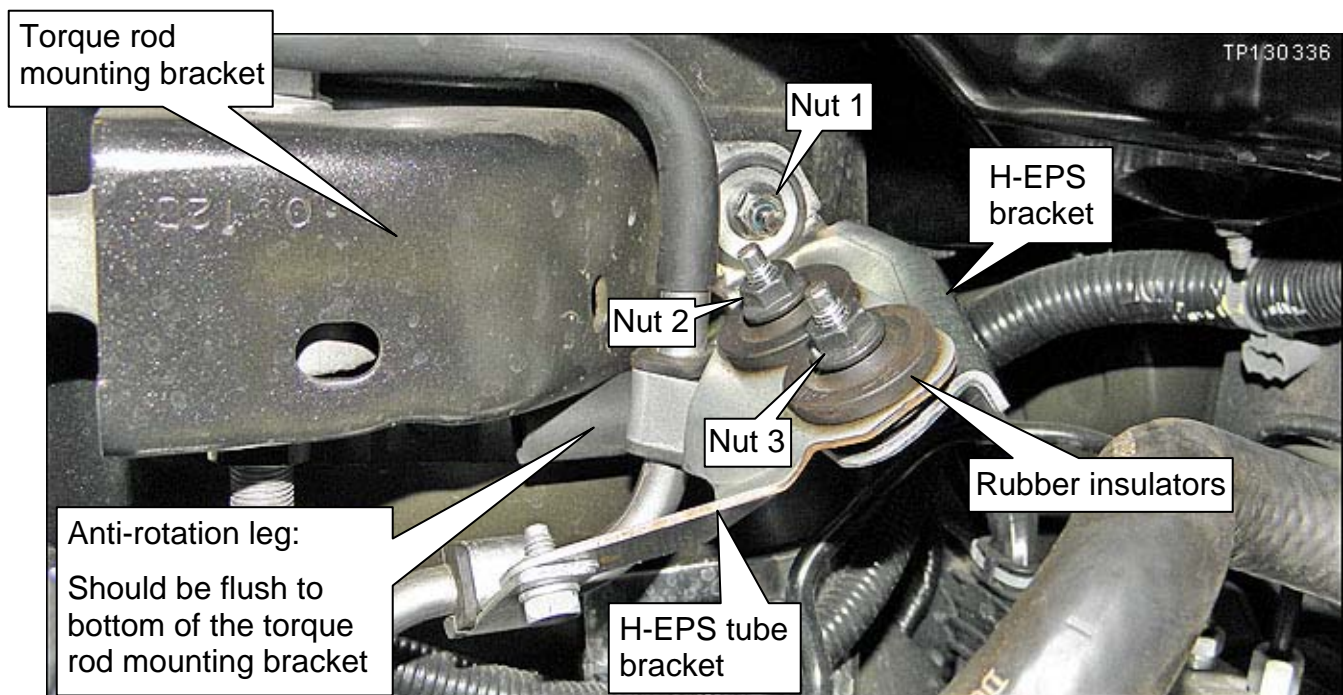
Figure 19

4a. Make sure the H-EPS bracket and the H-EPS tube bracket are not touching (see Figure 19).

5a. Make sure the anti-rotation leg of the H-EPS bracket is flush to the bottom of the torque rod mounting bracket (see Figure 19).

- There should be a gap between the brackets all the way around.
- Make sure the rubber insulators are seated properly.
- If needed, reposition the brackets so they are not touching.

- If needed, reposition the H-EPS bracket so the anti-rotation leg is flush to the bottom of the torque rod mounting bracket.
