Service Bulletin

Subject: Pop Noise From Fuel Tank After a Cold Start or EVAP Purge Event (Equinox / Terrain)

Models: 2010 -2014 Chevrolet Equinox
2010-2014 GMC Terrain

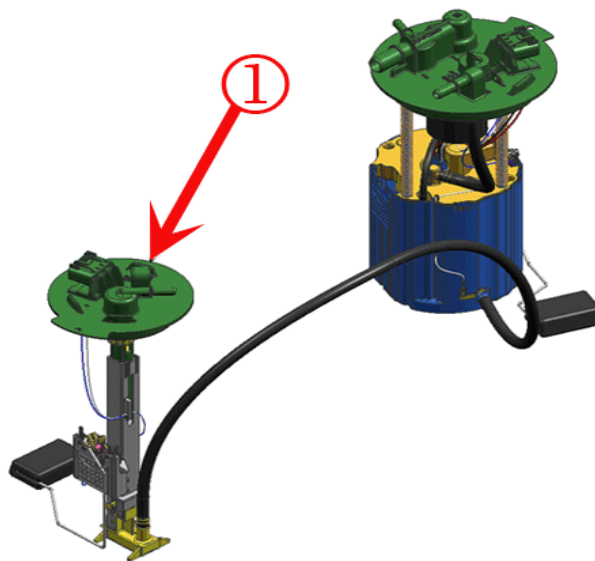
(1) Flange location

The part number on the box of the auxiliary fuel module has not changed but the auxiliary fuel module inside of the box has. After ordering the auxiliary fuel module, remove it from the box and verify the letters "PPA" are casted into the top of the fuel module flange. This is the revised auxiliary fuel module designed to correct the pop/popping noise. The original auxiliary fuel module has "POM" casted into the flange.
