Special Instruction**Air Control Valve (ACV) Connector with Plugs Installed Backwards in Empty Connector Cavities{7000}**

Media Number -REHS8421-00

On Highway Truck:

CT660 (S/N: TRK1-UP; TKL1-UP; TGT1-UP)

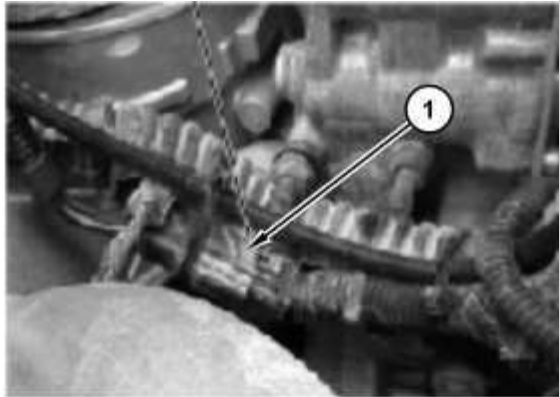
Illustration 1

(1) ACV connector

4. Locate updated ACV connector (1) secured to Coolant Control Valve (CCV) near front on passenger side of engine.
 5. Unlatch red lock button and disconnect ACV connector.
 6. Locate one of the small rectangular holes inside ACV connector that corresponds to one of the incorrectly installed plugs. Using terminal release tool, gently push plastic plug out of the end of connector. Repeat for remaining two plugs.
-

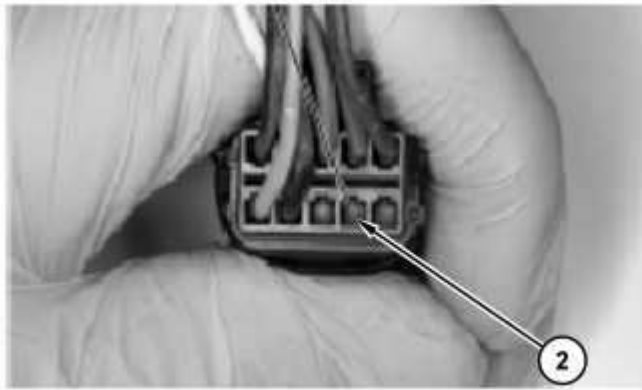
Illustration 2 g03380624

(2) Incorrectly installed plugs

7. Inspect plugs in ACV connector to determine if the connector has been inserted backwards (2). If installed incorrectly, plugs must be reinstalled to proper orientation (3) following this procedure.

Note: Incorrectly installed plugs may cause corrosion due to moisture intrusion. If ACV connector is corroded or damaged, do not attempt repair.

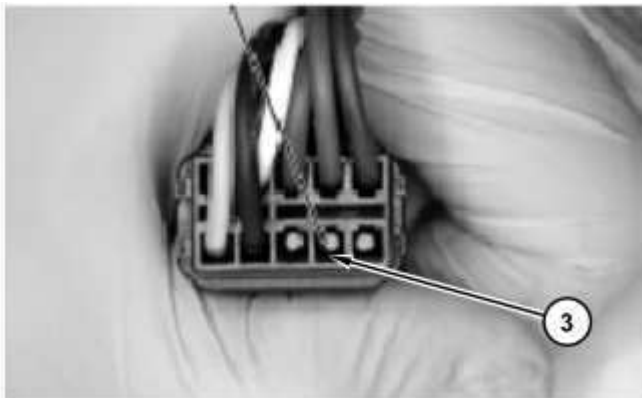
Illustration 3 g03380626

(3) Correctly installed plugs

9. Reinsert plugs with square end first and barbed tooth facing outward. Gently push plugs into connector, leaving approximately 2.5 mm (0.1 inch) protruding.

10. Using a small flathead screwdriver, gently push each plug into locked position. Plugs will click when fully inserted.

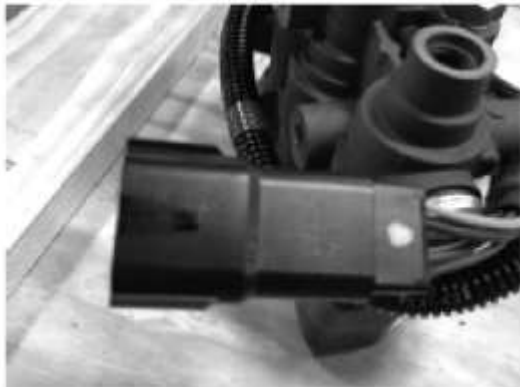
Illustration 14

Marked ACV Connector

14. Plug both mating ends of connector back together and re-latch red lock button. Using a paint marker, place a yellow paint dot on base of connector to indicate connector has been reworked.
