Service Bulletin

SUBJECT: Service Update for Inventory and Customer Vehicles
Incorrect Battery Current Sensor on Negative Battery Cable Assembly
Expires with Base Warranty

MODELS: 2013 Cadillac Escalade, Escalade ESV
2013 Chevrolet Tahoe, Suburban
2013-2014 Chevrolet Captiva, Captiva Sport
2014 Chevrolet Silverado
2013 GMC Yukon, Yukon XL
2014 GMC Sierra

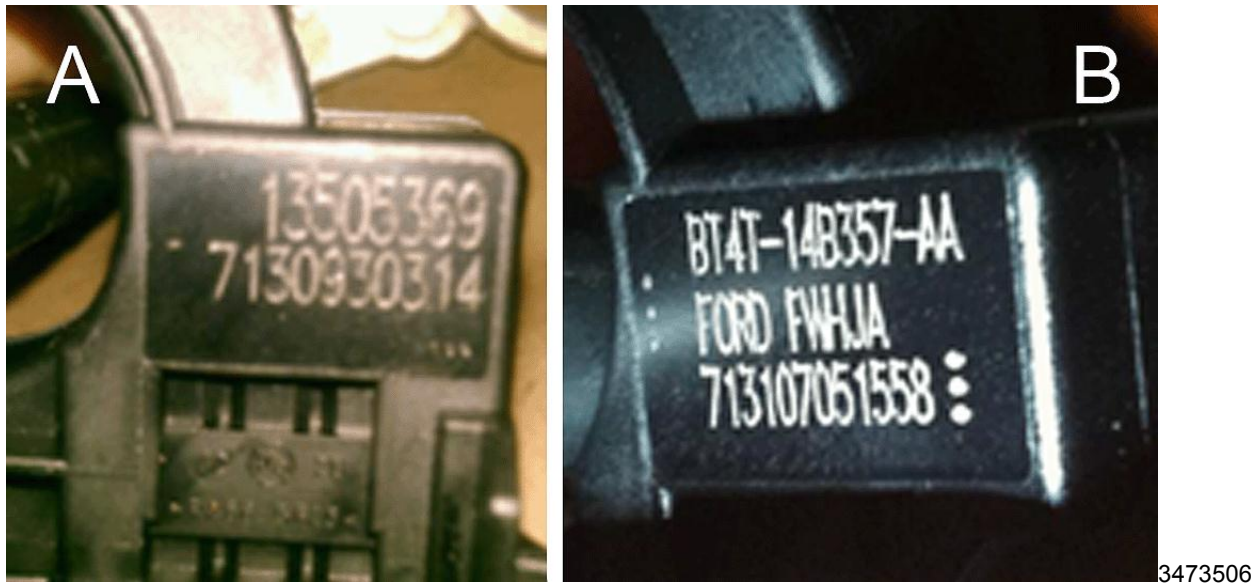
An incorrect battery current sensor may have been installed on the negative battery cable assembly. Perform the inspection procedure below to determine if an incorrect battery current sensor was installed.

Note: The battery current sensor part number is located on the backside of the sensor. Use a mirror and light to read the part number. If you cannot read the part number with a mirror and light, disconnect the sensor to read the part number. Refer to photograph. Portion 'A' of the photograph shows the correct part number for the battery current sensor. Portion 'B' of the photograph shows an incorrect part number for the battery current sensor.

3. Determine the part number on the battery current sensor.
 - If the battery current sensor part number is 13505369, the correct battery current sensor is installed on the negative battery cable. No further action is required.
 - If the battery current sensor part number is BT4T-14B357-AA, the incorrect battery current sensor is installed on the negative battery cable. Proceed to step 4.
4. Remove the negative battery cable from the vehicle. Refer to *Battery Negative Cable Replacement* or *Battery Positive and Negative Cable Replacement* in SI.
5. Install a new negative battery cable. Refer to *Battery Negative Cable Replacement* or *Battery Positive and Negative Cable Replacement* in SI.
