TECHNICAL BULLETIN
LTB00550NAS1
27 JUN 2013

Driver's Door Window Control Switch Pack Inoperative

Range Rover (LG)

Model Year: 2013

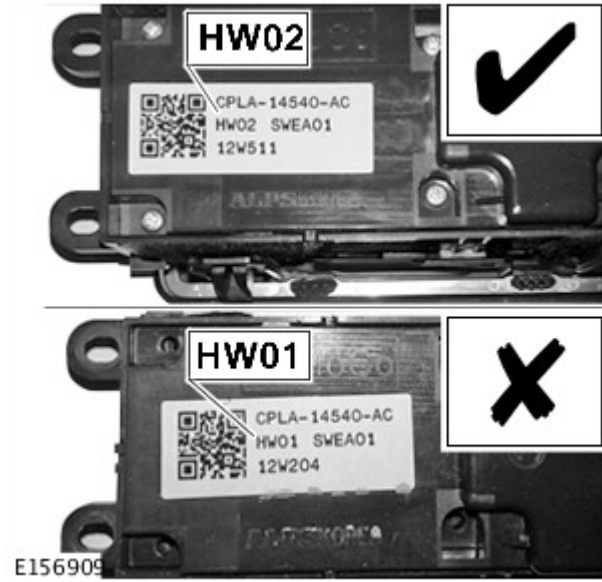
**NOTE: The new driver's door window control switch pack will be identified by the software number 'HW02'.**

Replace the driver's door window control switch pack (see Topix Workshop Manual section 501-11).
