SB-10052508-4836

Title: Terra Exhaust Leak Repair at Turbocharger Adapter to Down Pipe Joint

Applies To: TerraStar Models

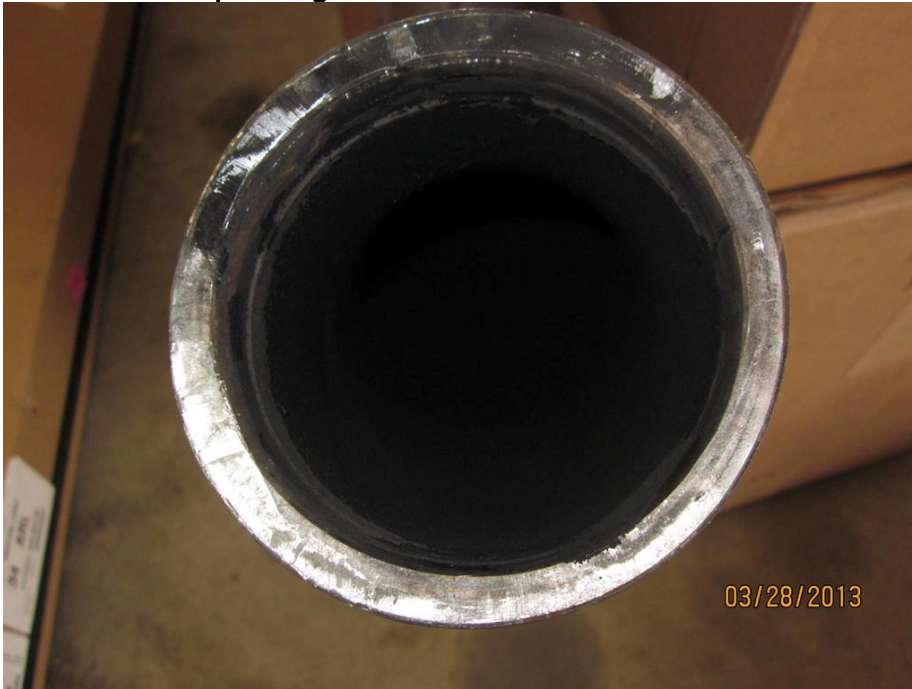
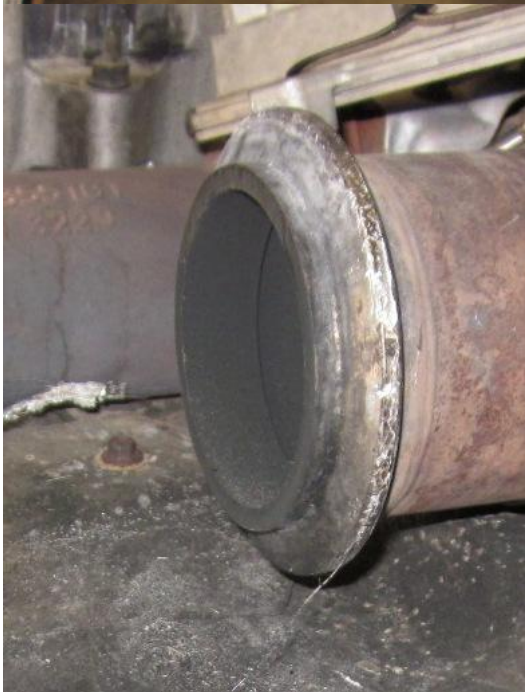
TerraStar Exhaust Leak between the Turbocharger Adapter and the Turbocharger Down Pipe

Leak at Down Pipe Flange Area

Remove the V-Band Clamp that retains the Turbo Down Pipe to the Adapter.
 Install gasket listed between the mating flanges and reassemble.
 Inspect V-Band clamp P/N 3844630C1 for damage and replace if required.
 Install clamp and Torque Clamp to Specs 14-18Nm / 124-168 lbs. inch
