**SB-10052508-6585**

Title: Terra Exhaust Leak Repair at Turbocharger Adapter to Down Pipe Joint

Applies To: TerraStar Models

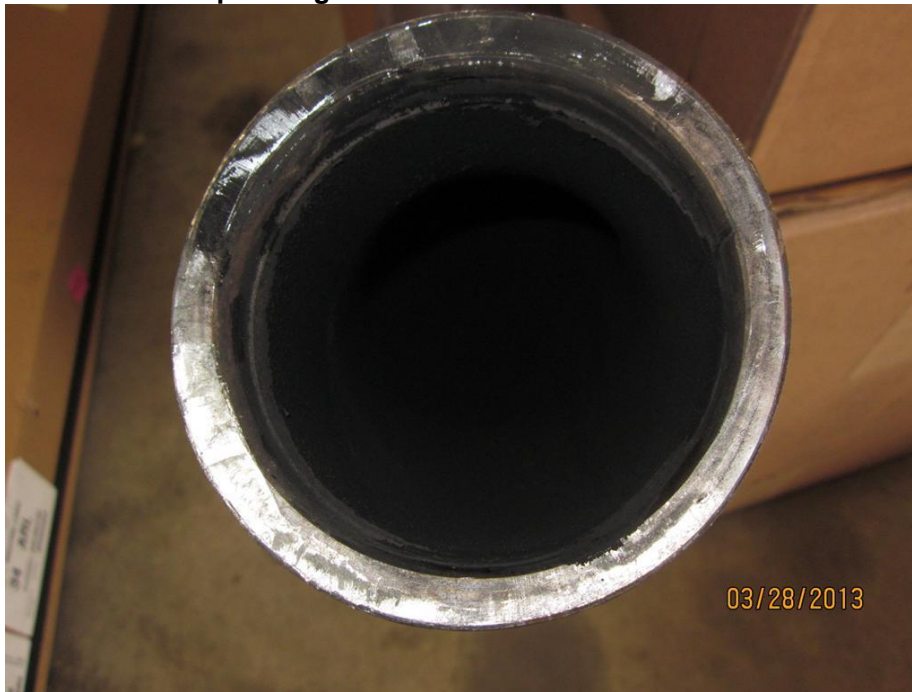
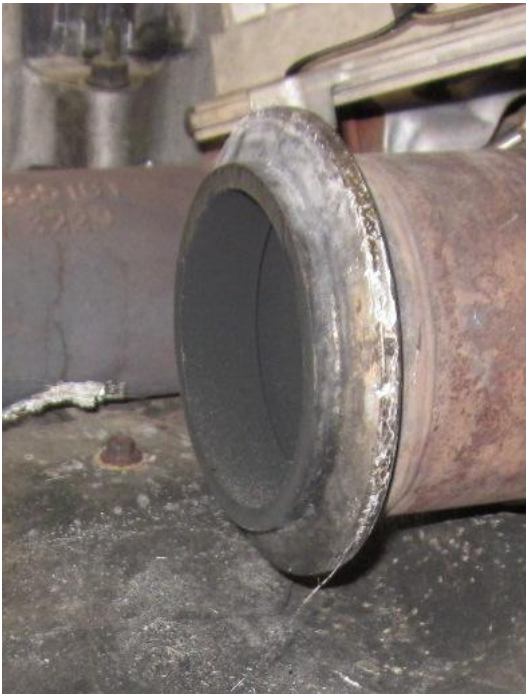
**Leak at Down Pipe Flange Area**

Remove the V-Band Clamp that retains the Turbo Down Pipe to the Adapter.  
 Install gasket listed between the mating flanges and reassemble.  
 Inspect V-Band clamp P/N 3844630C1 for damage and replace if required.  
 Install clamp and Torque Clamp to Specs 14-18Nm / 124-168 lbs. inch
