Authorized Field Change

AFC 13908

Subject: 9900® and Paystar® Clutch Adjustment for Certain Vehicles Marked in Service PortalSM with AFC 13908

Model: 9900® and PayStar®

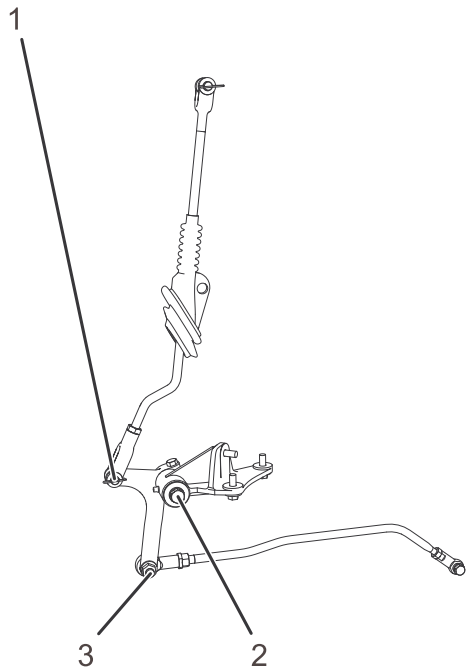
Figure 1. Clutch Relay Lever (Bell Crank Lever).

Certain 9900® and PayStar® models may not be able to obtain the proper clutch adjustment specification. If the clutch is not adjusted properly, this can cause improper clutch pedal free play, or the clutch brake may not function properly. If the clutch cannot be adjusted correctly, this AFC provides the service procedures to replace the vertical clutch rod and bell crank (clutch relay lever).

1. Clutch rod vertical linkage
 2. Clutch relay lever connection to bracket
 3. Clutch relay lever horizontal linkage
4. Disconnect clutch rod vertical linkage (Figure 1, Item 1) from clutch relay lever (bell crank).
 5. Disconnect horizontal linkage (Figure 1, Item 3) from clutch relay lever.
 6. Remove clutch relay lever (Figure 1, Item 2) from clutch relay lever bracket.

1. Install new clutch relay lever (Figure 1, Item 2) on clutch relay lever bracket.
2. Install horizontal linkage (Figure 1, Item 3) to clutch relay lever.
3. Install new vertical clutch rod linkage (Figure 1, Item 1) to clutch relay lever.
