Technical Service Bulletin

01 Engine does not start, rough running, excess moisture found in intake piping

01 13 04 2032958/1 June 6, 2013.

Model(s)	Year	VIN Range	Vehicle-Specific Equipment
A3 TDI	2010-2013	All	Not Applicable

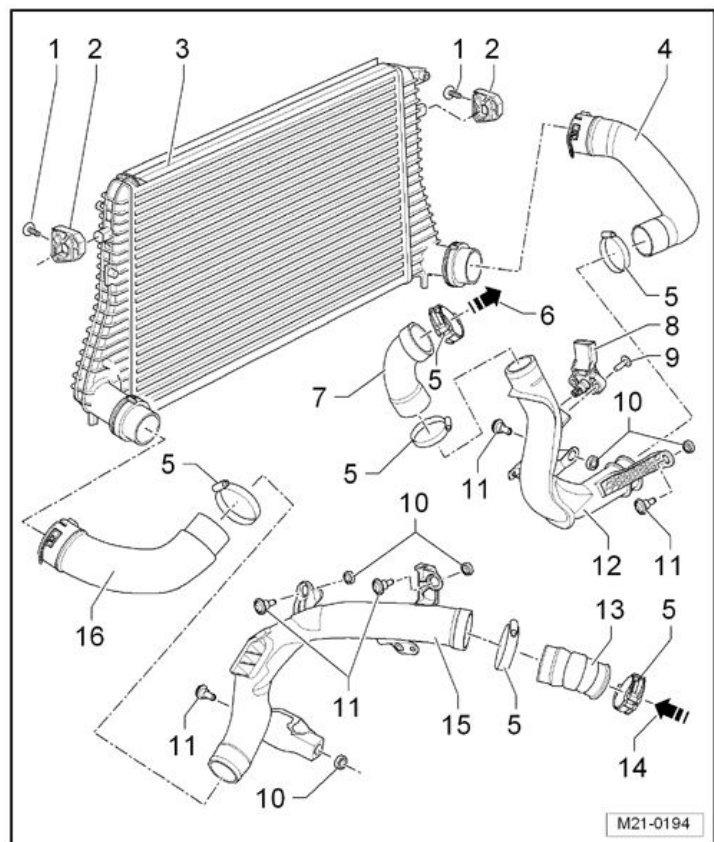
Figure 1: Charge air cooler and intake hose layout

Moisture from the intake air condenses and collects in the charge air cooler. At cold temperatures, this moisture can freeze, causing blockage of the intake air system.

Install revised charge air cooler kit **1K0198803B** to avoid the formation of this moisture in the boost system:

1. Lock carrier in service position. See *Repair Manual* >> *Group 50* in ElsaWeb.
2. Remove radiator and radiator fan assembly.
3. Separate A/C condenser from charge air cooler.
4. Remove the original charge air cooler (Figure 1, number 3) from the vehicle.

5. Remove the lower charge pressure hoses (Figure 1, numbers 4 and 16) and clean off any moisture or sludge. See *Repair Manual Group 21* >> *Turbocharger/G-Charger* >> *Description and Operation* >> *Component Overview* in ElsaWeb.
6. Remove cold side charge air pipe (Figure 1, number 12) and pressure hose to throttle valve (Figure 1, number 7).
7. Separate the A/C condenser from the charge air cooler.
8. Separate the charge air pressure sensor –G31– from cold side charge air pipe.

17. Install the revised charge air cooler (Figure 1, number 3) with regulating flap and connect the regulating flap vacuum hose.
18. Re-assemble all charge air pipe connections.
19. Connect A/C condenser to charge air cooler using fasteners from kit, and install radiator with fan assembly.
20. Reassemble front carrier.
21. Re-aim headlights.

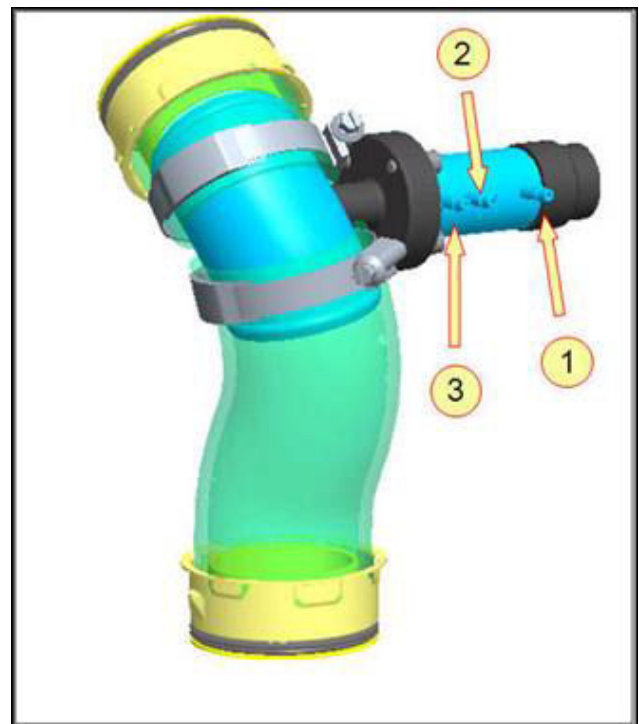
Figure 2: Vacuum hose routing on temperature switch, showing ventilation hose to air cleaner (1), hose to vacuum source (2), and hose to charge air cooler regulator flap (3).

11. Install the cold side charge air pipe (Figure 1, number 12) and connect the charge air pressure sensor -G31- electrical connector.
12. Note the vacuum hose routing on the temperature switch (Figure 2).

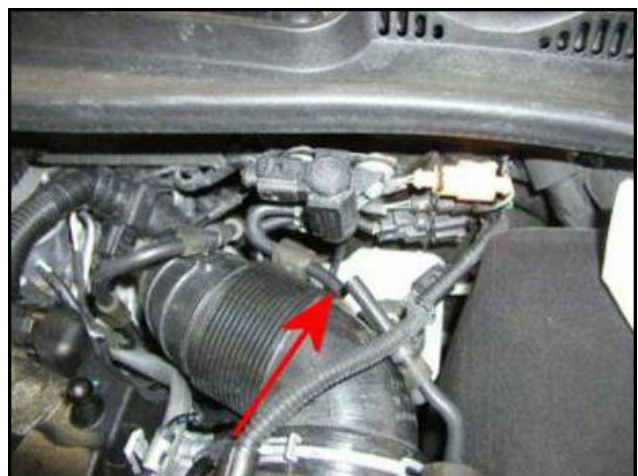
Figure 5: The red arrow indicates where to cut ventilation hose.

14. Cut ventilation hose to air cleaner (Figure 5).

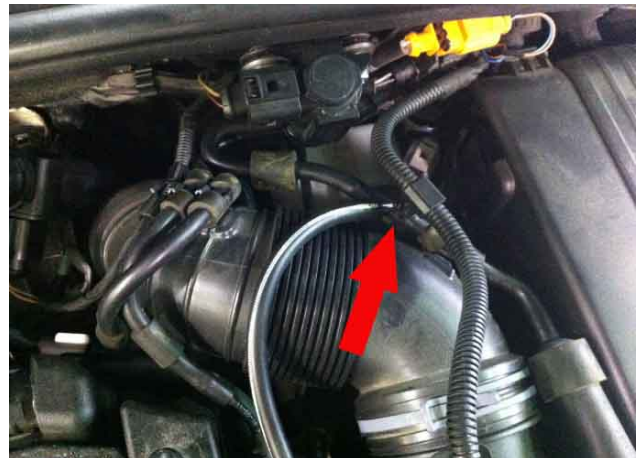
Figure 6: The red arrow indicates where to install splice.

15. Install splice (Figure 6).

Tip: Note the white tracer on the vacuum hose (Figure 6).

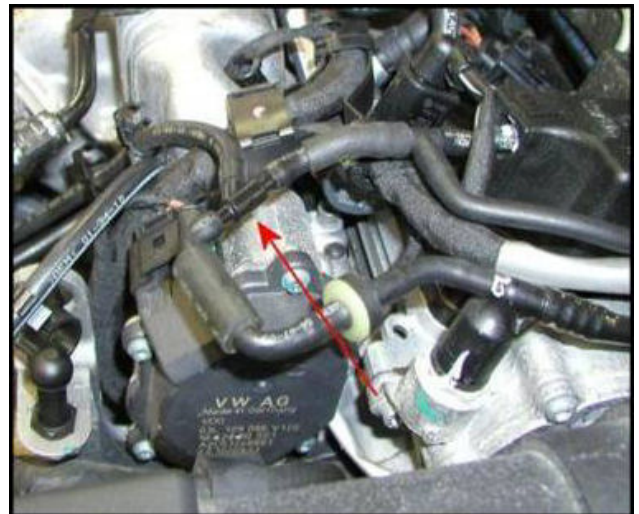
Figure 7: The red arrow indicates where to cut vacuum source hose and install splice.

16. Cut vacuum source hose where indicated (Figure 7) and install splice.
