# Technical Service Bulletin

## 21 Mil on (DTC P0299 - negative pressure deviation); turbocharger excessive wastegate play

21 13 16 2031245/6 July 9, 2013. Supersedes Technical Service Bulletin Group 21 number 13-14 dated June 7, 2013 for reasons listed below.

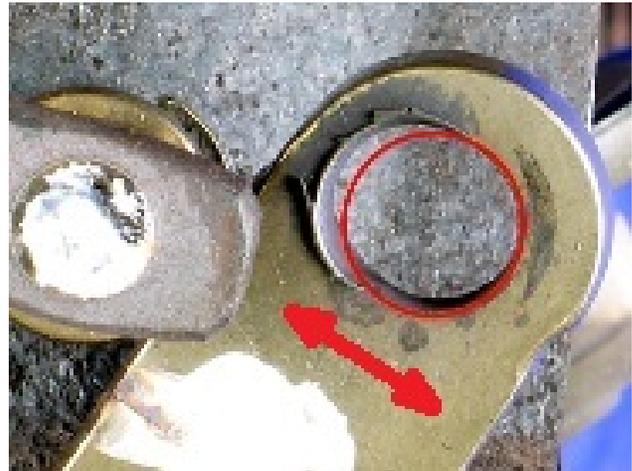
Under certain driving conditions, the linkage for the waste gate actuation can encounter excessive wear which leads to play at the waste gate flap. This leads to boost escaping through a loose flap, which sets **DTC P029900** (Negative Pressure Deviation).

**Figure 1.** Worn eye on wastegate link plate allowing excessive play.

- ### 2. Remove turbocharger according to the instructions in ElsaWeb: *Repair Manual* >> *Engine / Engine Mechanical* >> *21 Turbocharger, G-Charger* >> *Removal and Installation* >> *Turbocharger*.

3. Install clip **06J145220B** on a new, replacement turbocharger's link plate and actuating rod joint as illustrated (Figures 2 and 3).

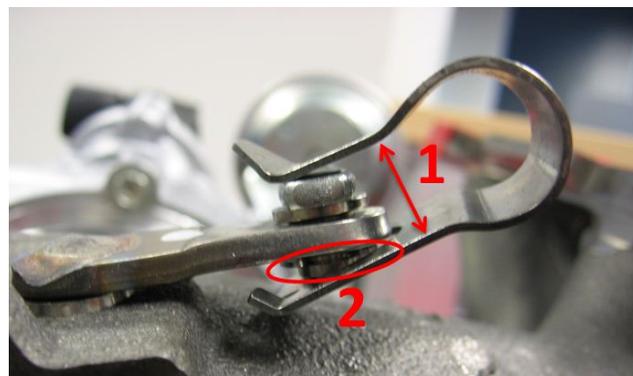
**Figure 4.** (1) Maximum opening of clip, (2) Position of original circlip

- The spring clip must not be overstretched. The maximum opening of the spring clip is 14 mm (Figure 4, 1).
- The spring clip must be replaced after every removal.

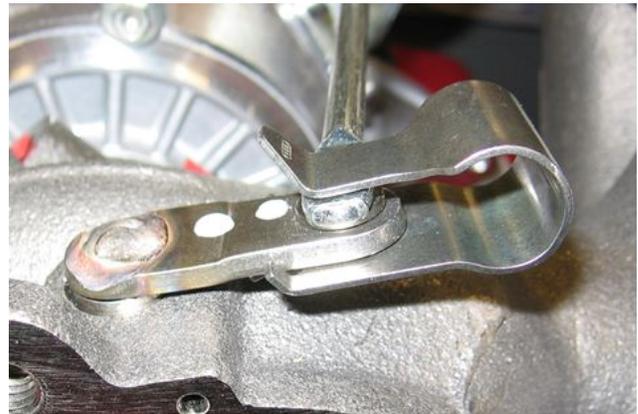
**Figure 5.** Correctly-fitted clip.

5. After fitting the spring clip, check for correct fit (Figure 5).

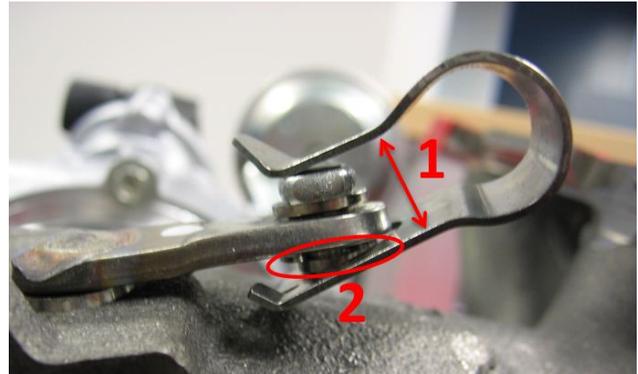
**Figure 6.** (1) Maximum opening of clip, (2) Position of original circlip

6. After fitting the spring clip, check the position of the original circlip (Figure 6, 2) and correct it if necessary.
